Preservation Survey and Situation Assessment

Acre's El-Jazzar Mosque

Engineering-Construction failures and risks in The Minaret (Al-Madhana) (summary)

February 2023

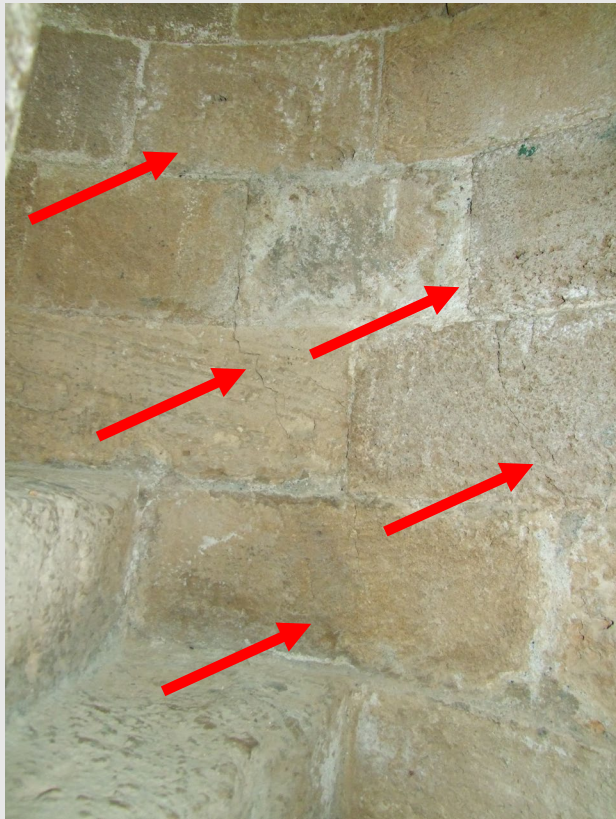
Stairs 9-13

Cracks and a fracture in the eastern wall, opposite the stair

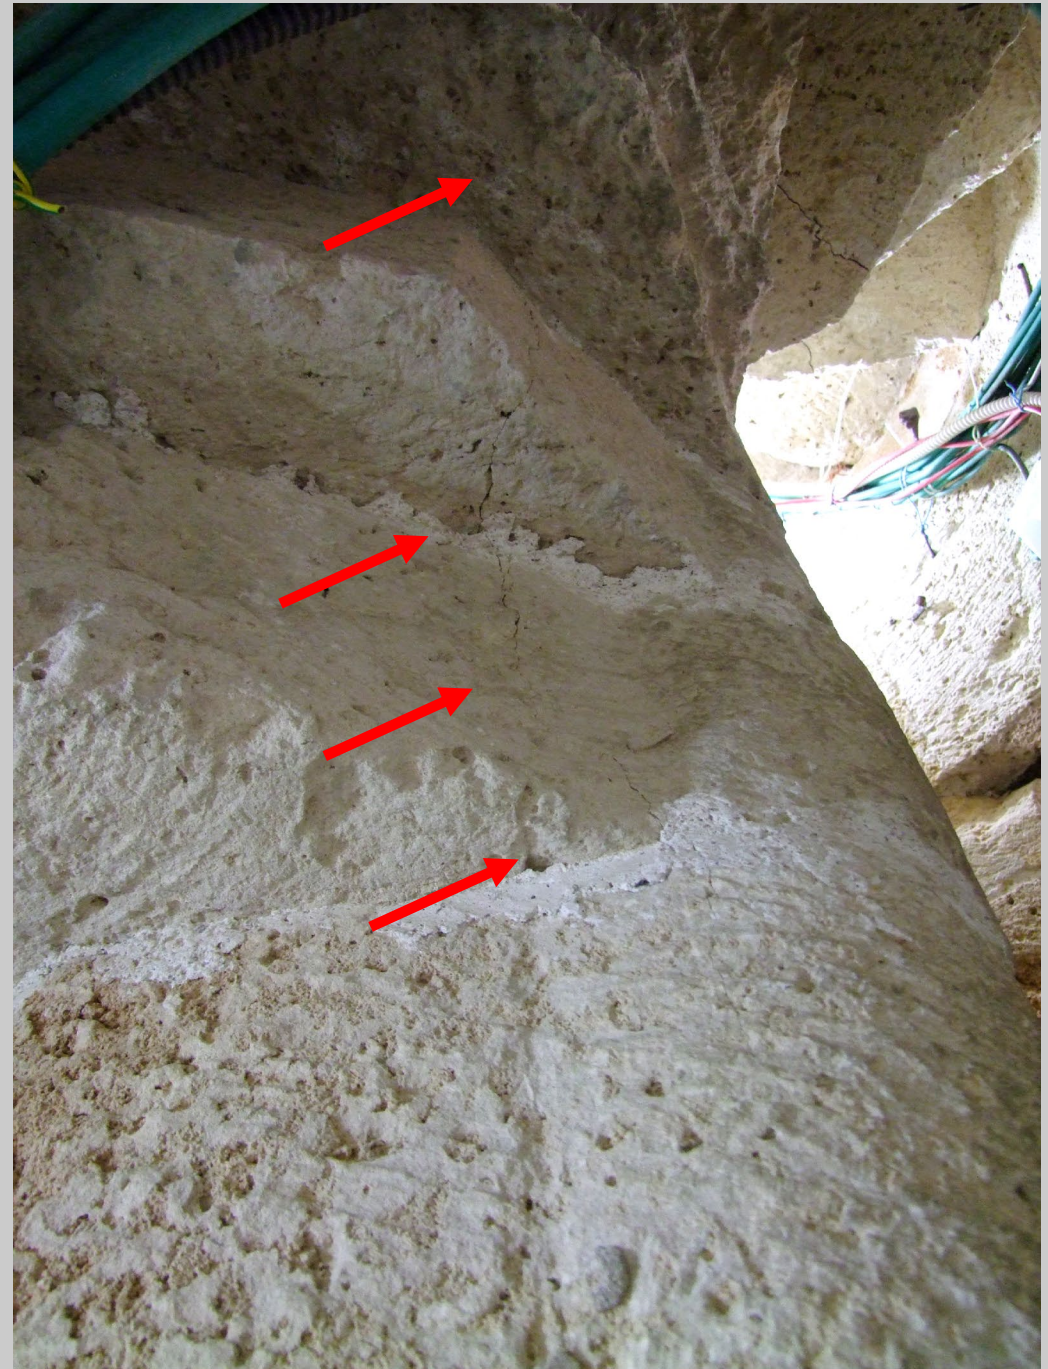
Stairs 11-13

Cracks running down the length of the stairs (0.3-0.6 cm)

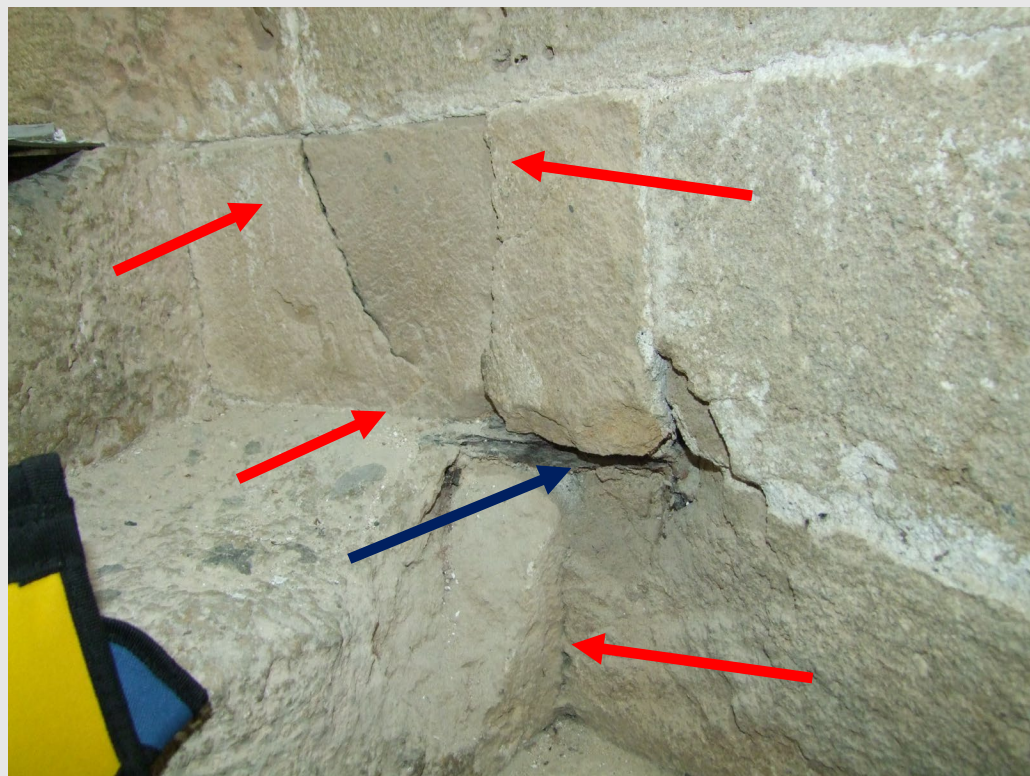
12

Cracks and a fracture in the southern wall, opposite Stair

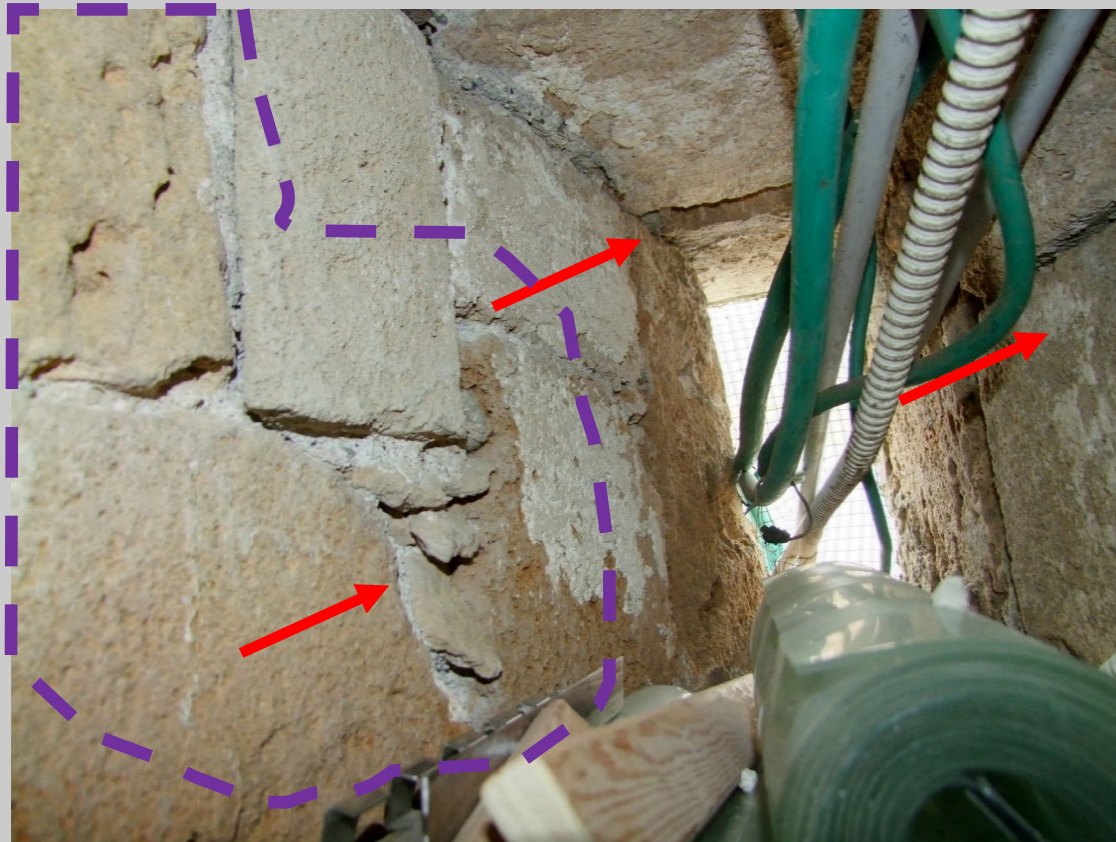
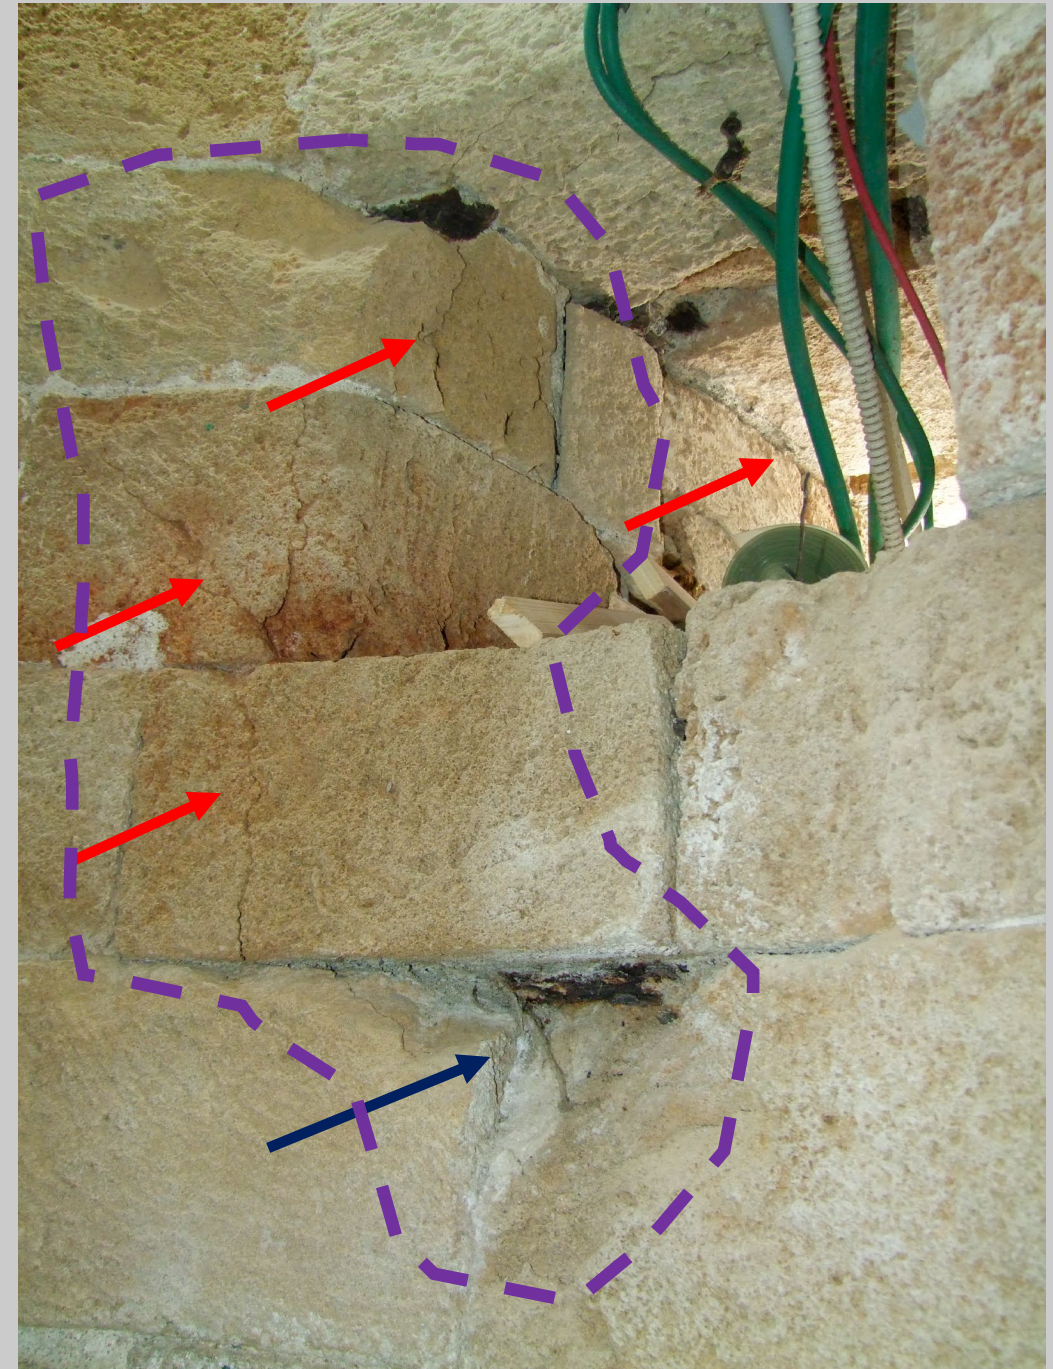
The first window

Cracks and weathering in the window stones
Rust and expansion of the steel nails under the window

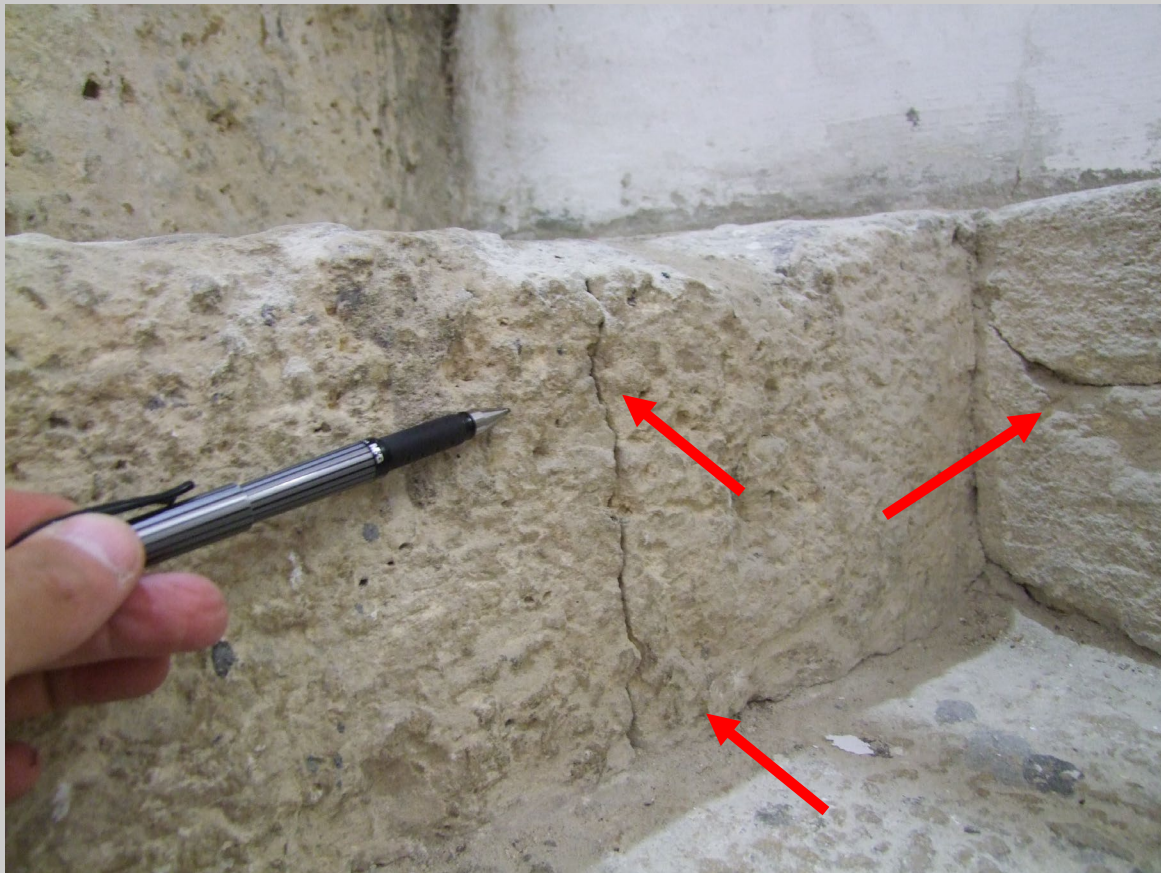
Stair 15

Crack at the center of the stair, which continues to the stairs above

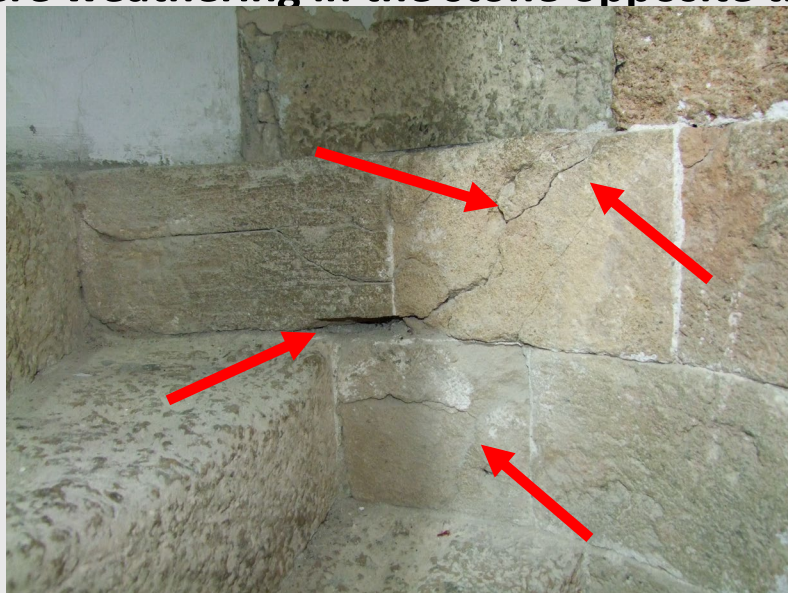
Cracks and severe weathering in the stone opposite the stair

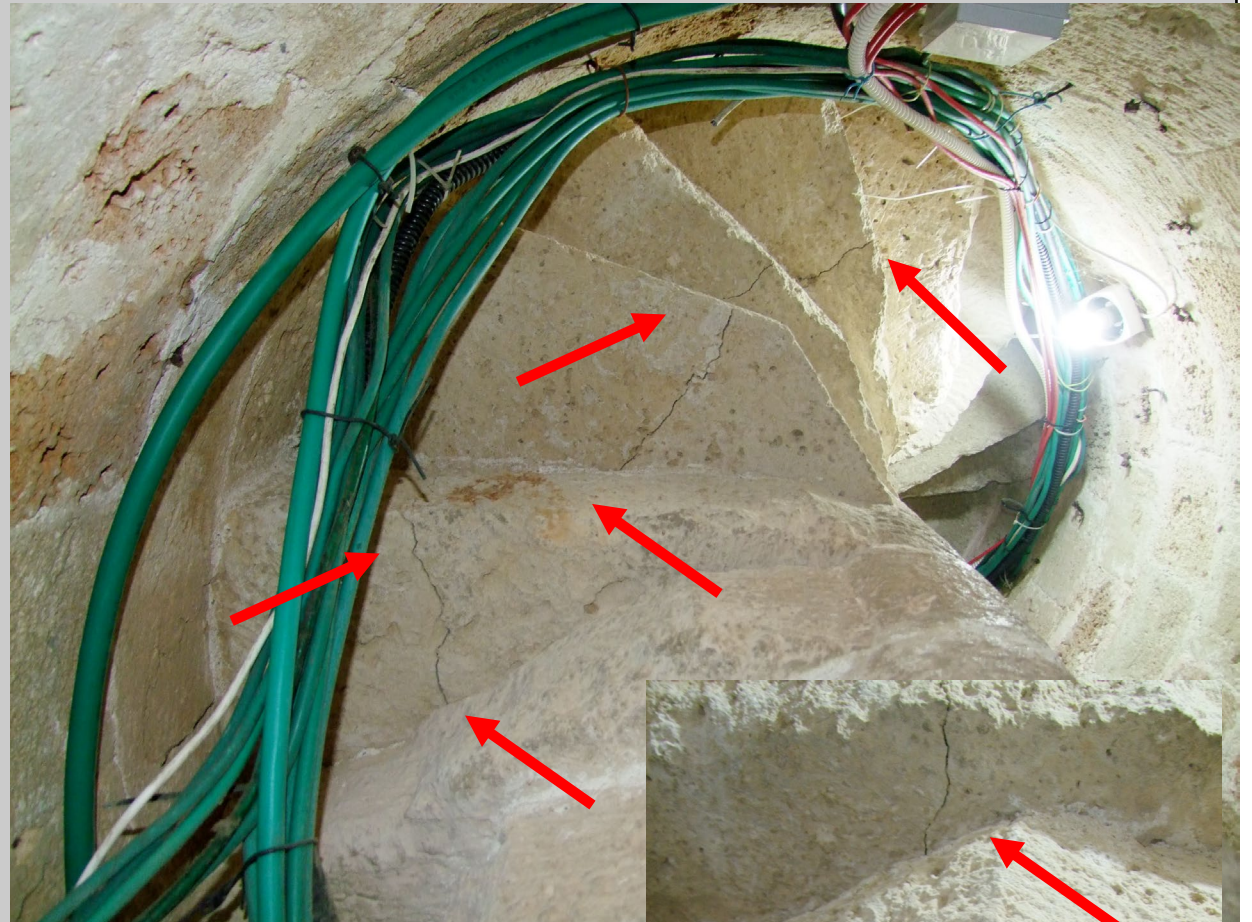
Stairs 15-22

Cracks along the stairs (0.5-0.7 cm)

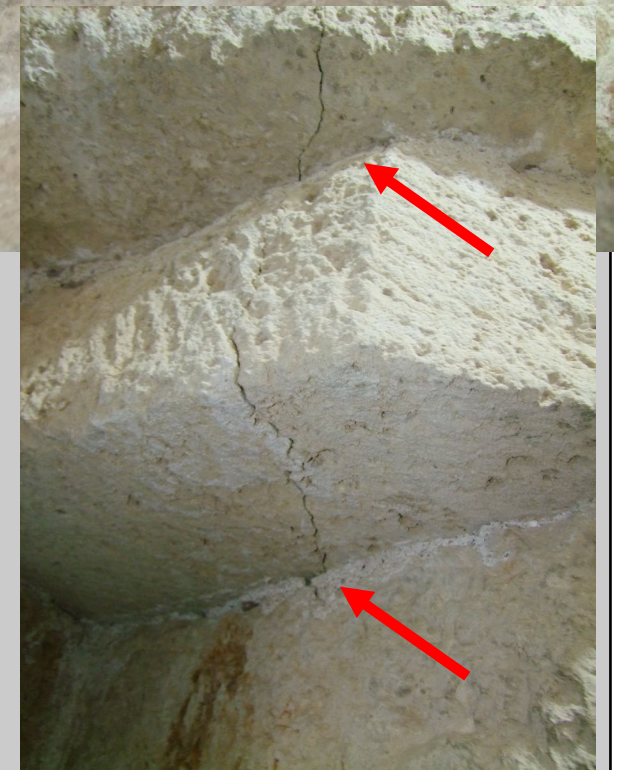
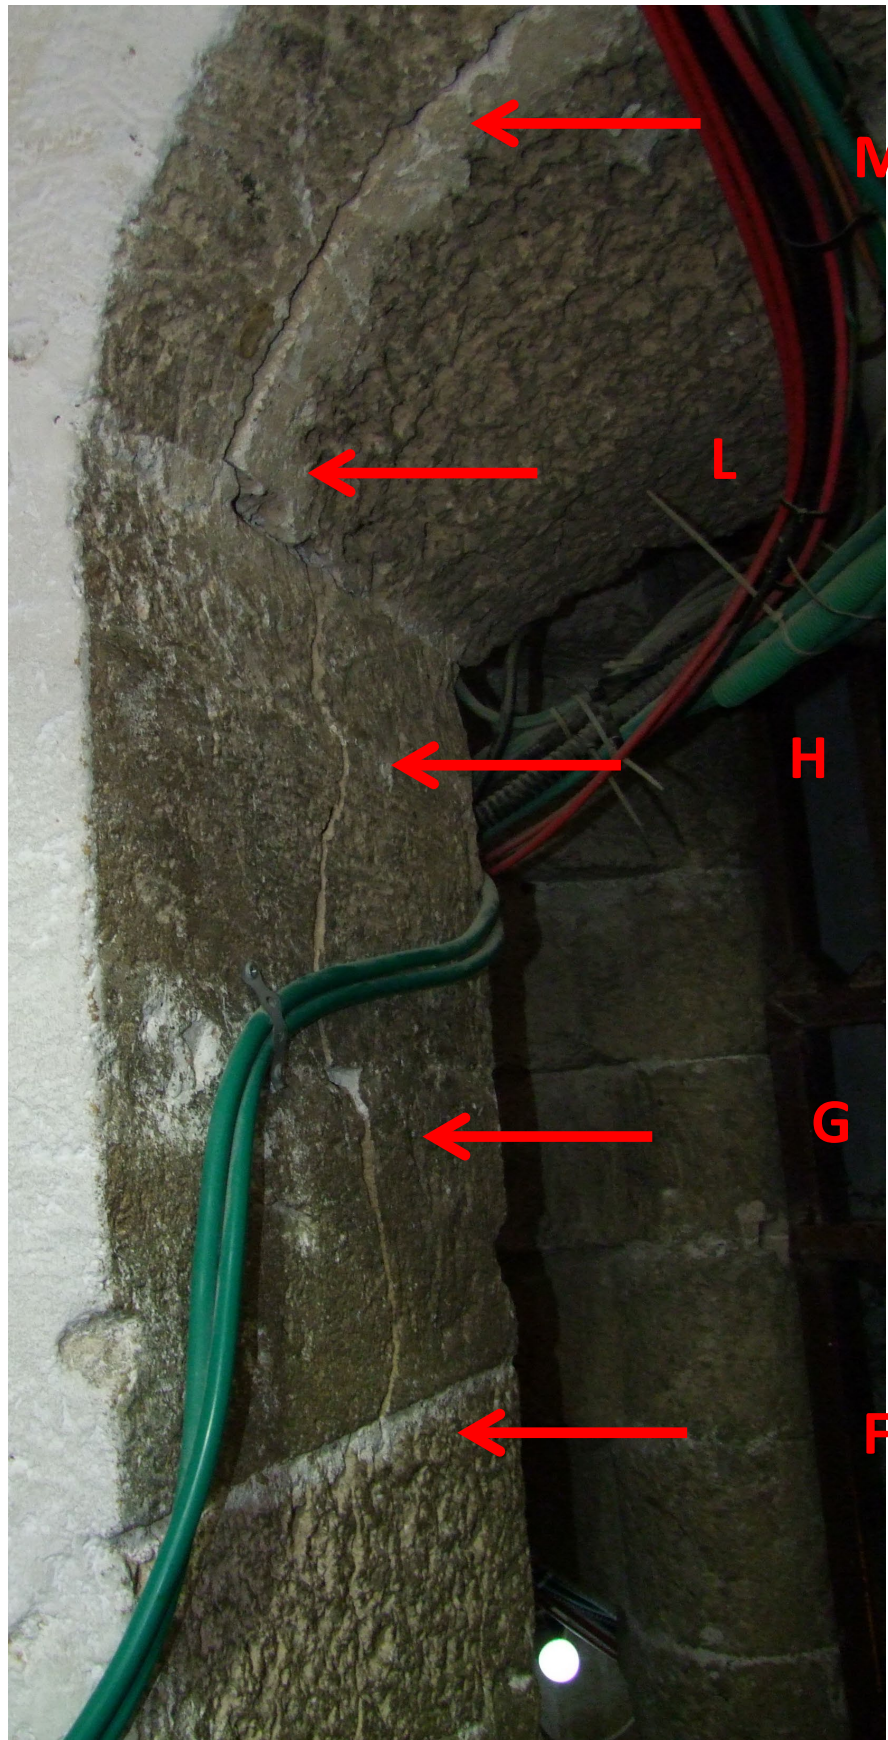
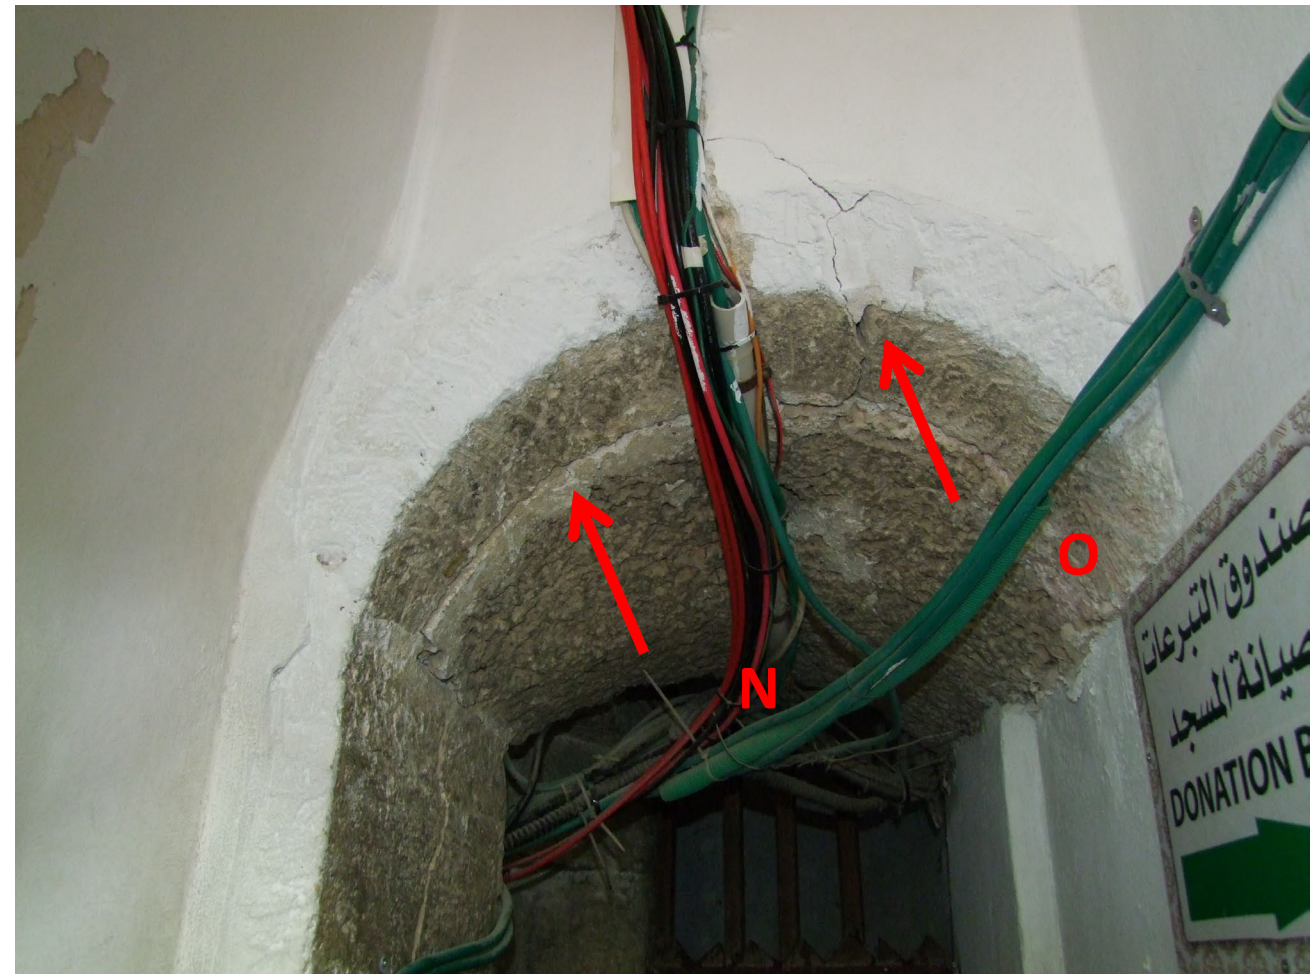
Measuring the width of the cracks in various places	
F	0.5 cm
G	0.4-1 cm, 2.5 cm deep
H	0.7 cm
L	0.6-1 cm
M	0.6 cm
N	0.7 cm
O	1.3 cm

The cracks in the vault at the entrance to the stairwell.

- At the entrance to the minaret, there are cracks running along the ceiling of the vault. **These cracks are very dangerous and they affect the minaret, particularly since this section is used as a support and is part of the base of the minaret and the pier in the northwestern corner (elephant leg pier).**
- Other cracks were found in the levels opposite the prayer hall's rear balcony (steps 16-24).
- We note that the base isn't merely a support for the minaret. It is also an important corner base for the prayer hall. The cracks in the base, combined with the cracks in the central column, put the minaret and the prayer hall at a great risk, and necessitate immediate and comprehensive intervention.

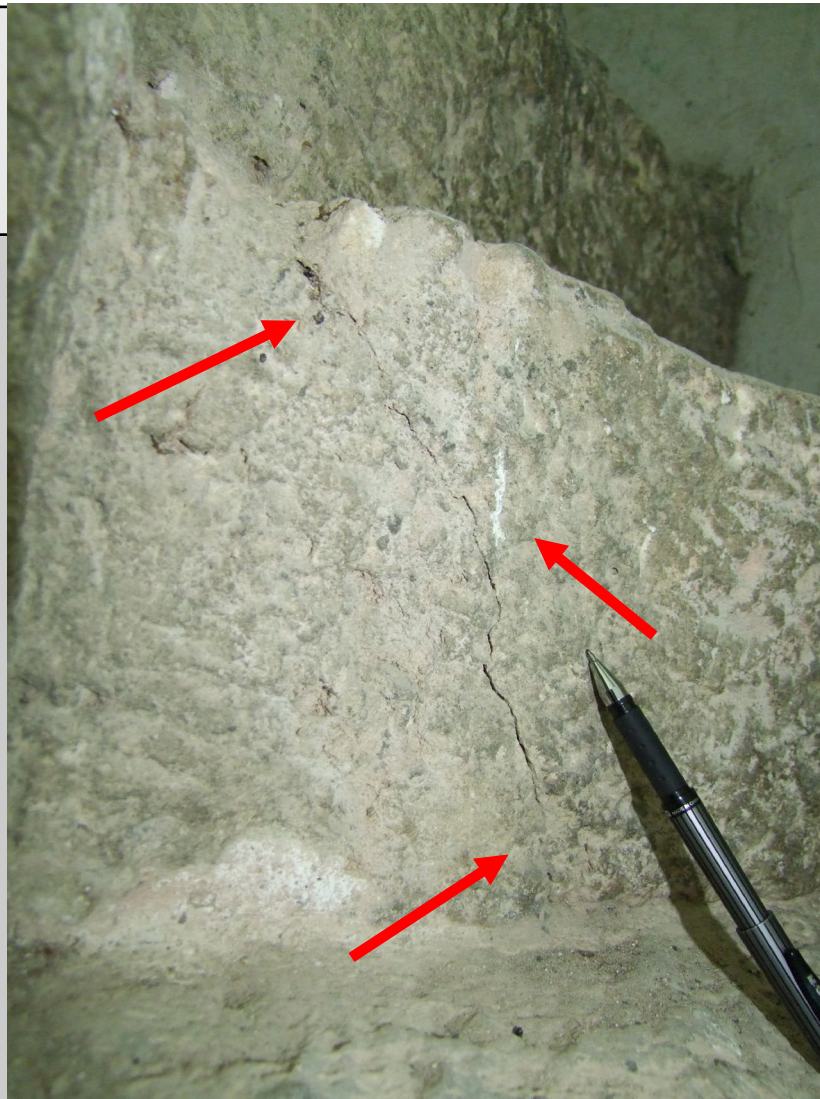
Stair 25

Crack in the stair

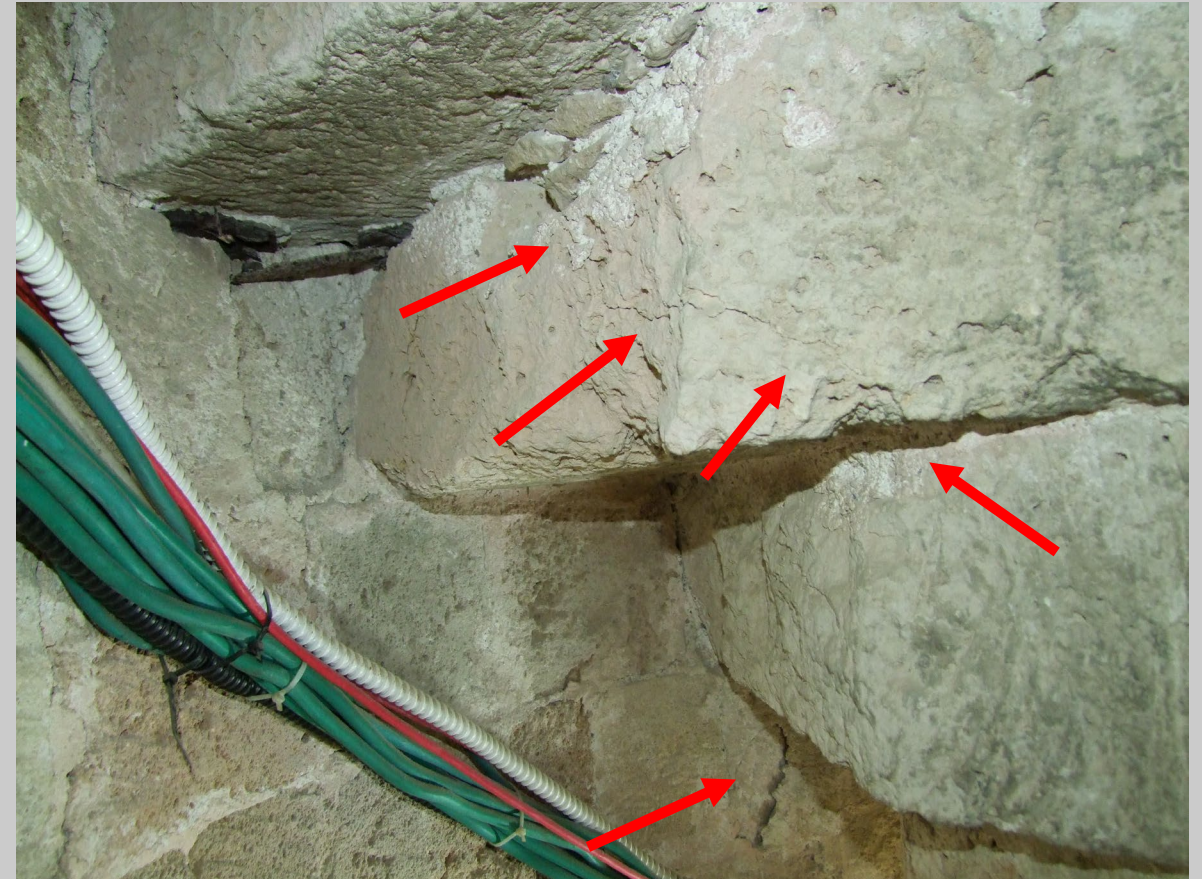
Stair 24

Crack in the stair

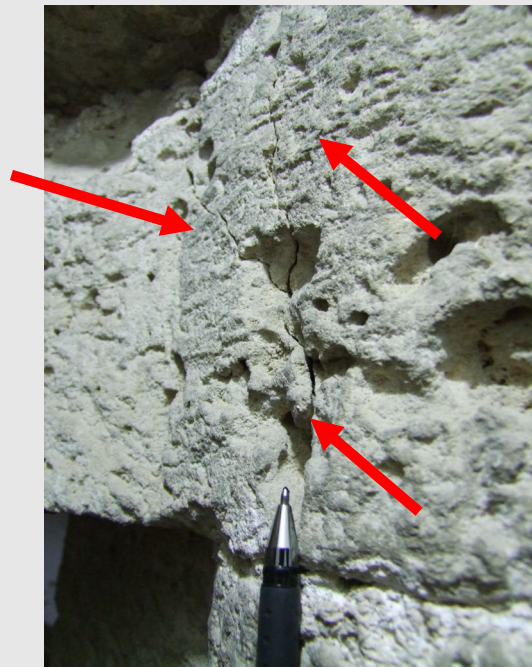
Stair 25

Crack in the column

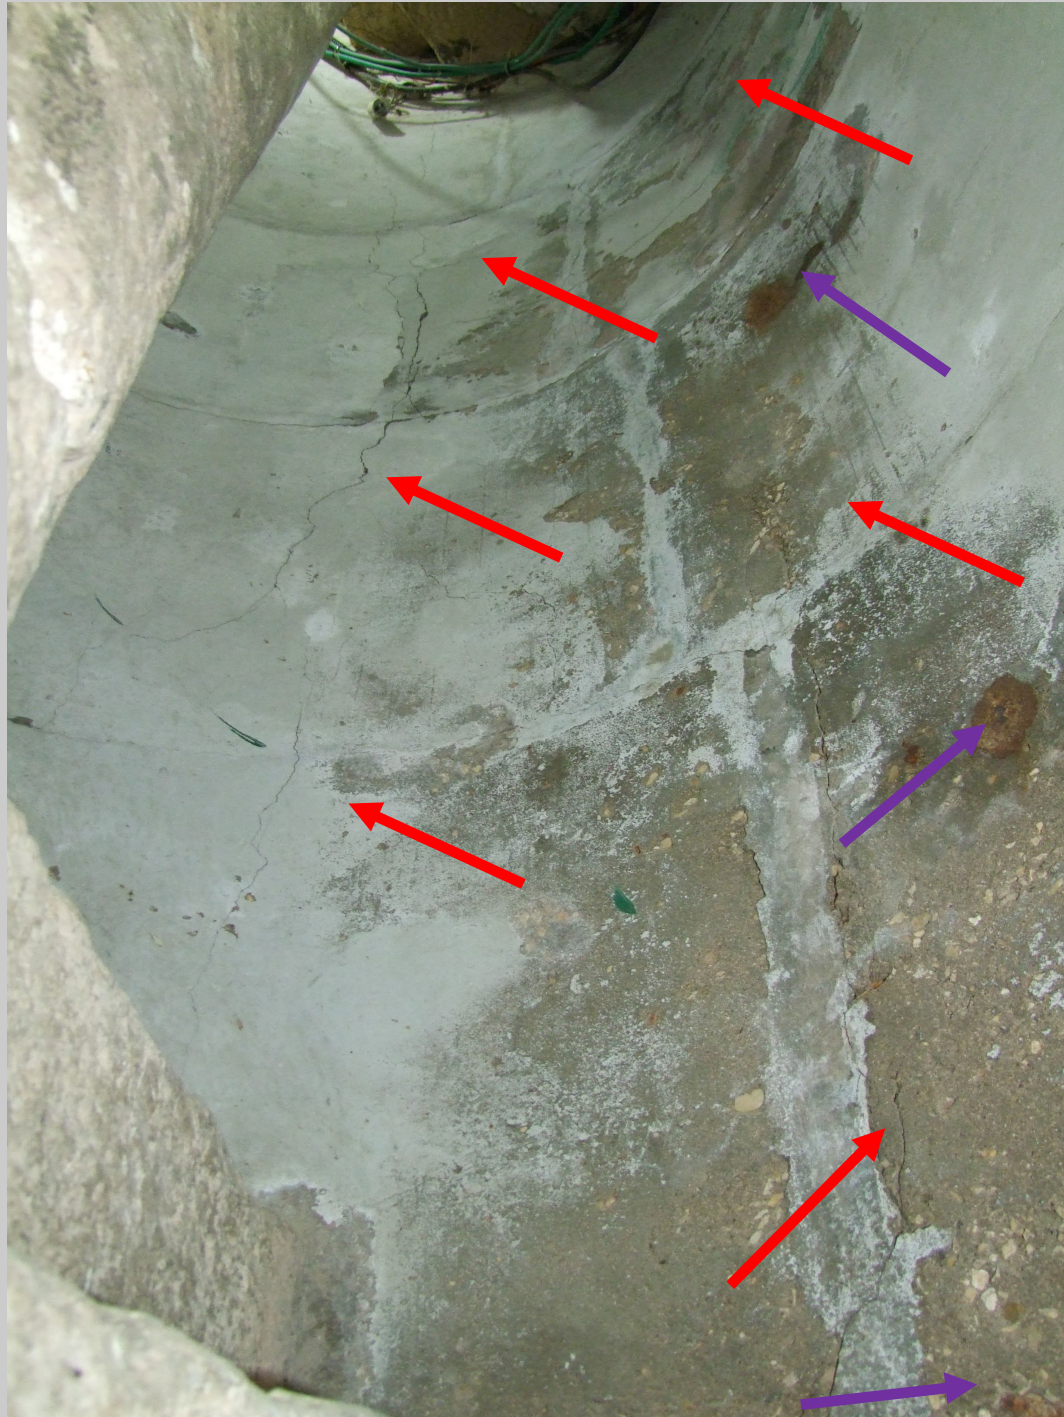
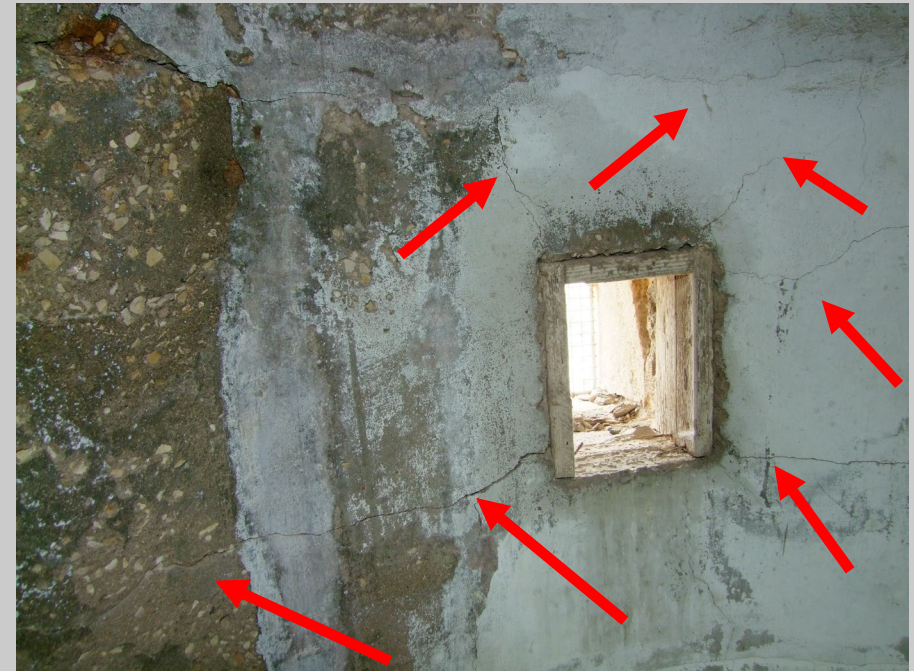
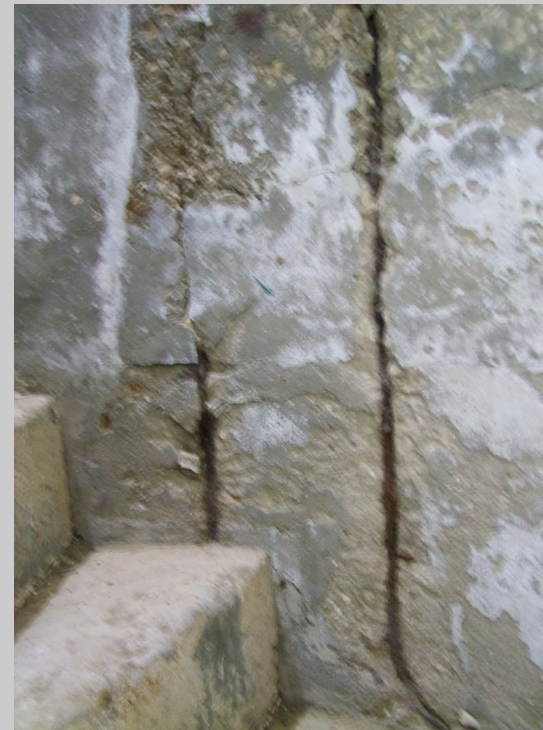
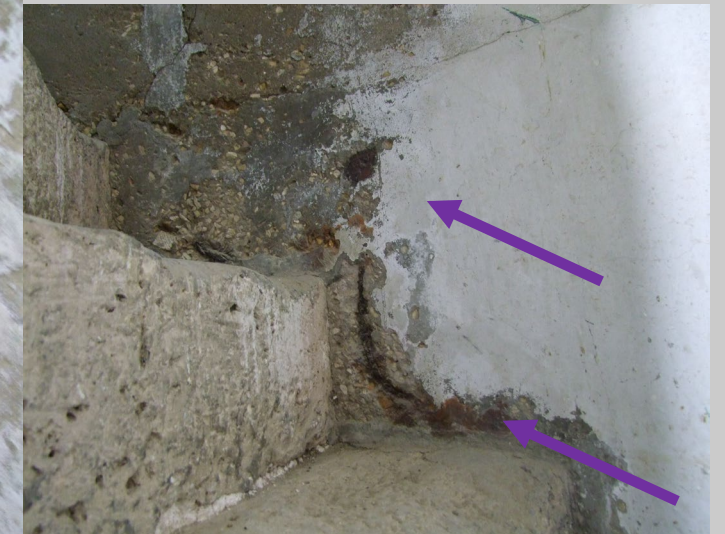
From Stair 96 and above

Severe weathering of the concrete reinforcement layer: horizontal, vertical and circumferential cracks in the shaft of the minaret

Severe rusting in the metal

- The interior layer of concrete along the wall and the mesh added to the minaret are rusty and have cracks, mainly in the upper section, and less so in the center of the shaft of the minaret.

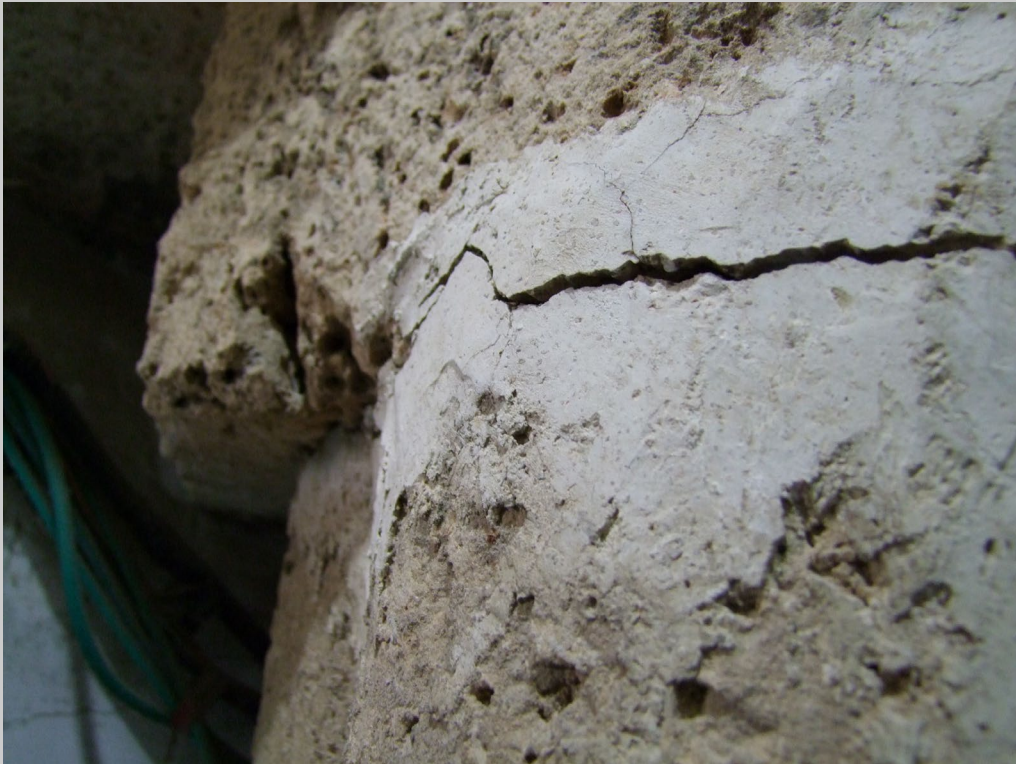
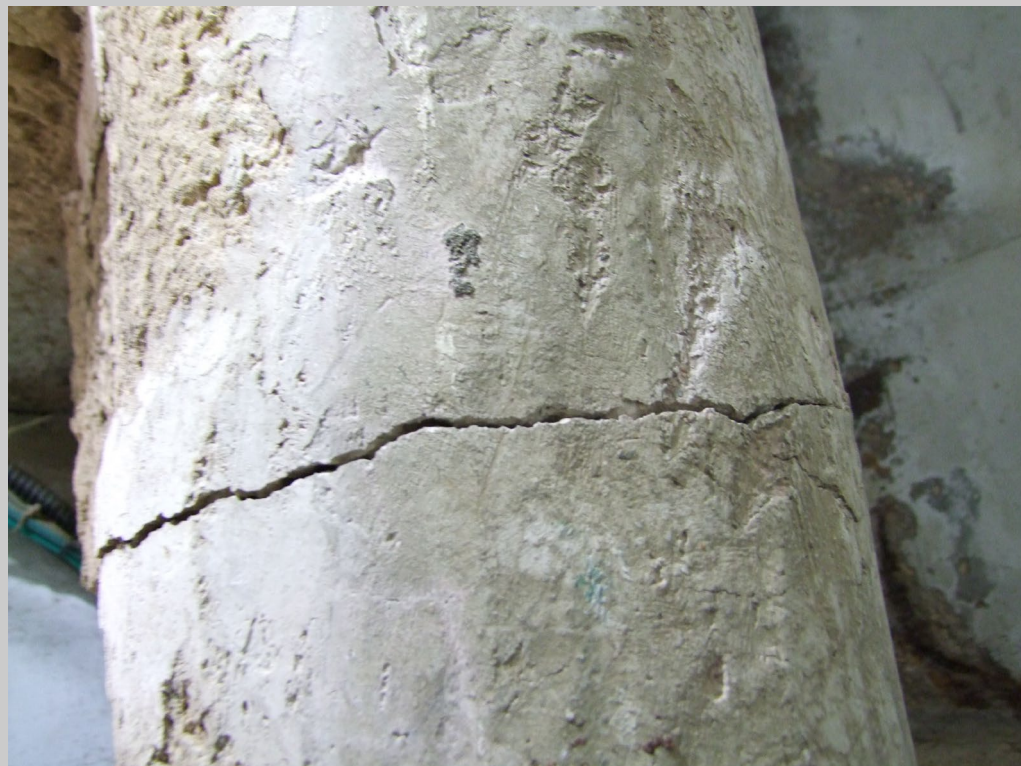
Stair 101

Circumferential crack in the column, above stair 101

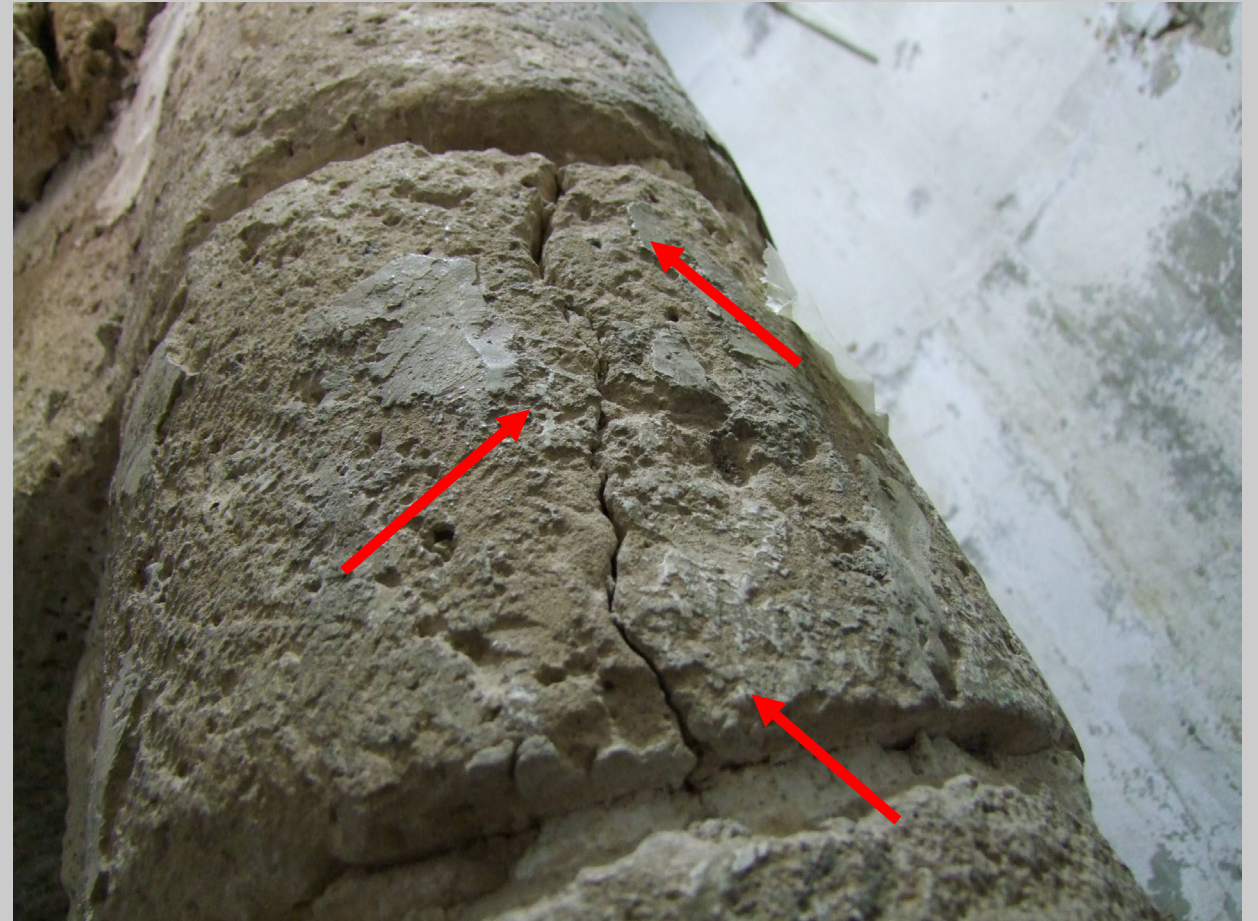
Stair 100

Very severe crack along the length of the stair/ column

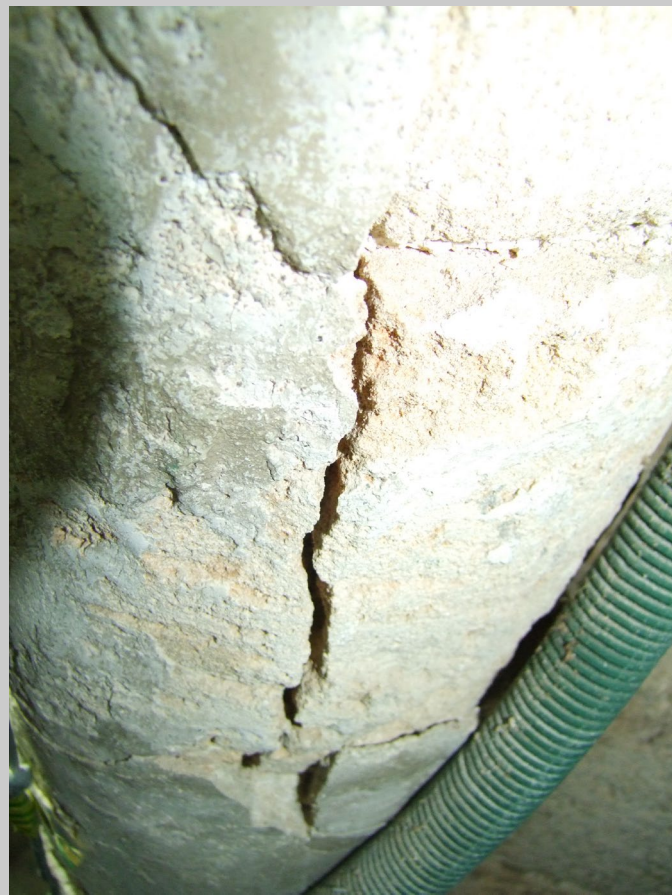
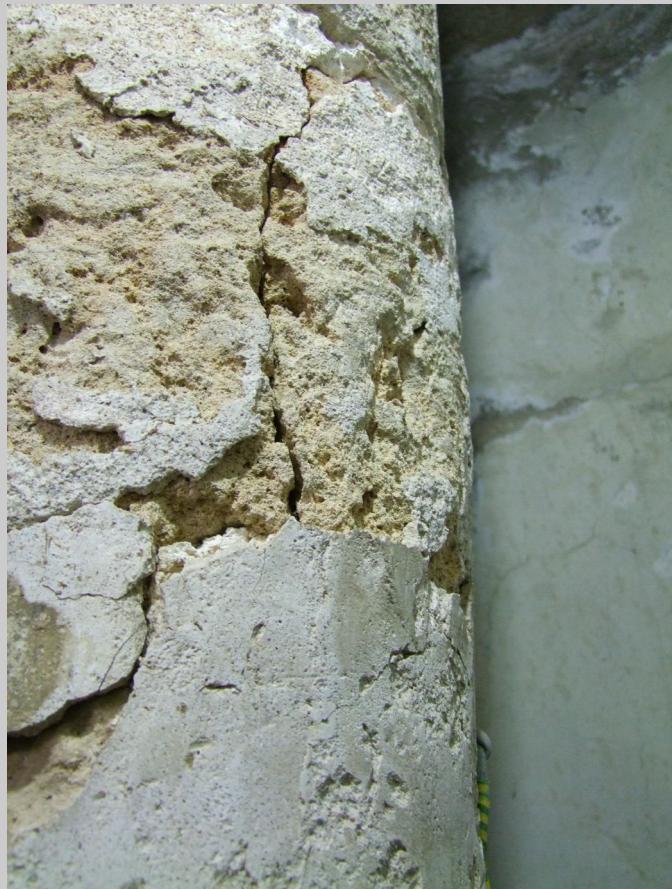
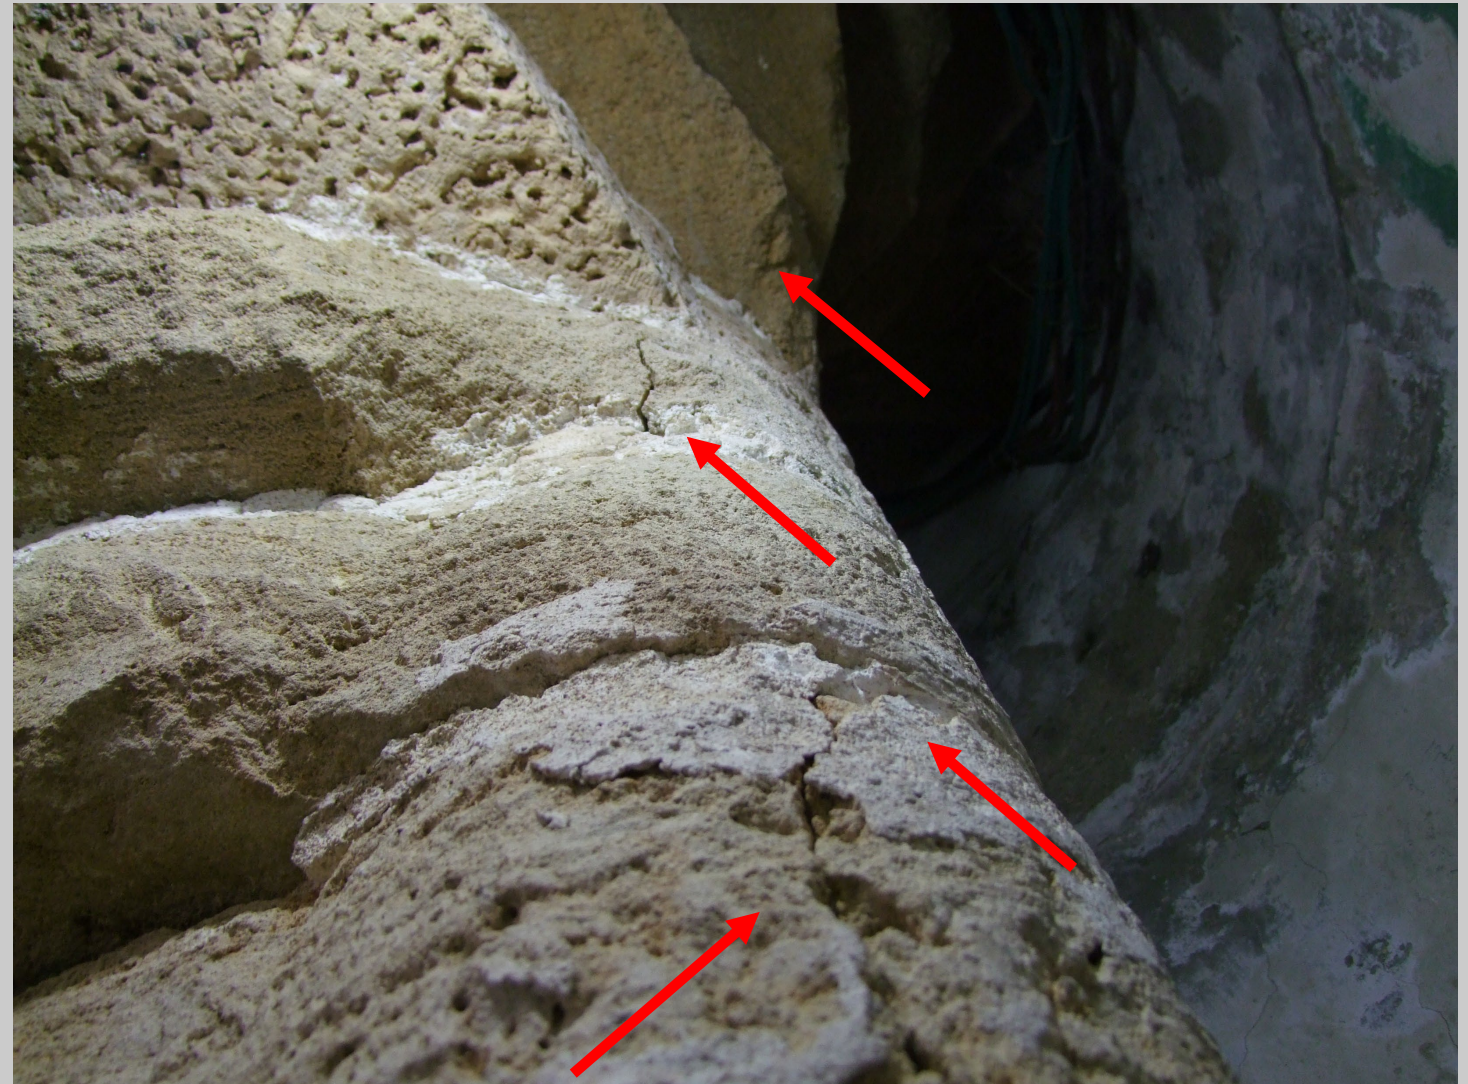
Stairs 114-117

Very severe damage in the column

Severe weathering and crumbling of the stone in the stair
