Preservation Survey and Situation Assessment

Acre's El-Jazzar Mosque (Various examples)

Dr. Abdel Razeq Matani

February 2023

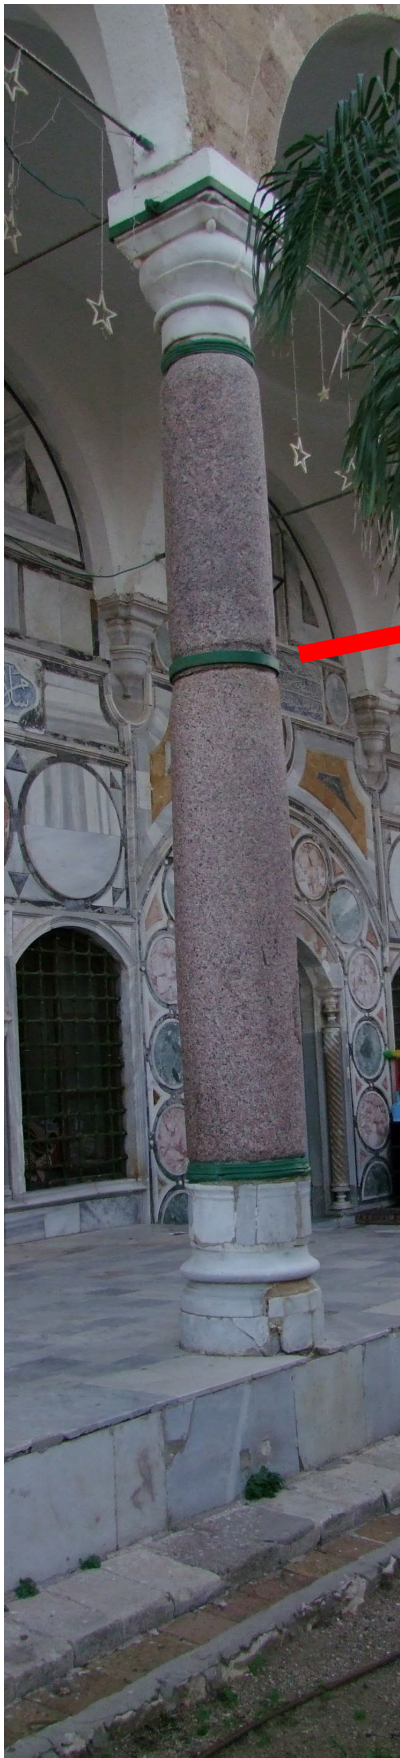
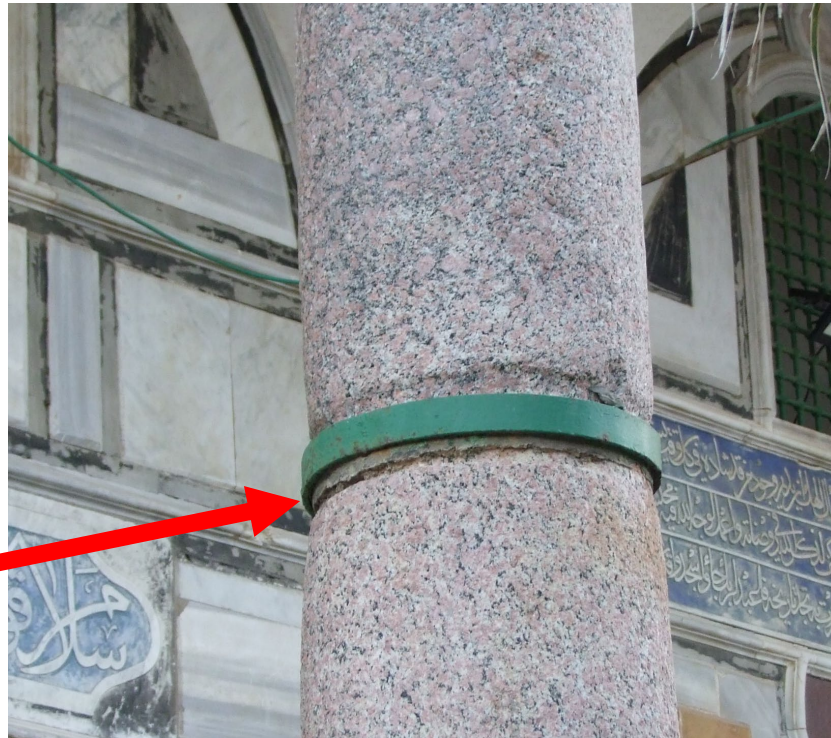
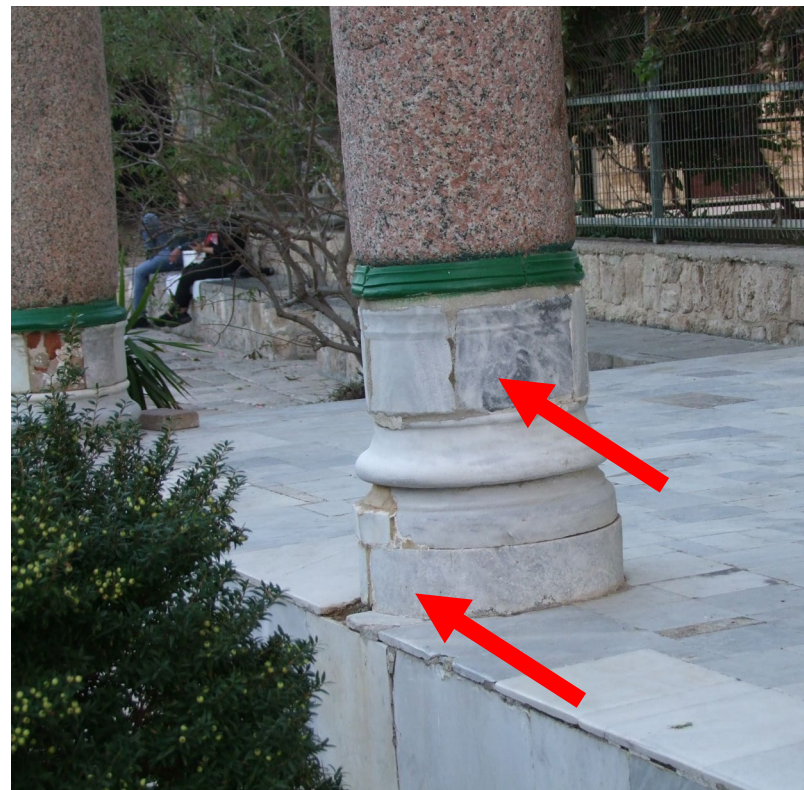
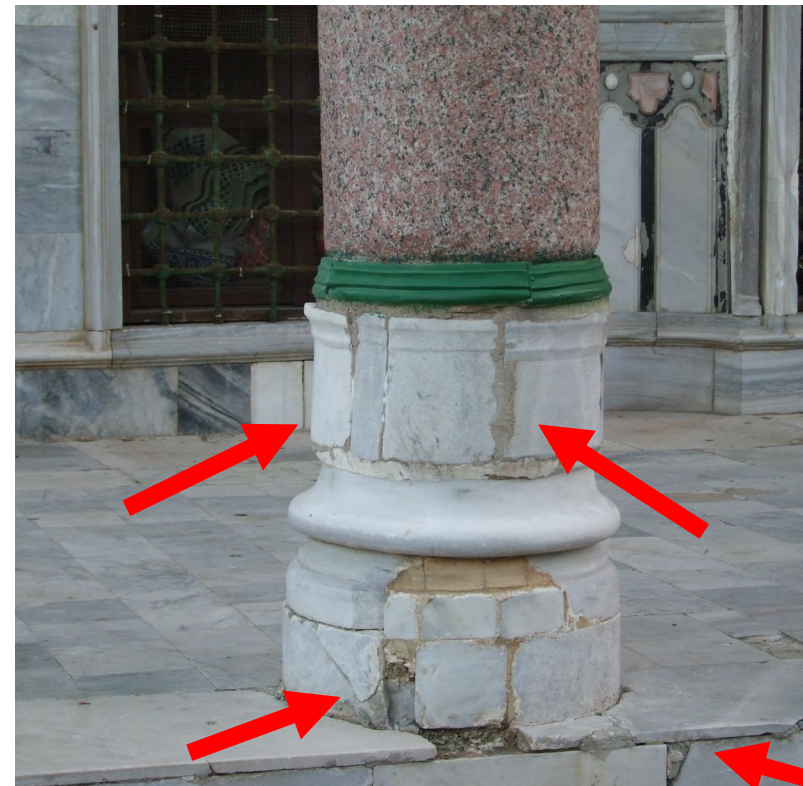
Column 5

- This column was heavily damaged, and it is at a very high risk

- Severe cracks in the base of the column
- A fracture at the center of the column. The column has two parts, which were connected. A metal band was placed around the connection. It isn't clear whether nails were embedded into the shaft of the pillar, which was apparently designed to strengthen the connection.
- Weathering and abrasion within the pillar, and flaking of the surface layer.
- Rust in the metal anchors holding the pillar

- **Repairing the floor:** The durability of the floor will need to be assessed. These assessment will be done after safety measures are taken, preferably after the acsadra is strengthened and given support.
- **Replacing the broken and cracked column bases**
- (Column 1's base was previously replaced)
- **Repairing the cracks in the column shafts,** and as artistic restoration, including polishing and handling light weathering in the columns
(the rare and unique marble columns require special treatment)
- **Repairing and replacing rusty metal anchors**
- **Restoration of the domes** (more information presented later in the presentation)

Damage to the columns must be repaired urgently. The work to be done in this section is very complex and special, and it must be done very cautiously, while putting in place strict safety measures and installing scaffolding and special supports to support the domes. A detailed work plan should be creat, and a team of experts should be created, to repair the columns and assess the existing alternatives, with an emphasis on preserving the shafts of the columns, due to their uniqueness.

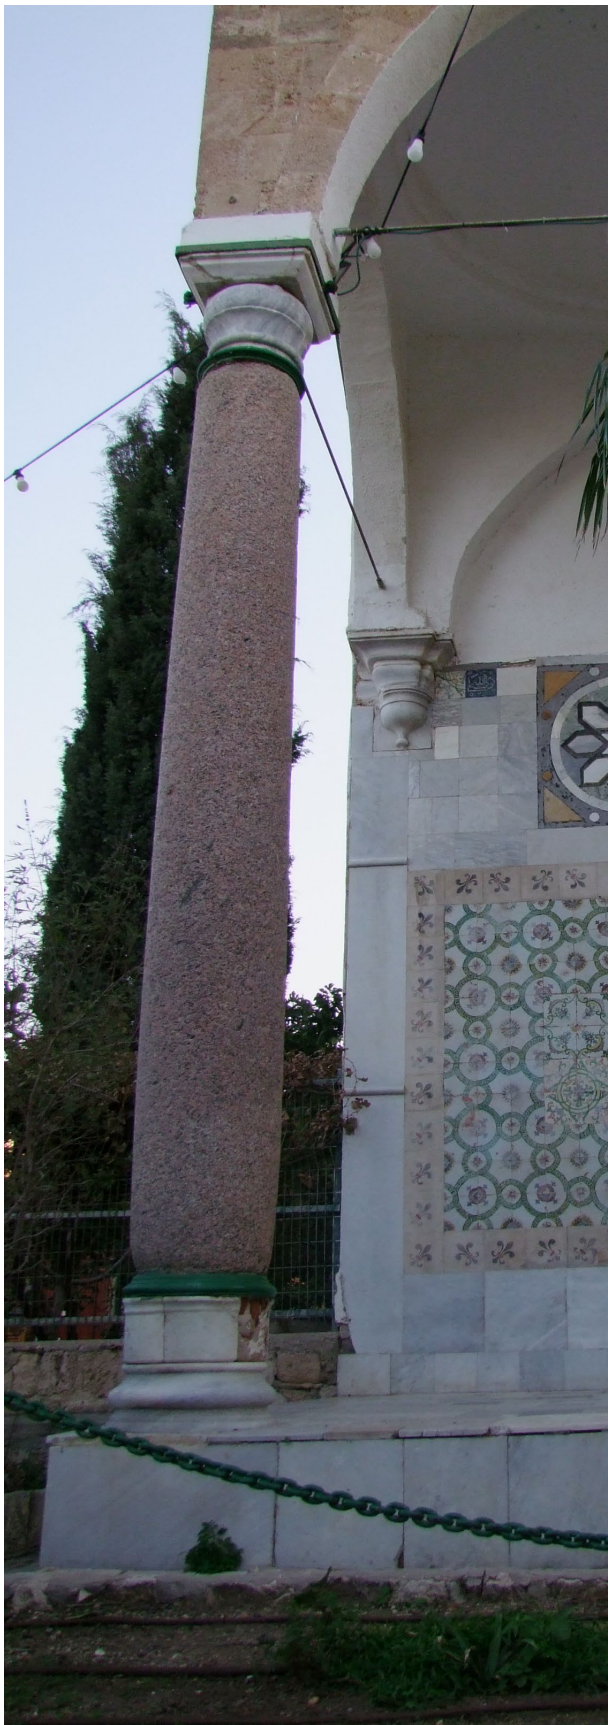
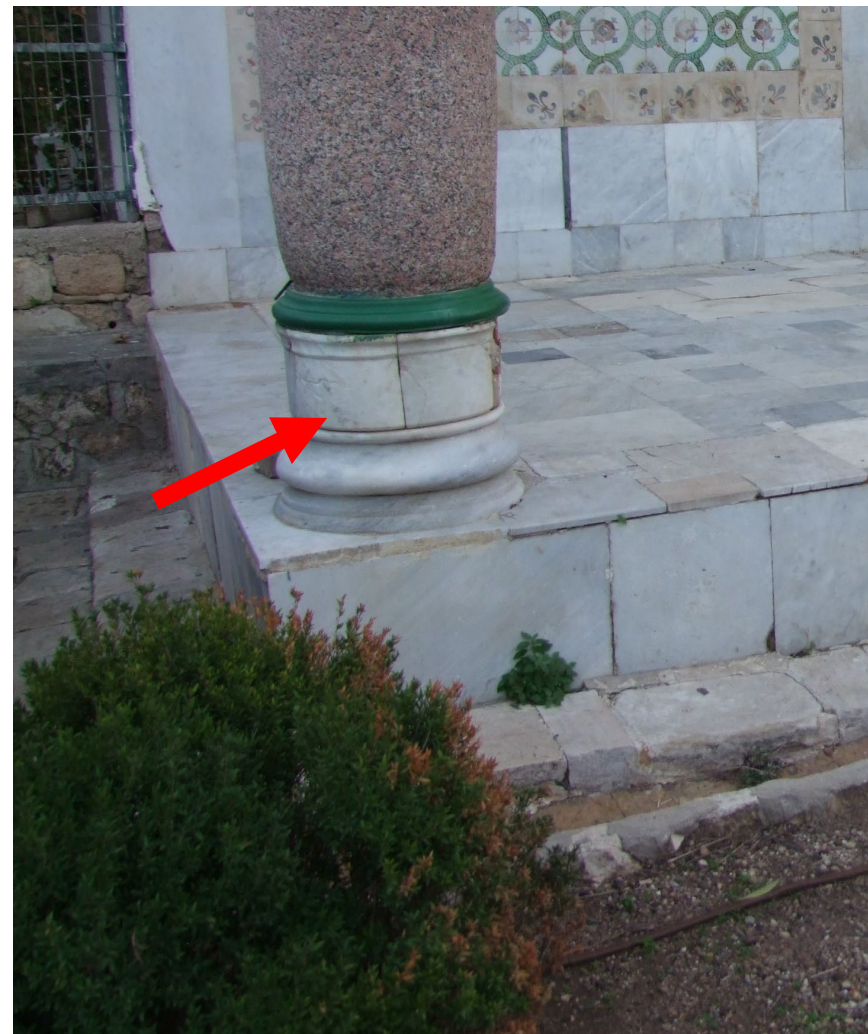
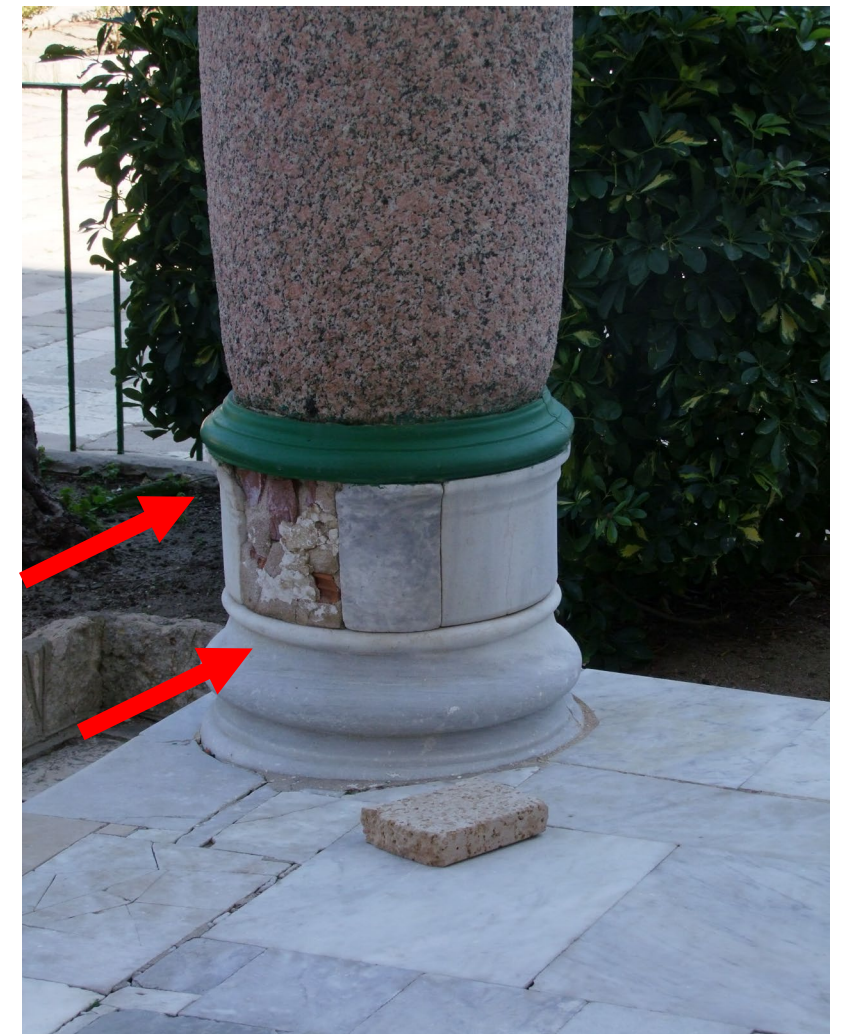
Column 6

This column was heavily damaged, and it is at a very high risk

- Very severe cracks and a fracture in the base.
- Weathering and abrasion within the pillar, and flaking of the surface layer.
- Rust in the metal anchors holding the pillar

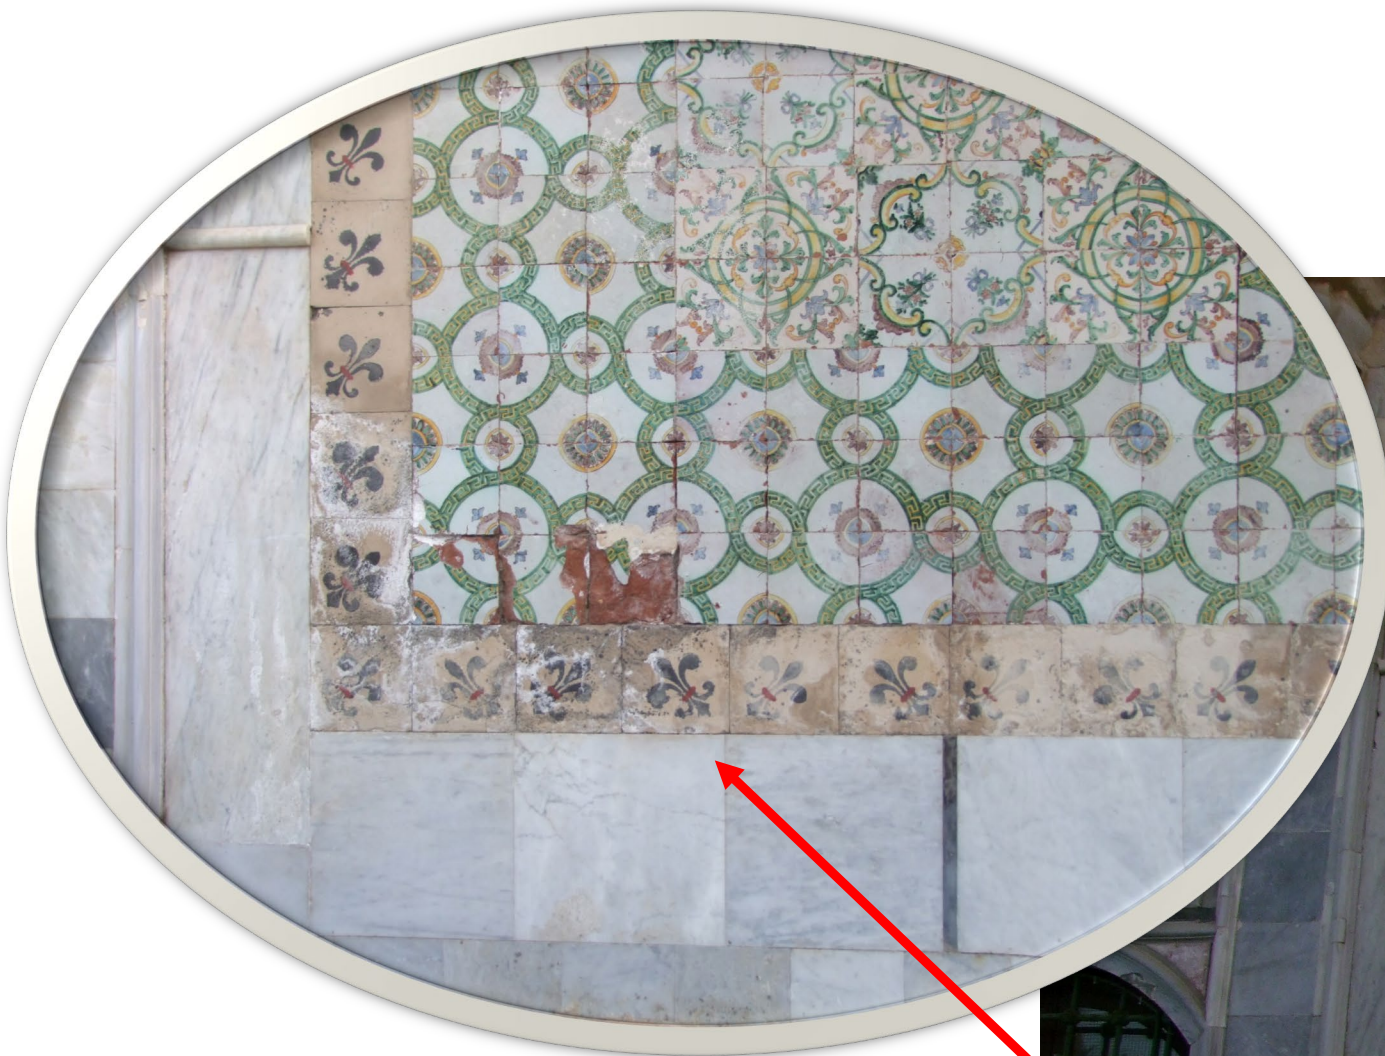
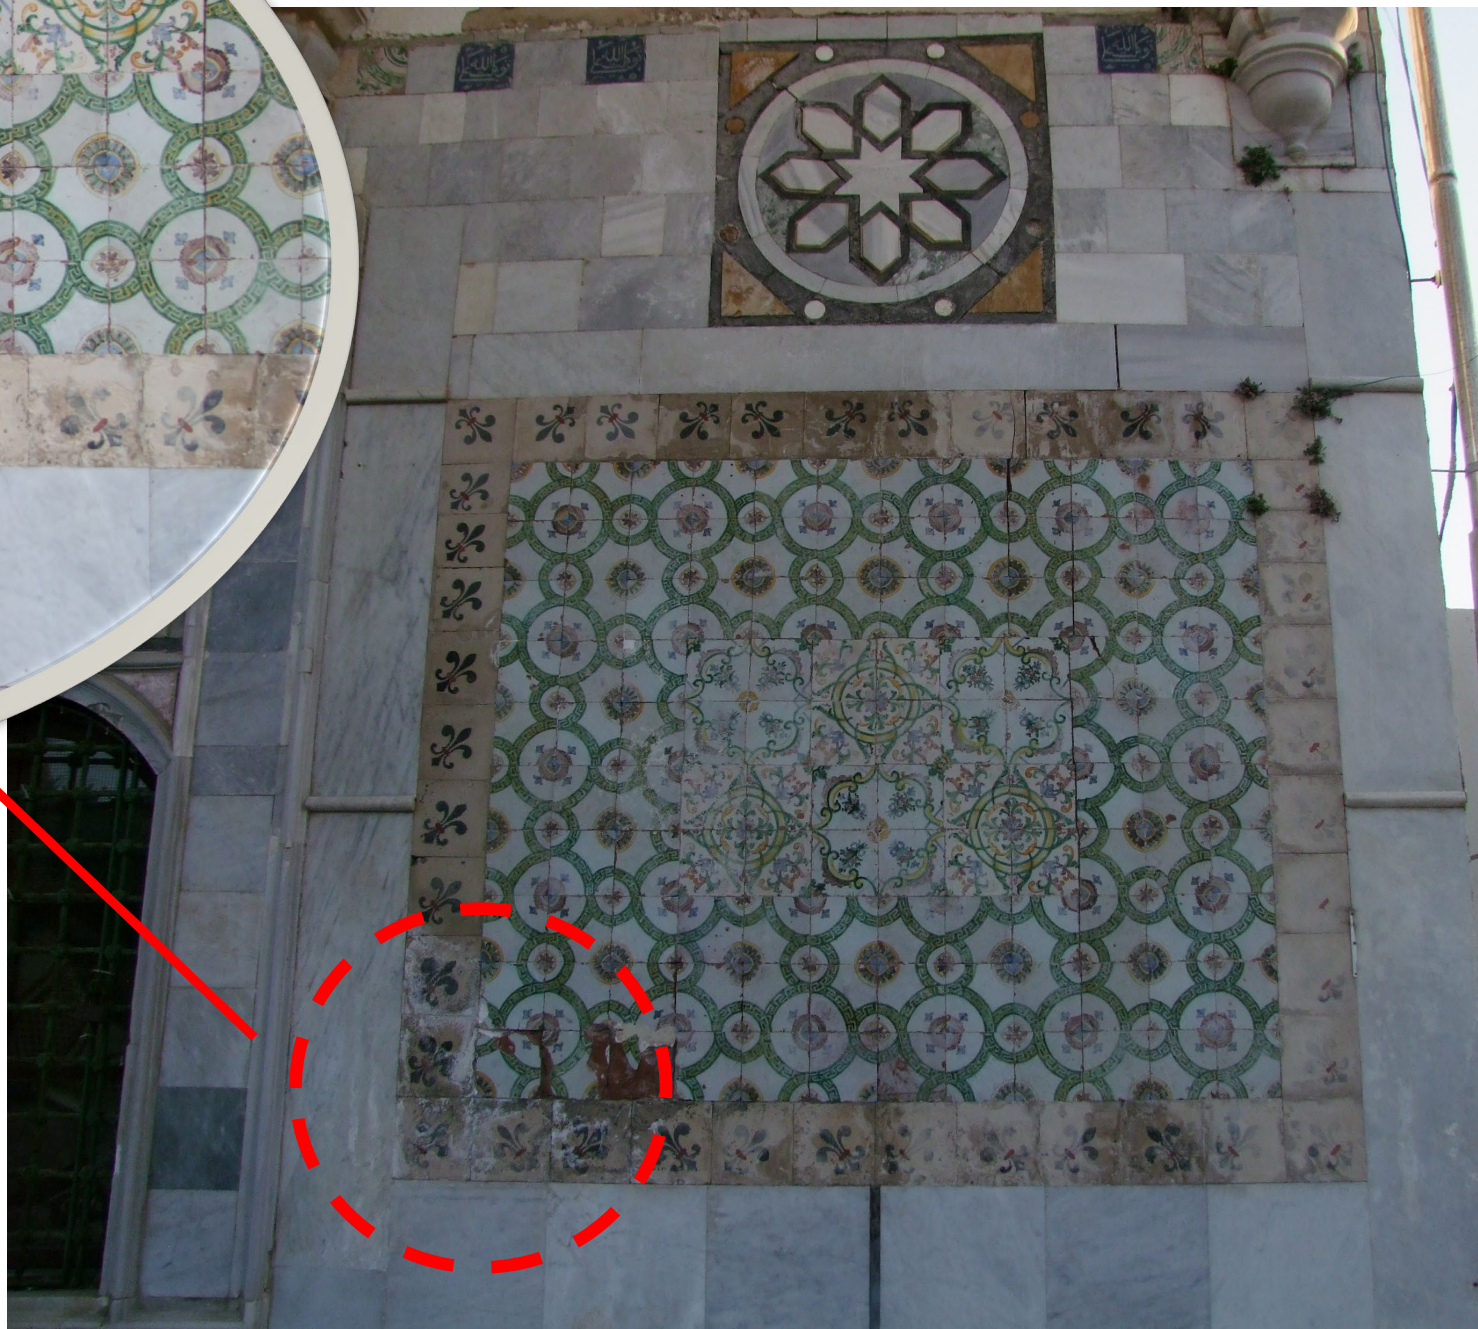
Weathering in the *qashan* panel in Vault 1 (V1)

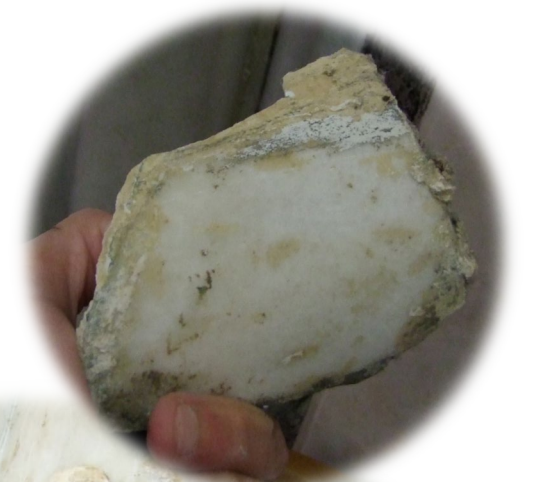
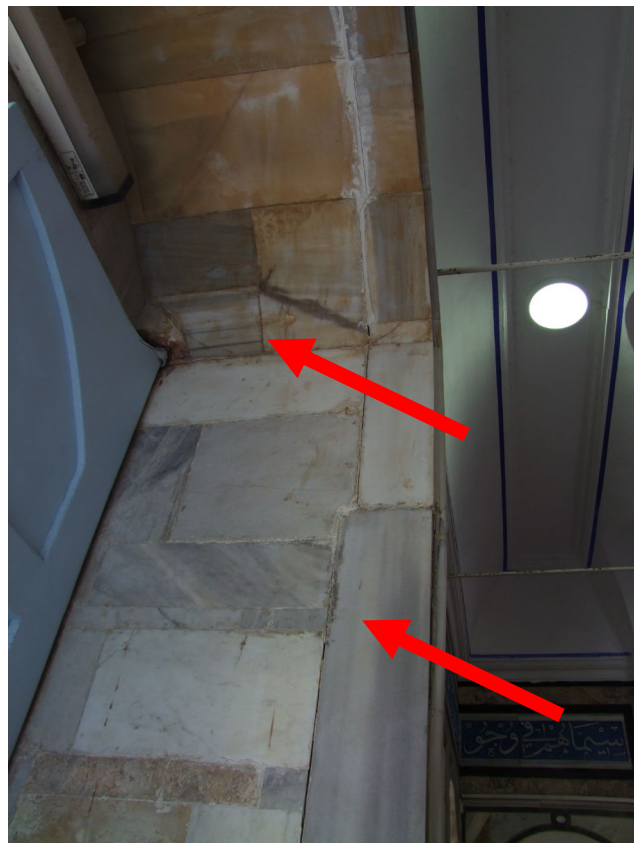
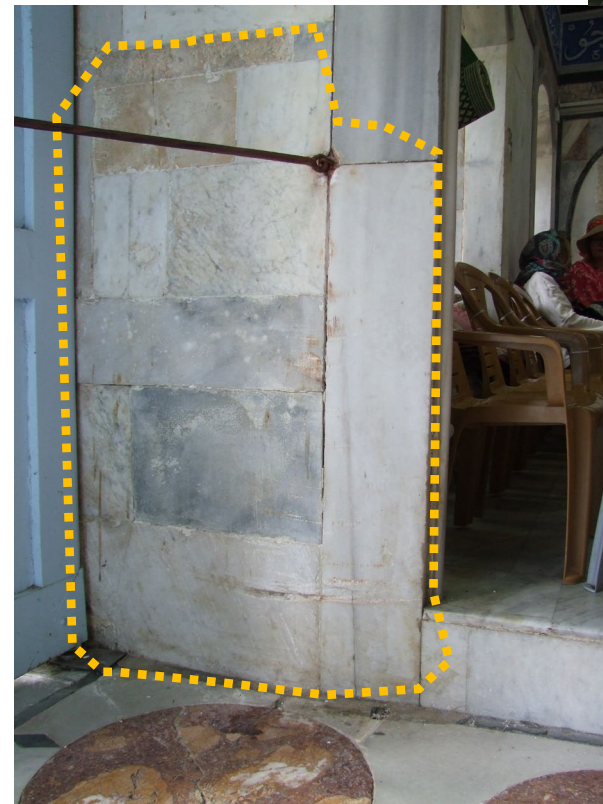
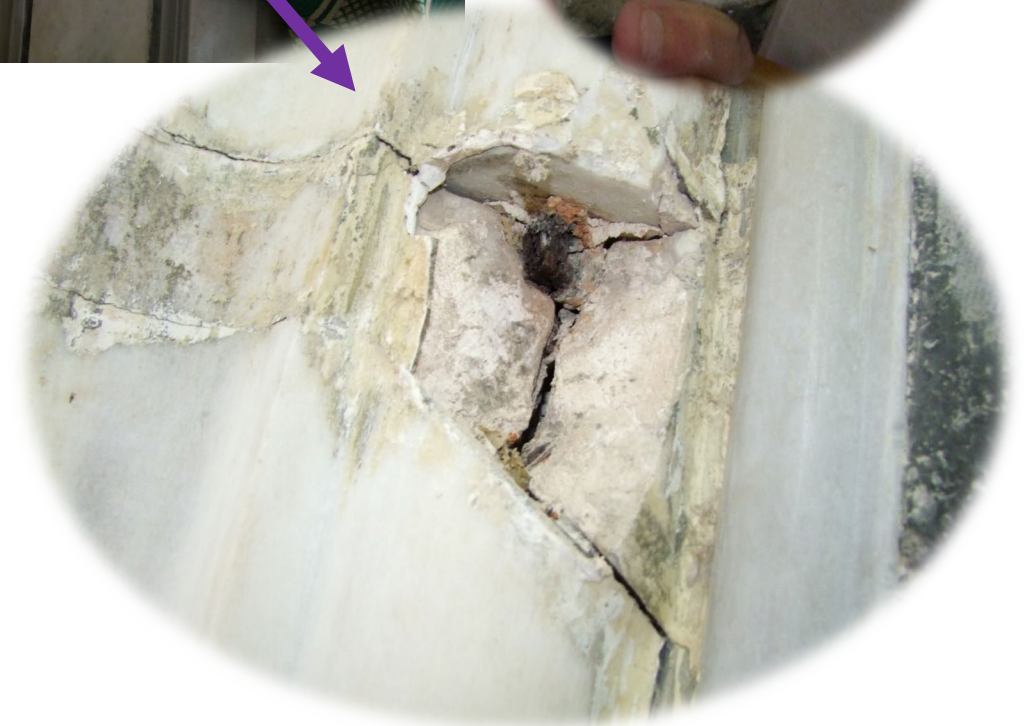
**Damage to the
lintel
Above the entranceway**

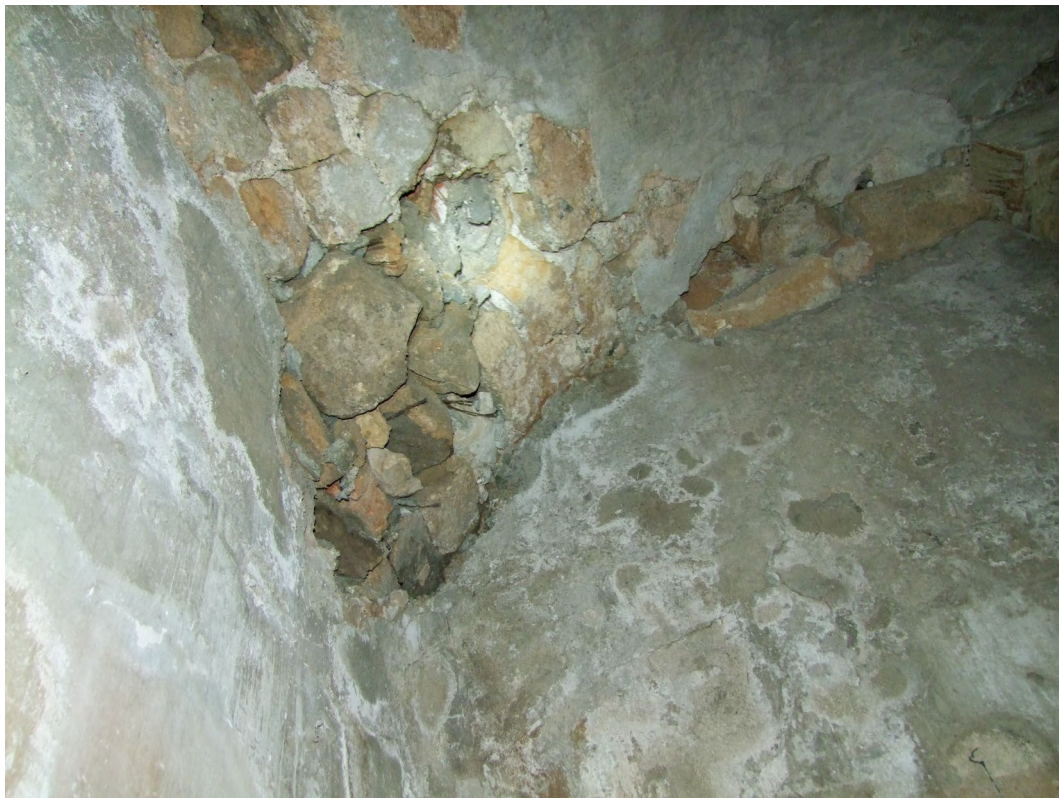
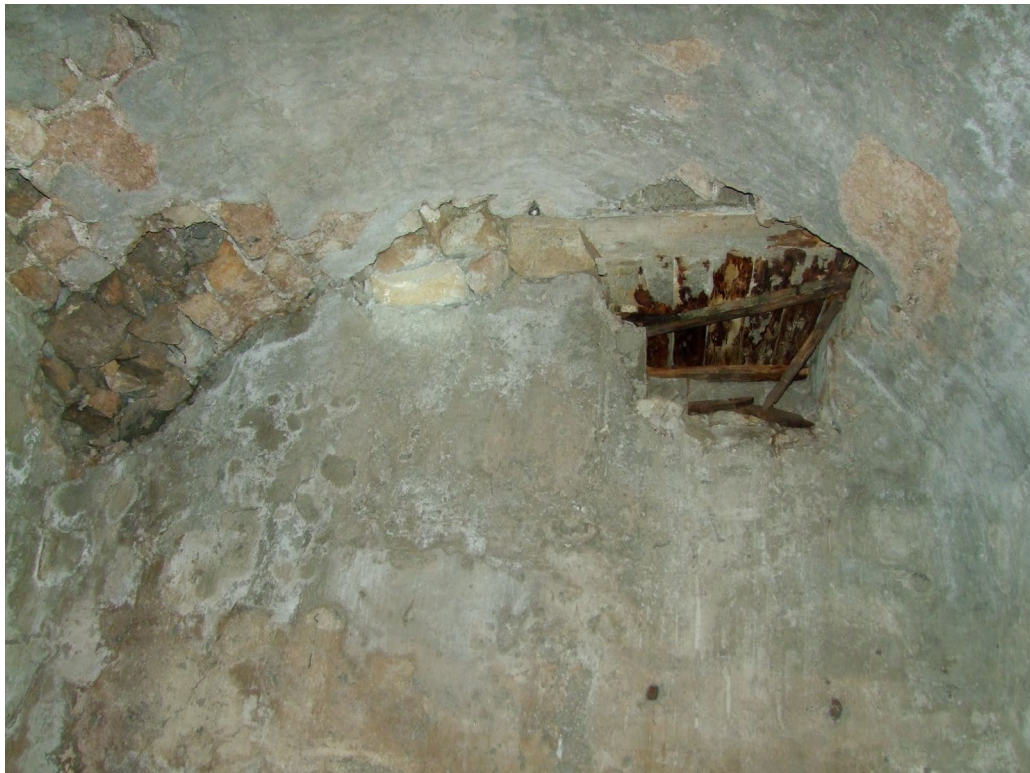
Entrance and drainage

- Piles of trash and filler material in the reservoir
- The opening of the upper pit is boarded off with wooden and metal boards, covered in a layer of cement.
- Severe weathering of the stones in the ceiling and above the opening of the upper pit, in the walls of the reservoir, and in the wall separating Reservoir 1 from Reservoir 2
- Damage and detachment of the original layer of plaster from the walls
- Severe dampness in the ceiling and walls

Right: General view of the reservoir

Above: The ceiling of the reservoir and the upper pit

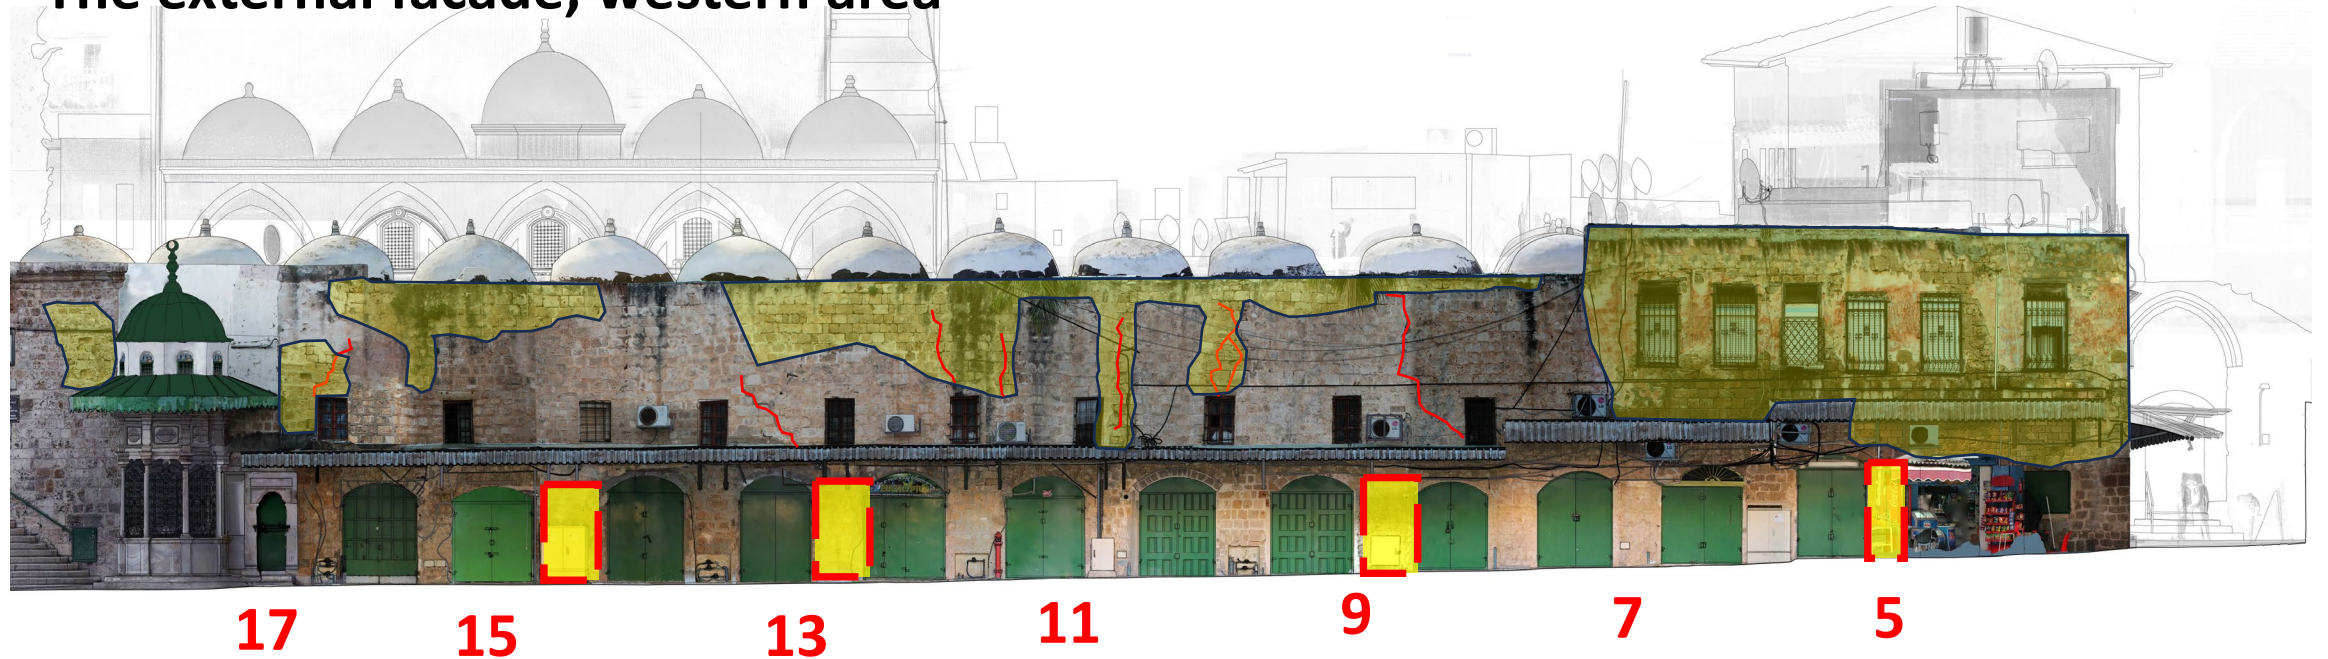
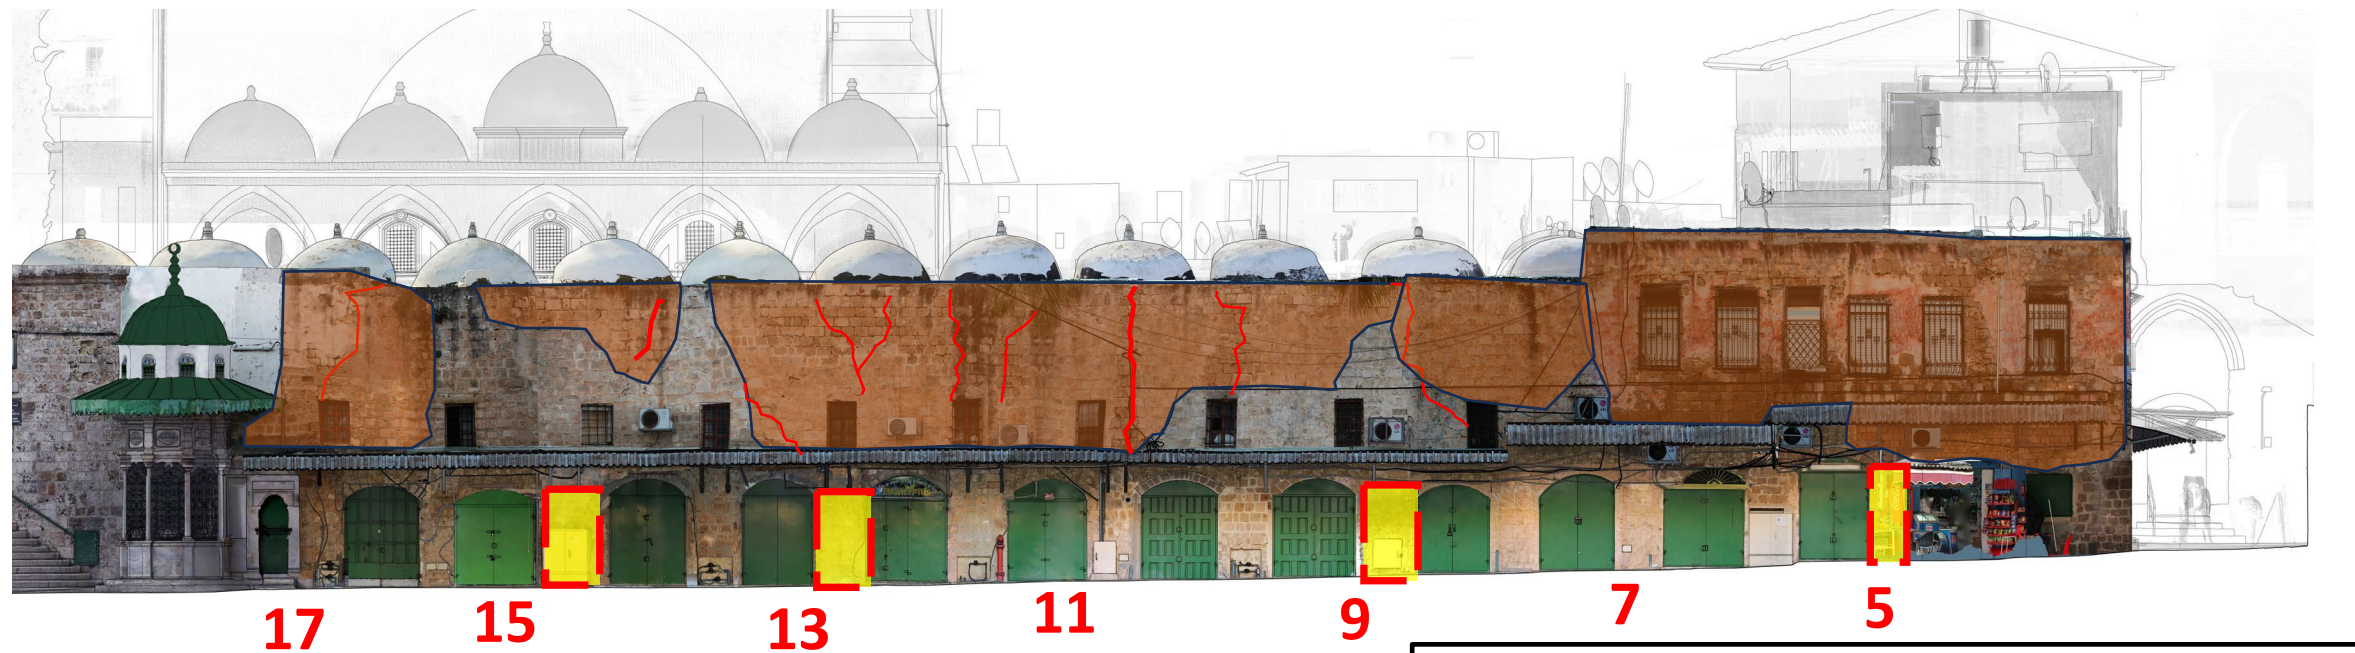
Damage to the northern facade – B – The external facade, western area

Above:: Damage to the northern wall of the compound, according to the 2017 survey.

Above:: Damage to the northern wall of the compound, according to the 2023 ATIK survey.
