Preservation Survey and Situation Assessment

Acre's El-Jazzar Mosque (Various examples)

Dr. Abdel Razeq Matani

February 2023

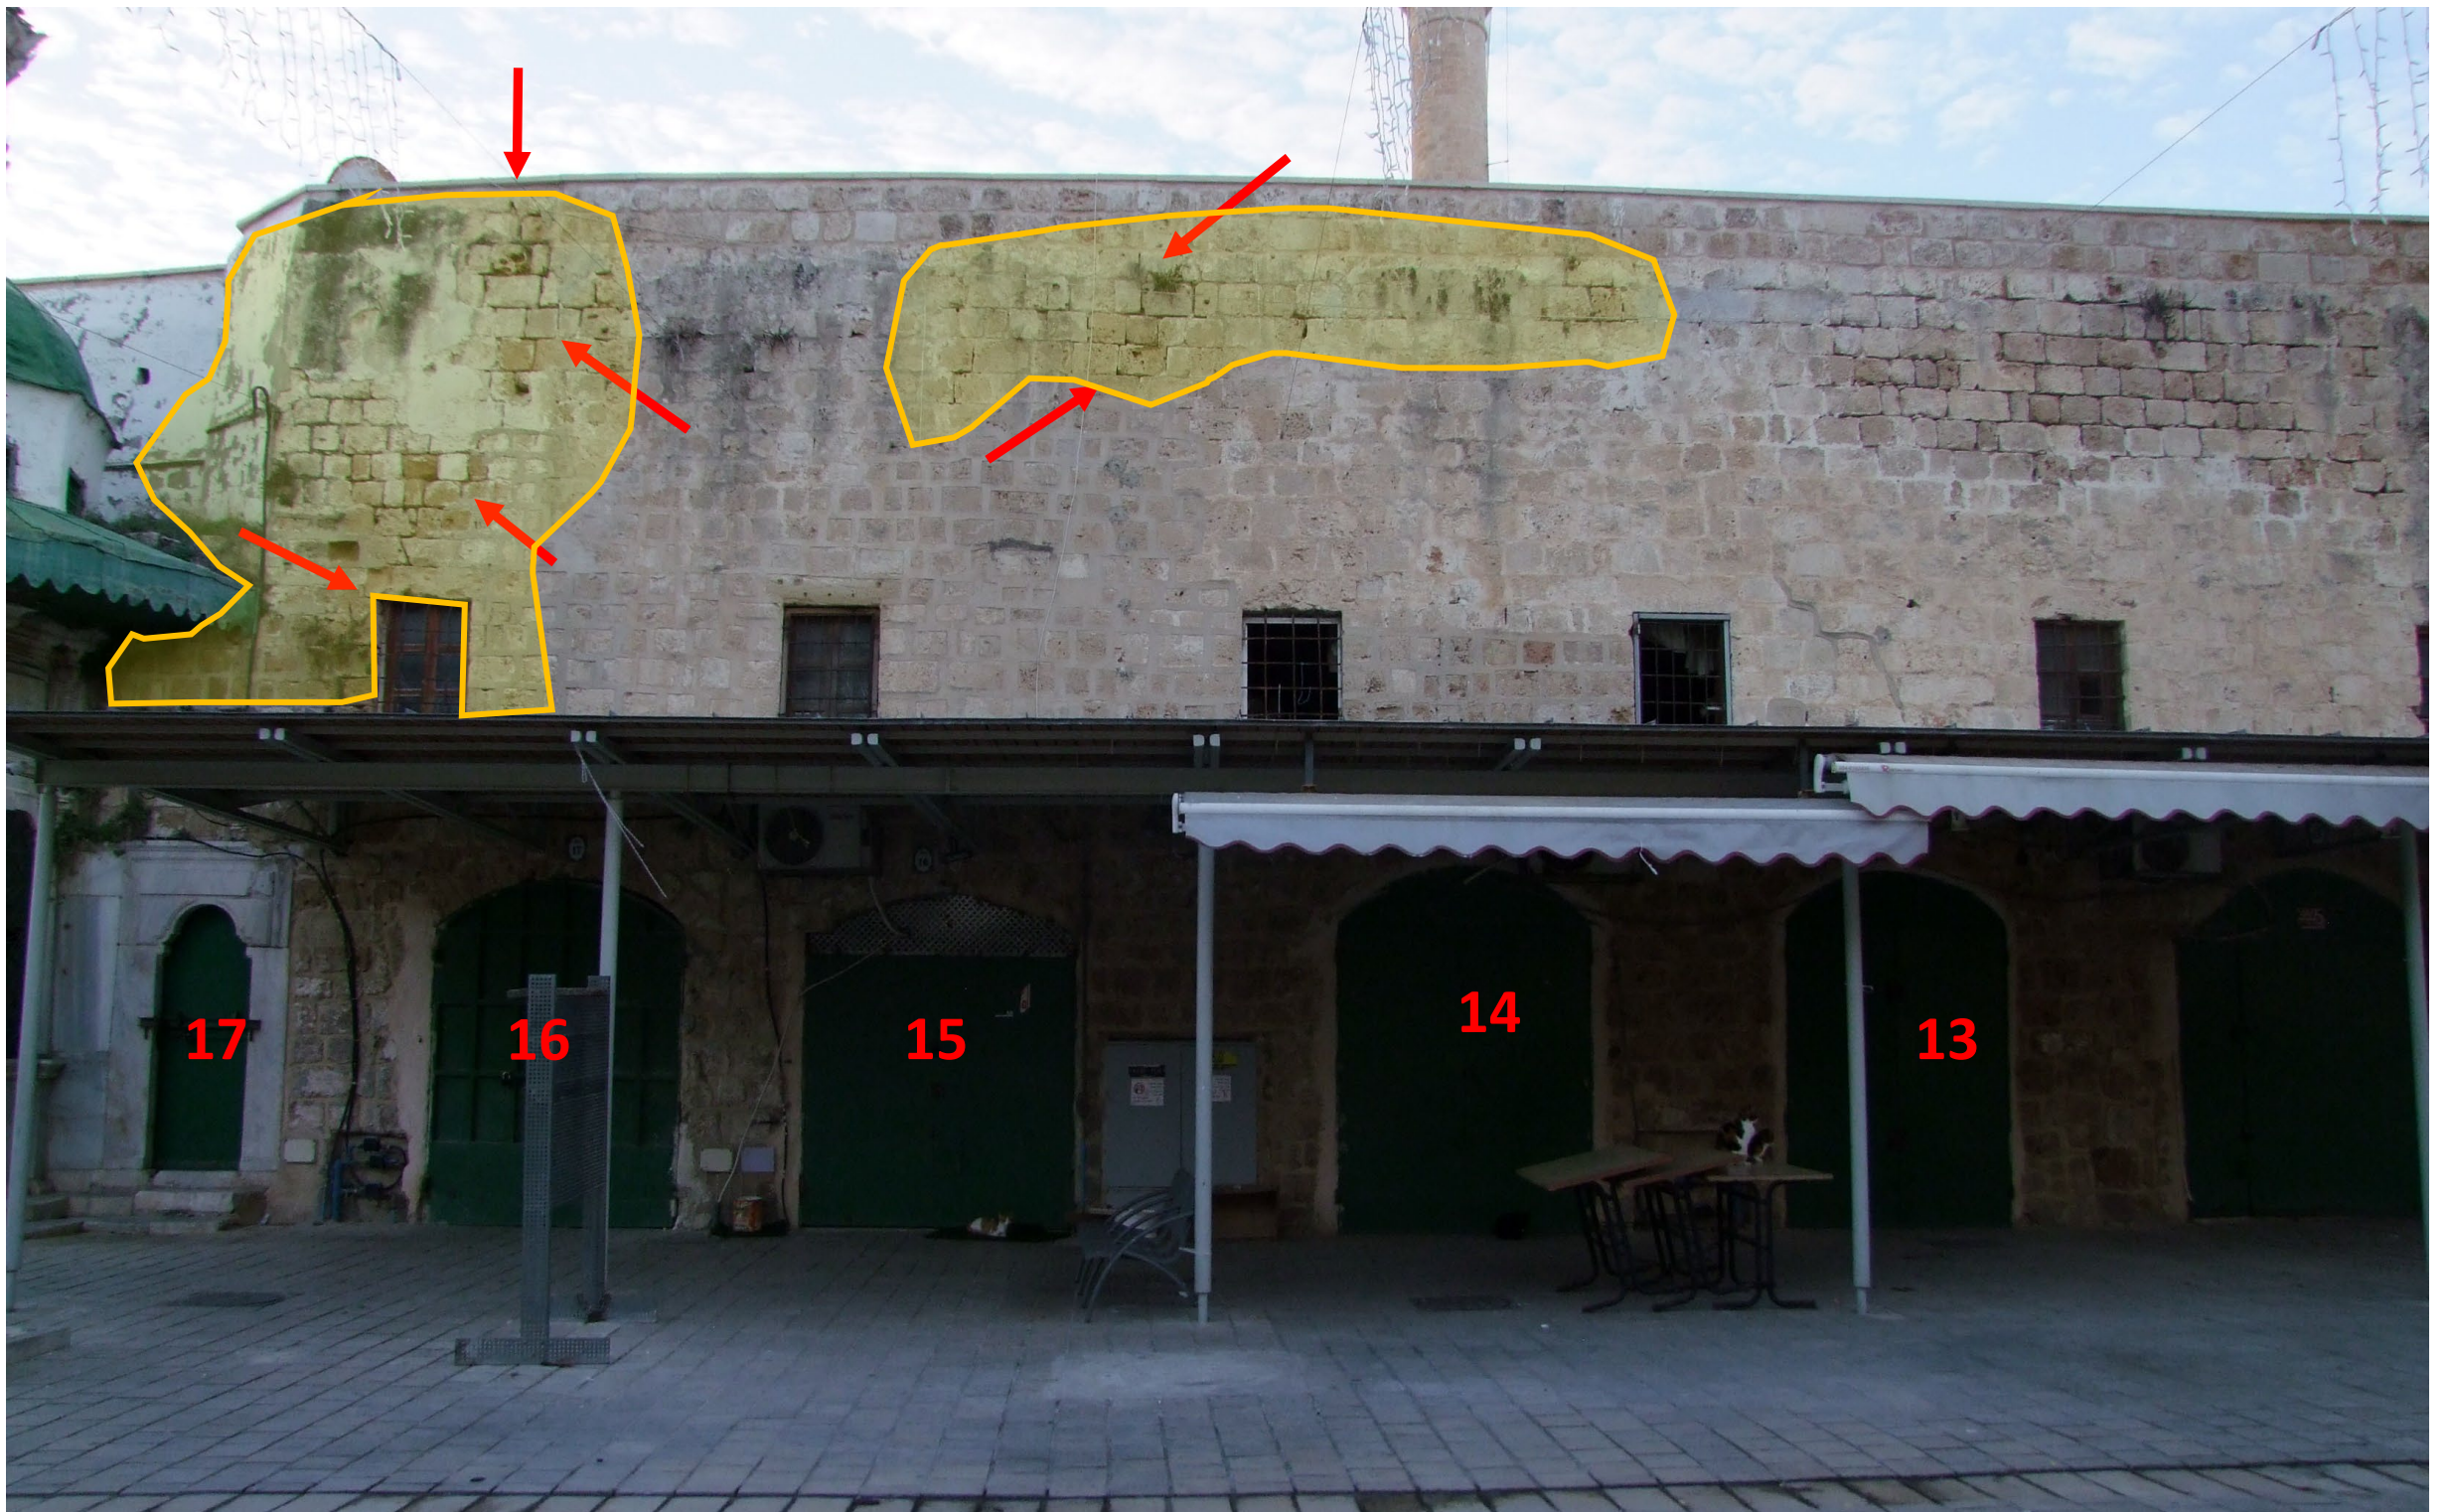
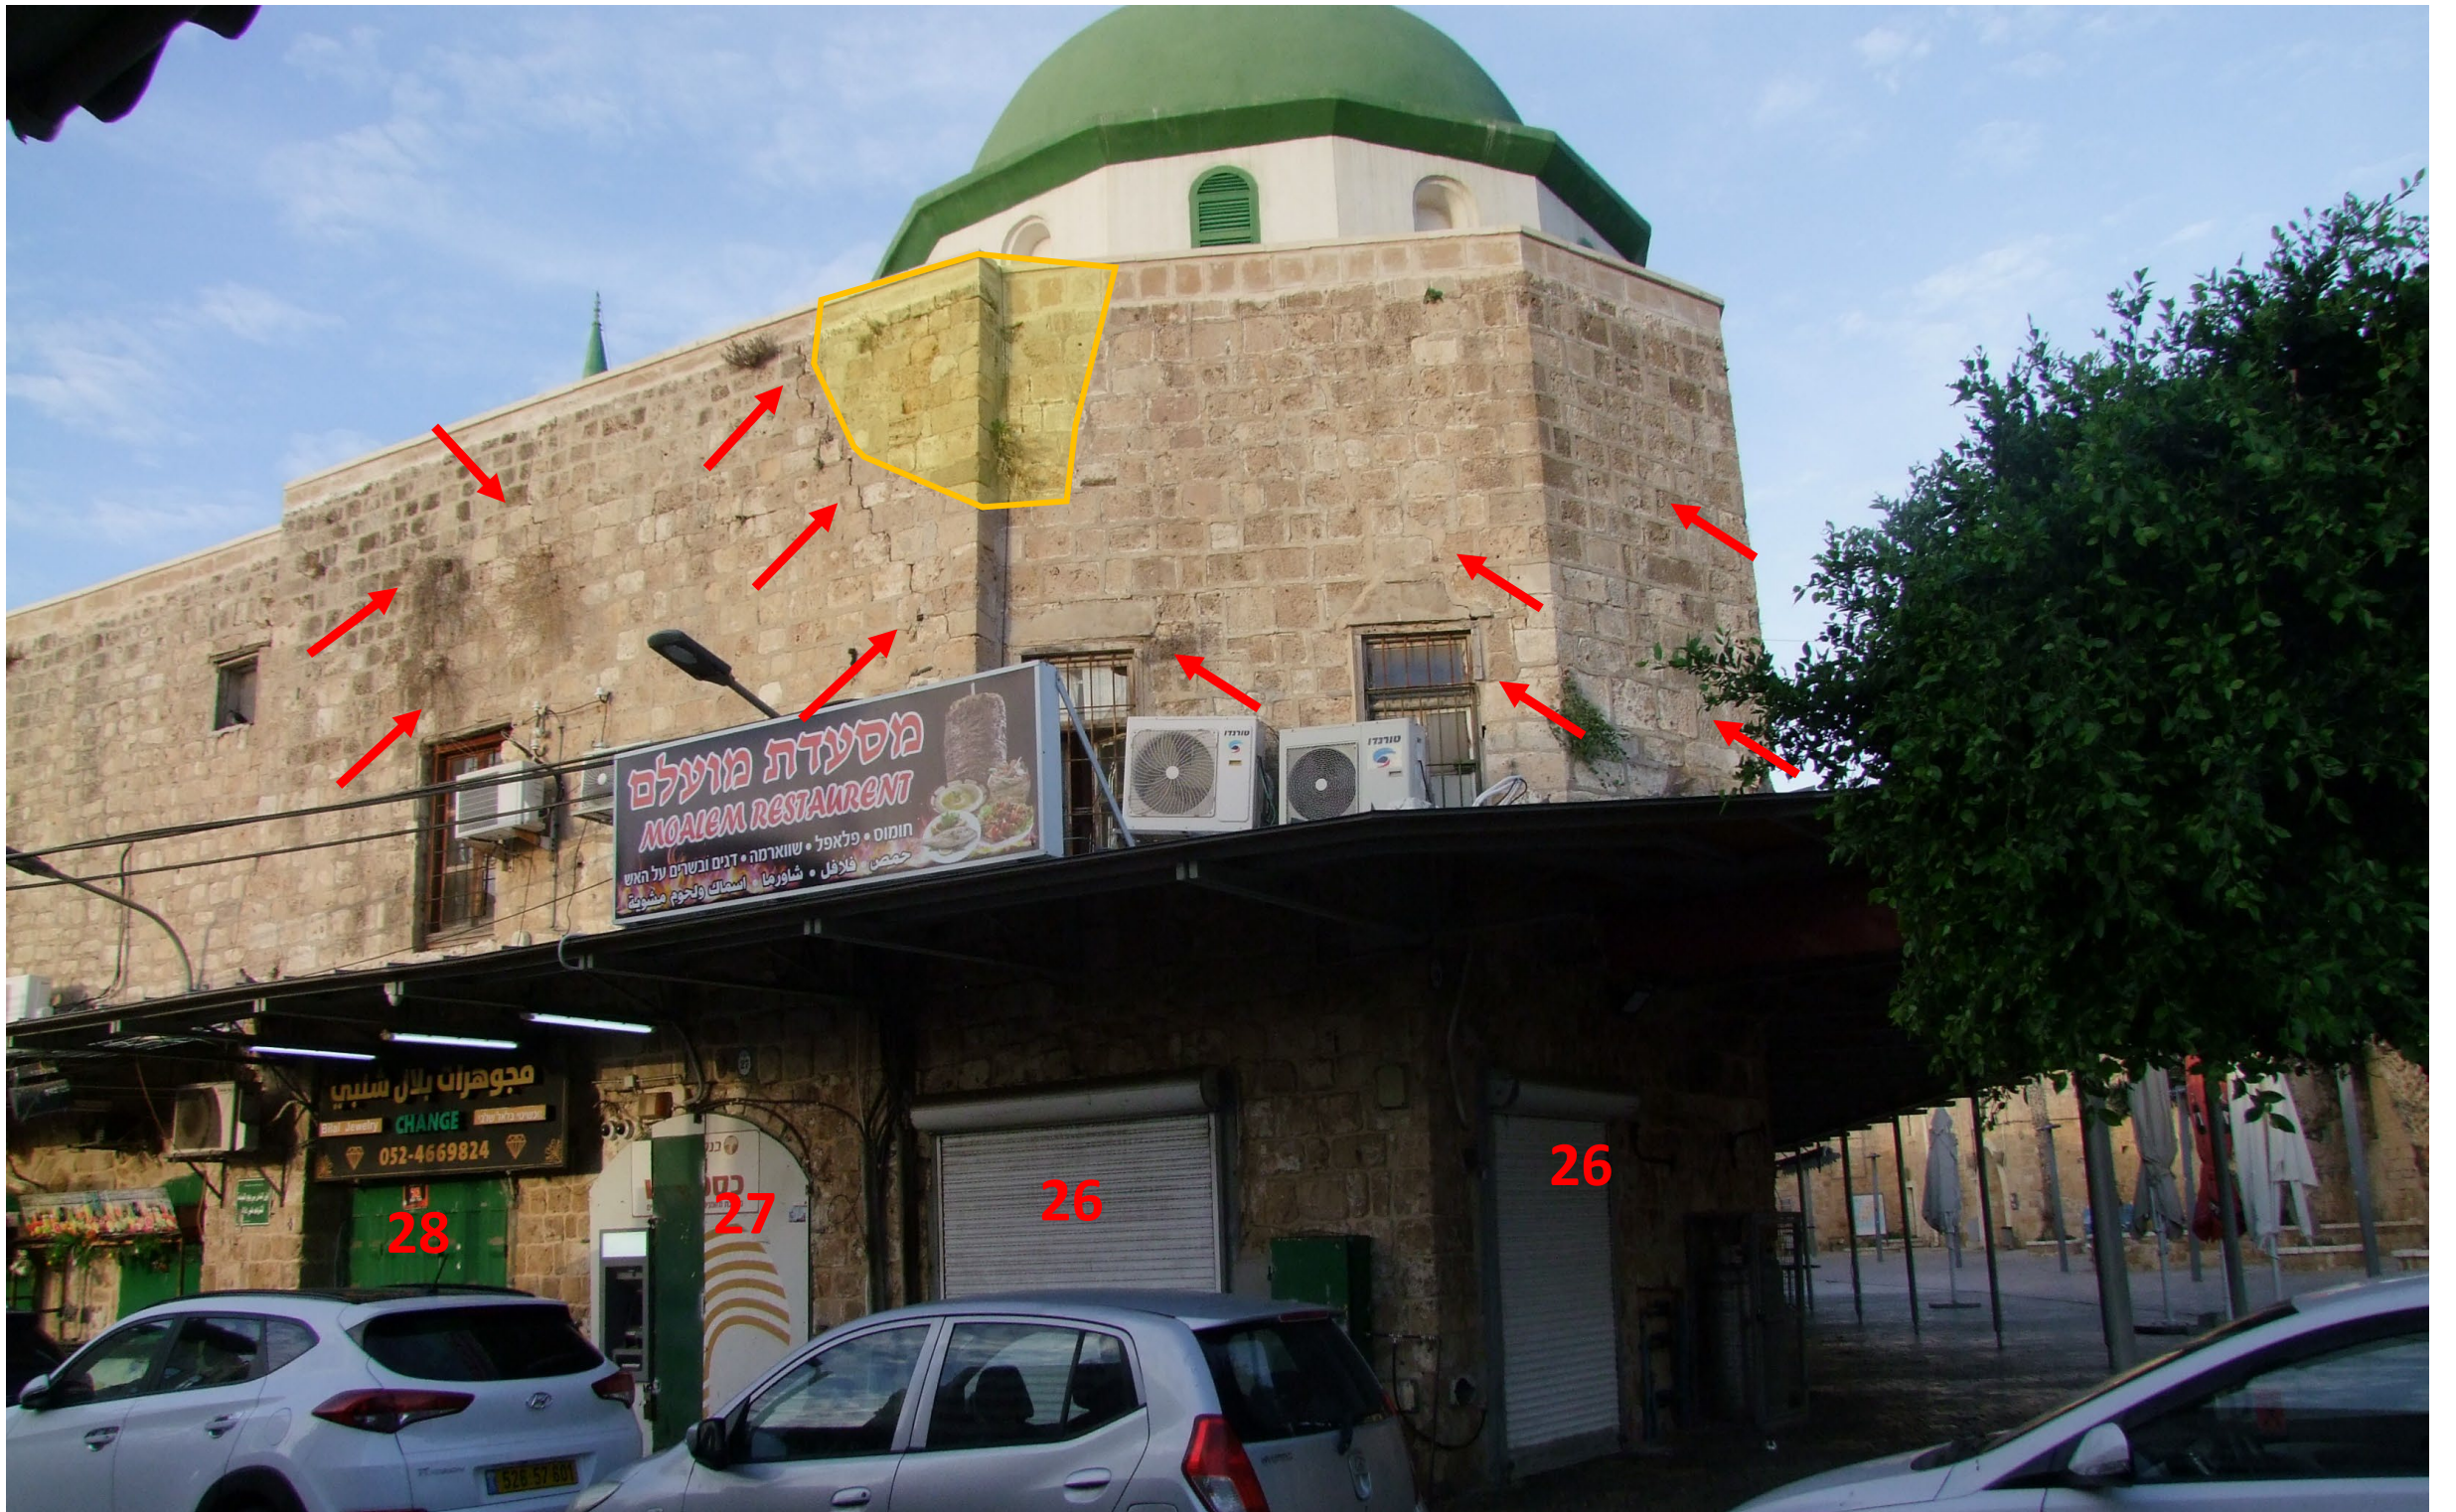
Stone weathering, according to the 2017 survey

Worsening of the stone weathering, according to the 2023 survey

Wall cracks

Areas in which openings were made between the shops

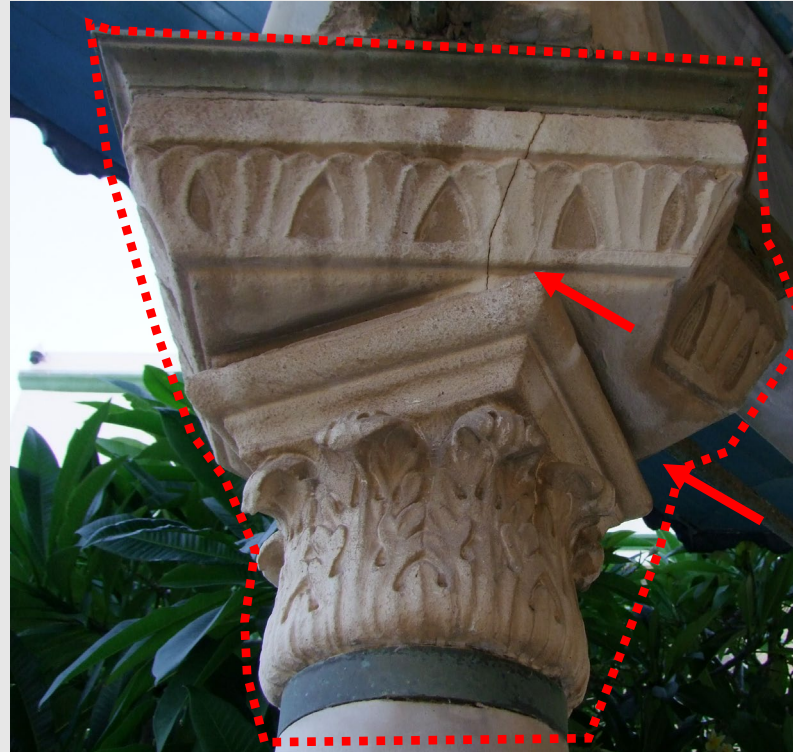
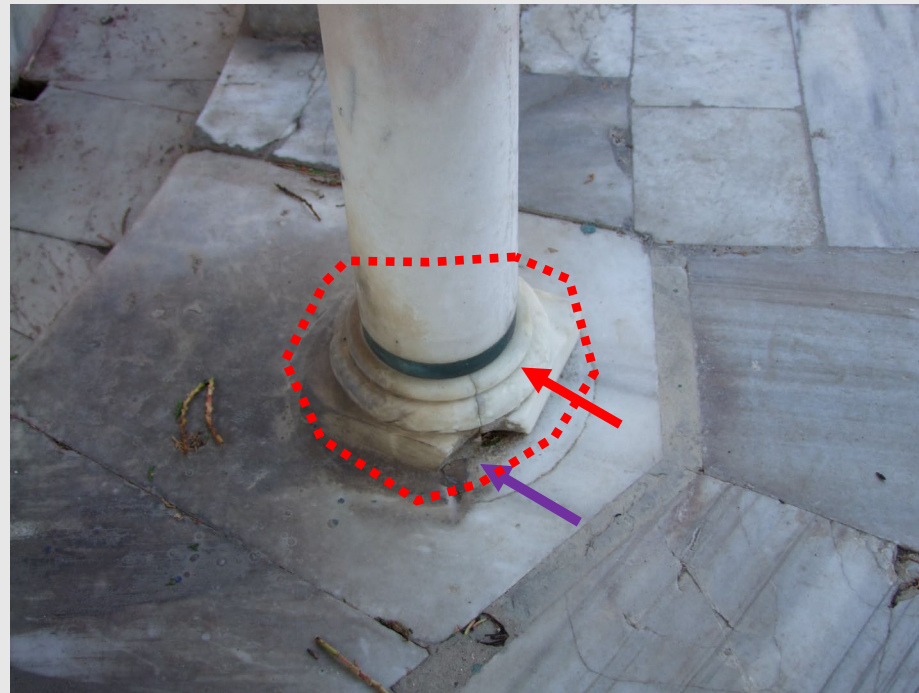
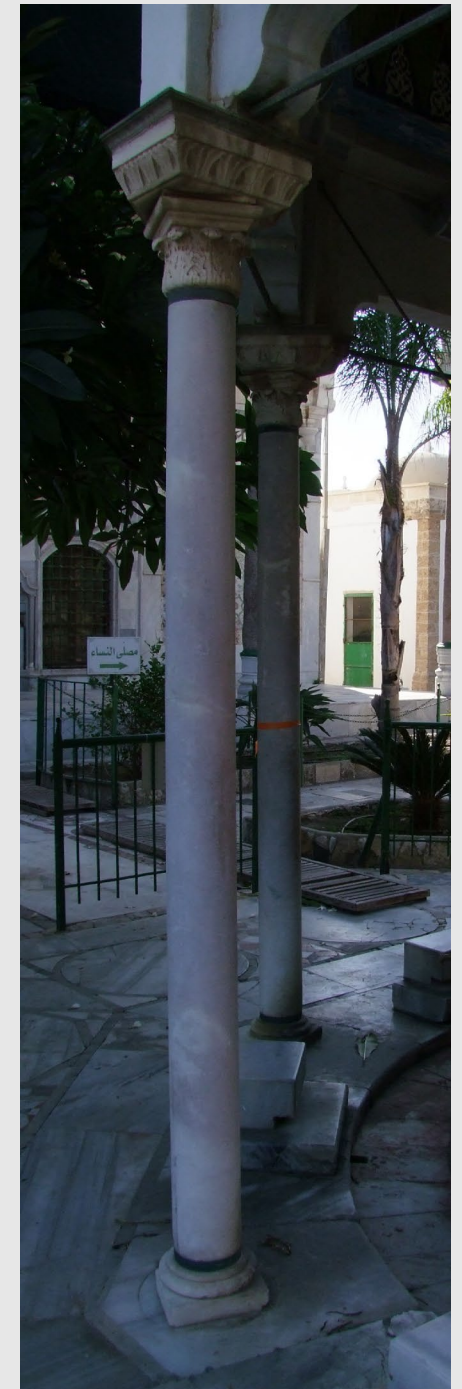
Column 2

- Light pulverization and erosion in the shaft
- Severe erosion and cracks in the pillar's capital
- Cracks in the base of the pillar, fractures and missing pieces in the base of the pillar
- Rust in the metal rings attaching the pillar
- Surface deposits and patina in the marble slabs above the pillar

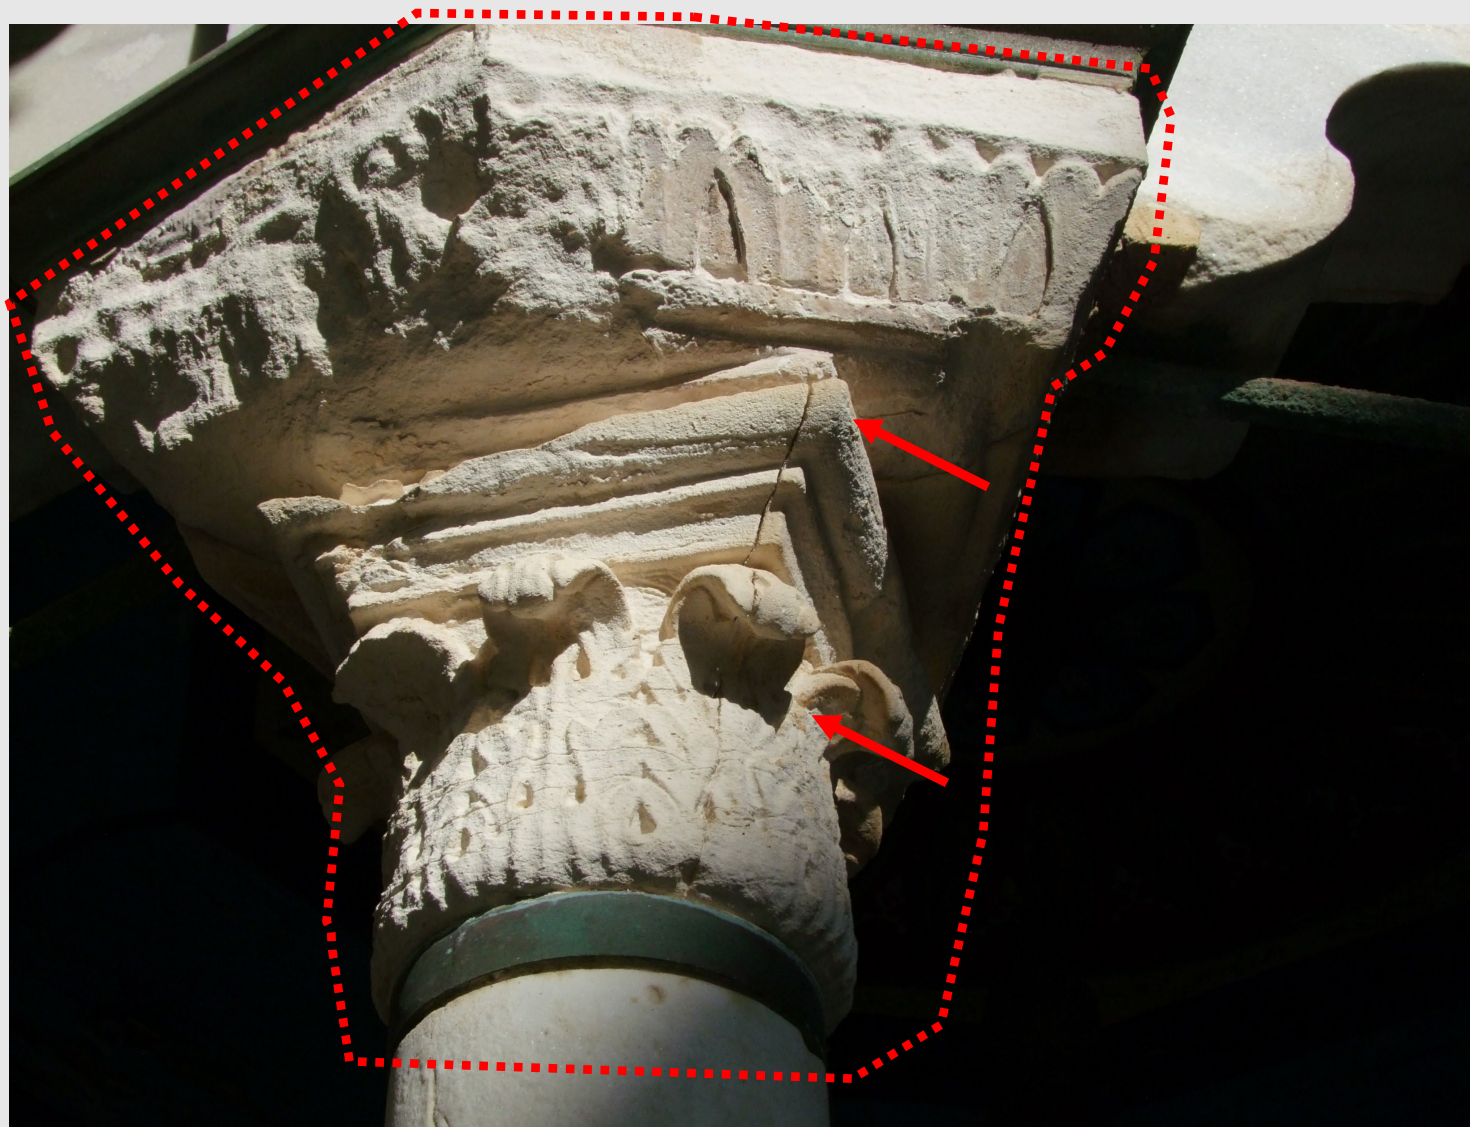
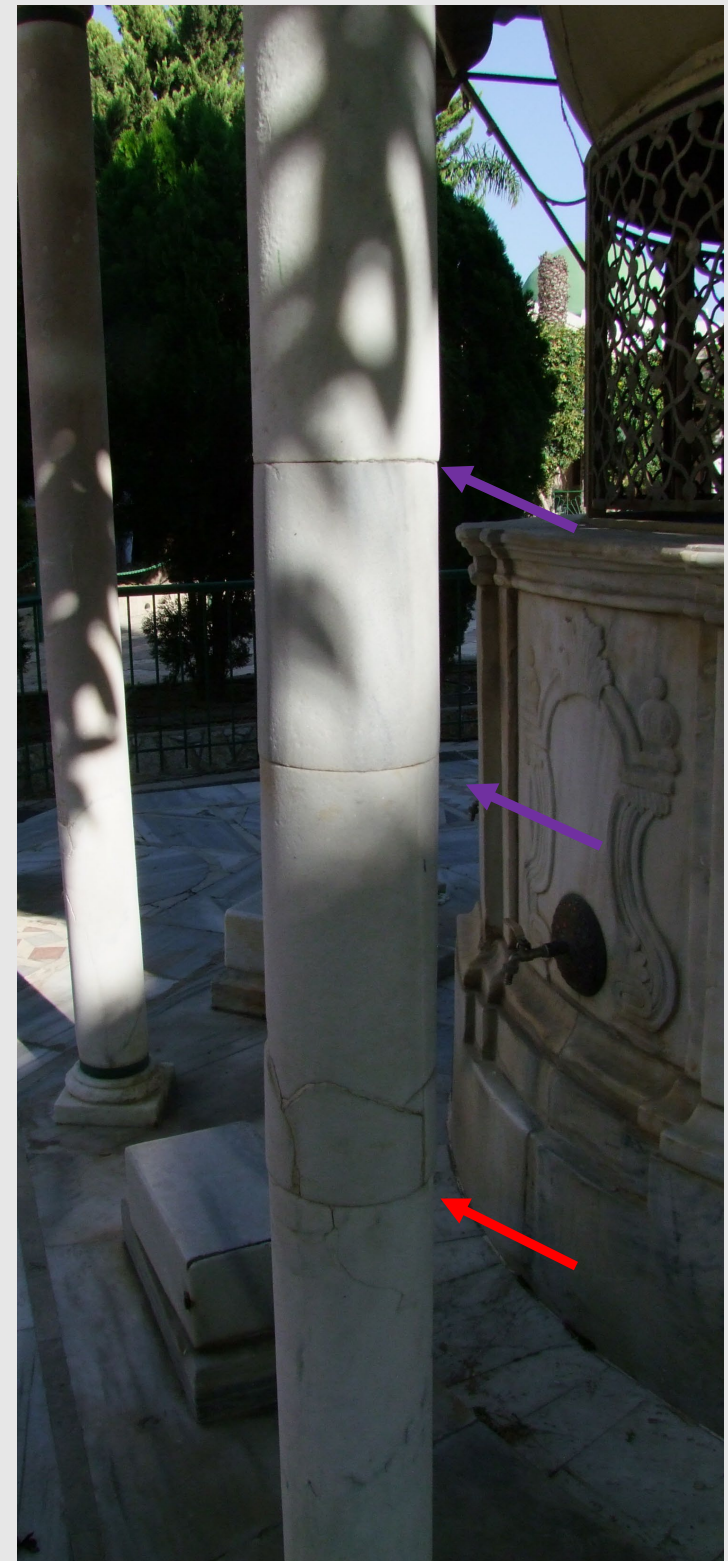
Column 7

- Cracks, fractures and very serious erosion in the pillar's capital
- Severe fractures and erosion in the shaft
- Rust in the metal rings that attach the pillar
- Fractures and cracks in the marble slabs above the capital
- Surface deposits and patina in the marble slabs above the pillar

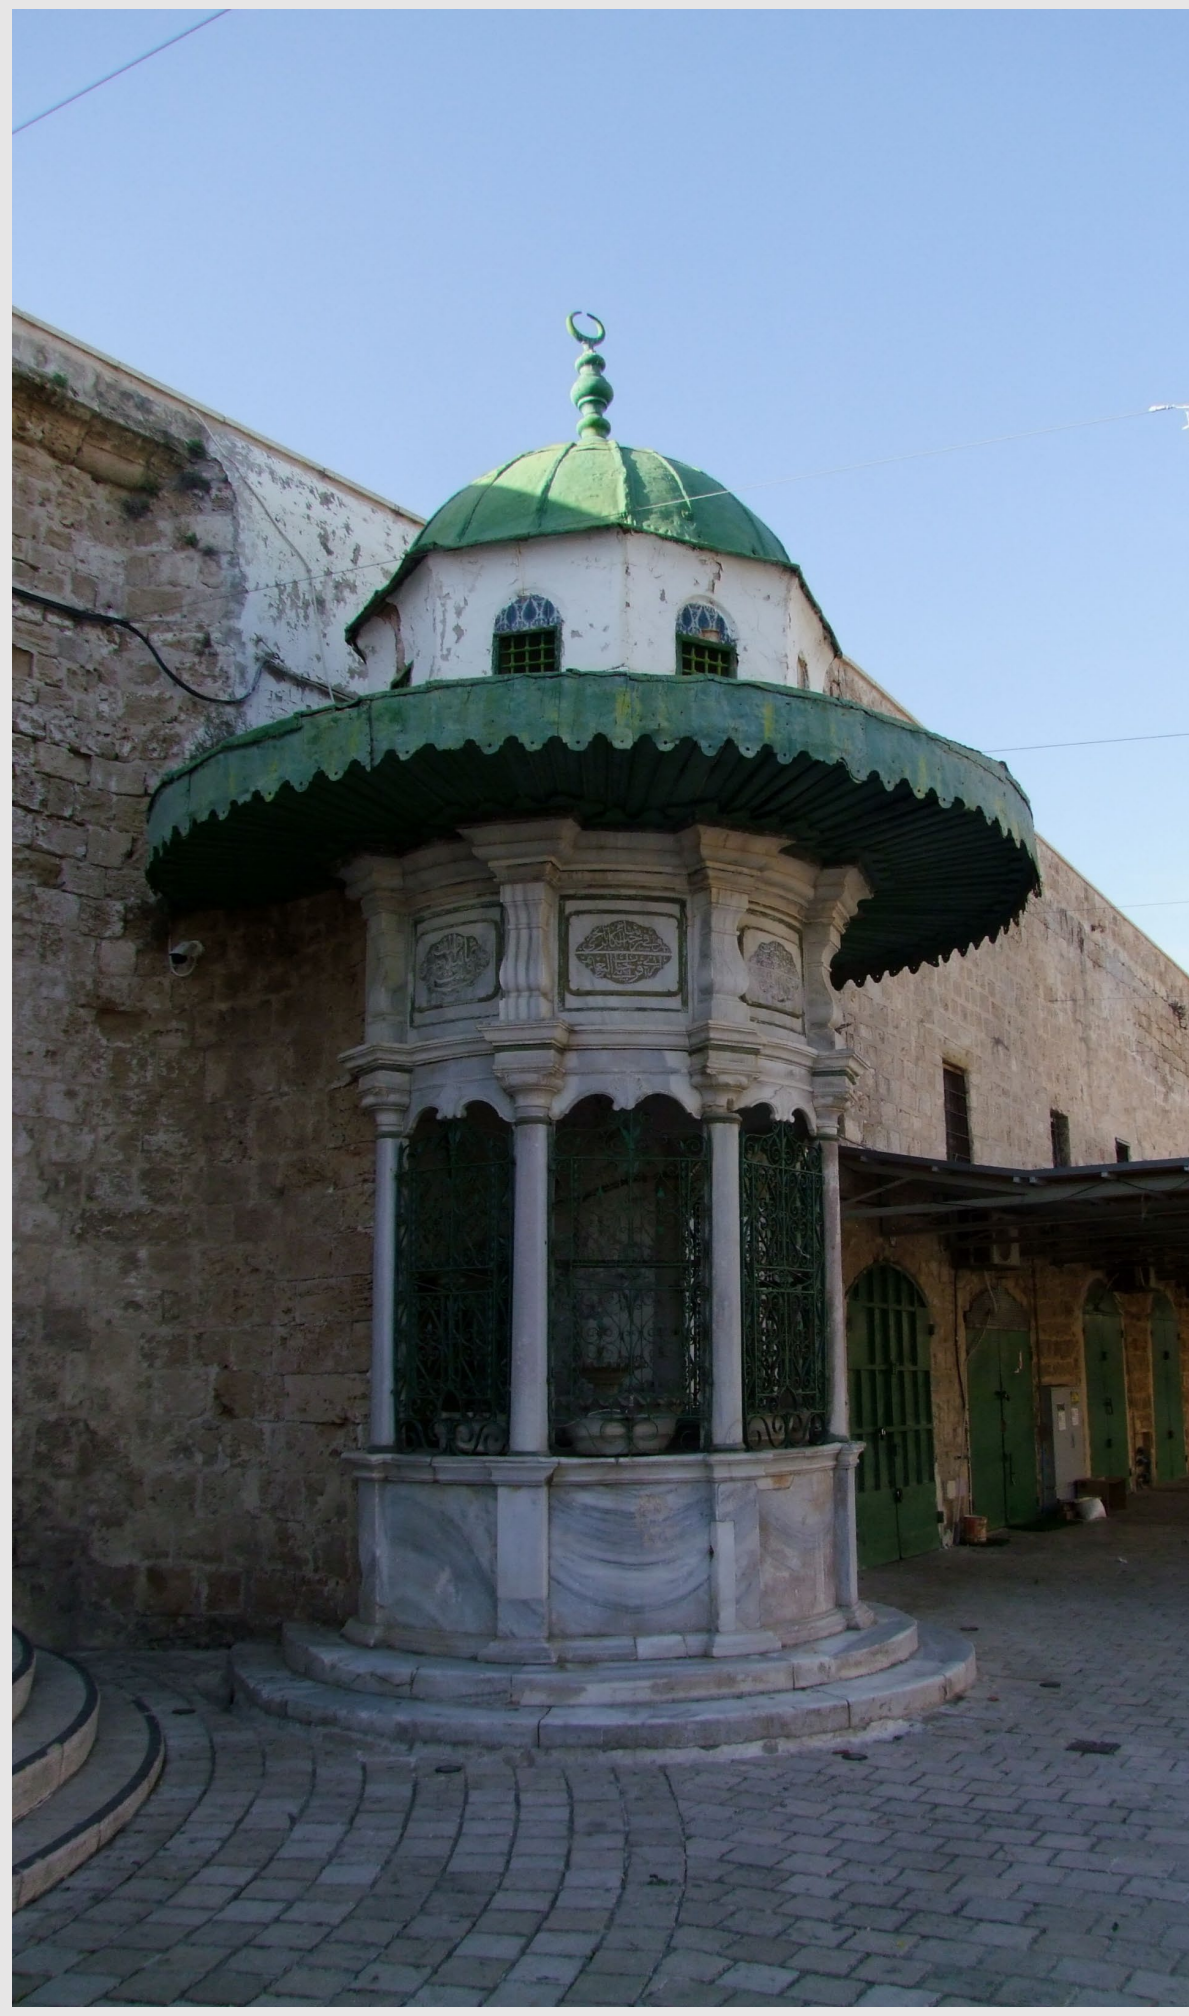
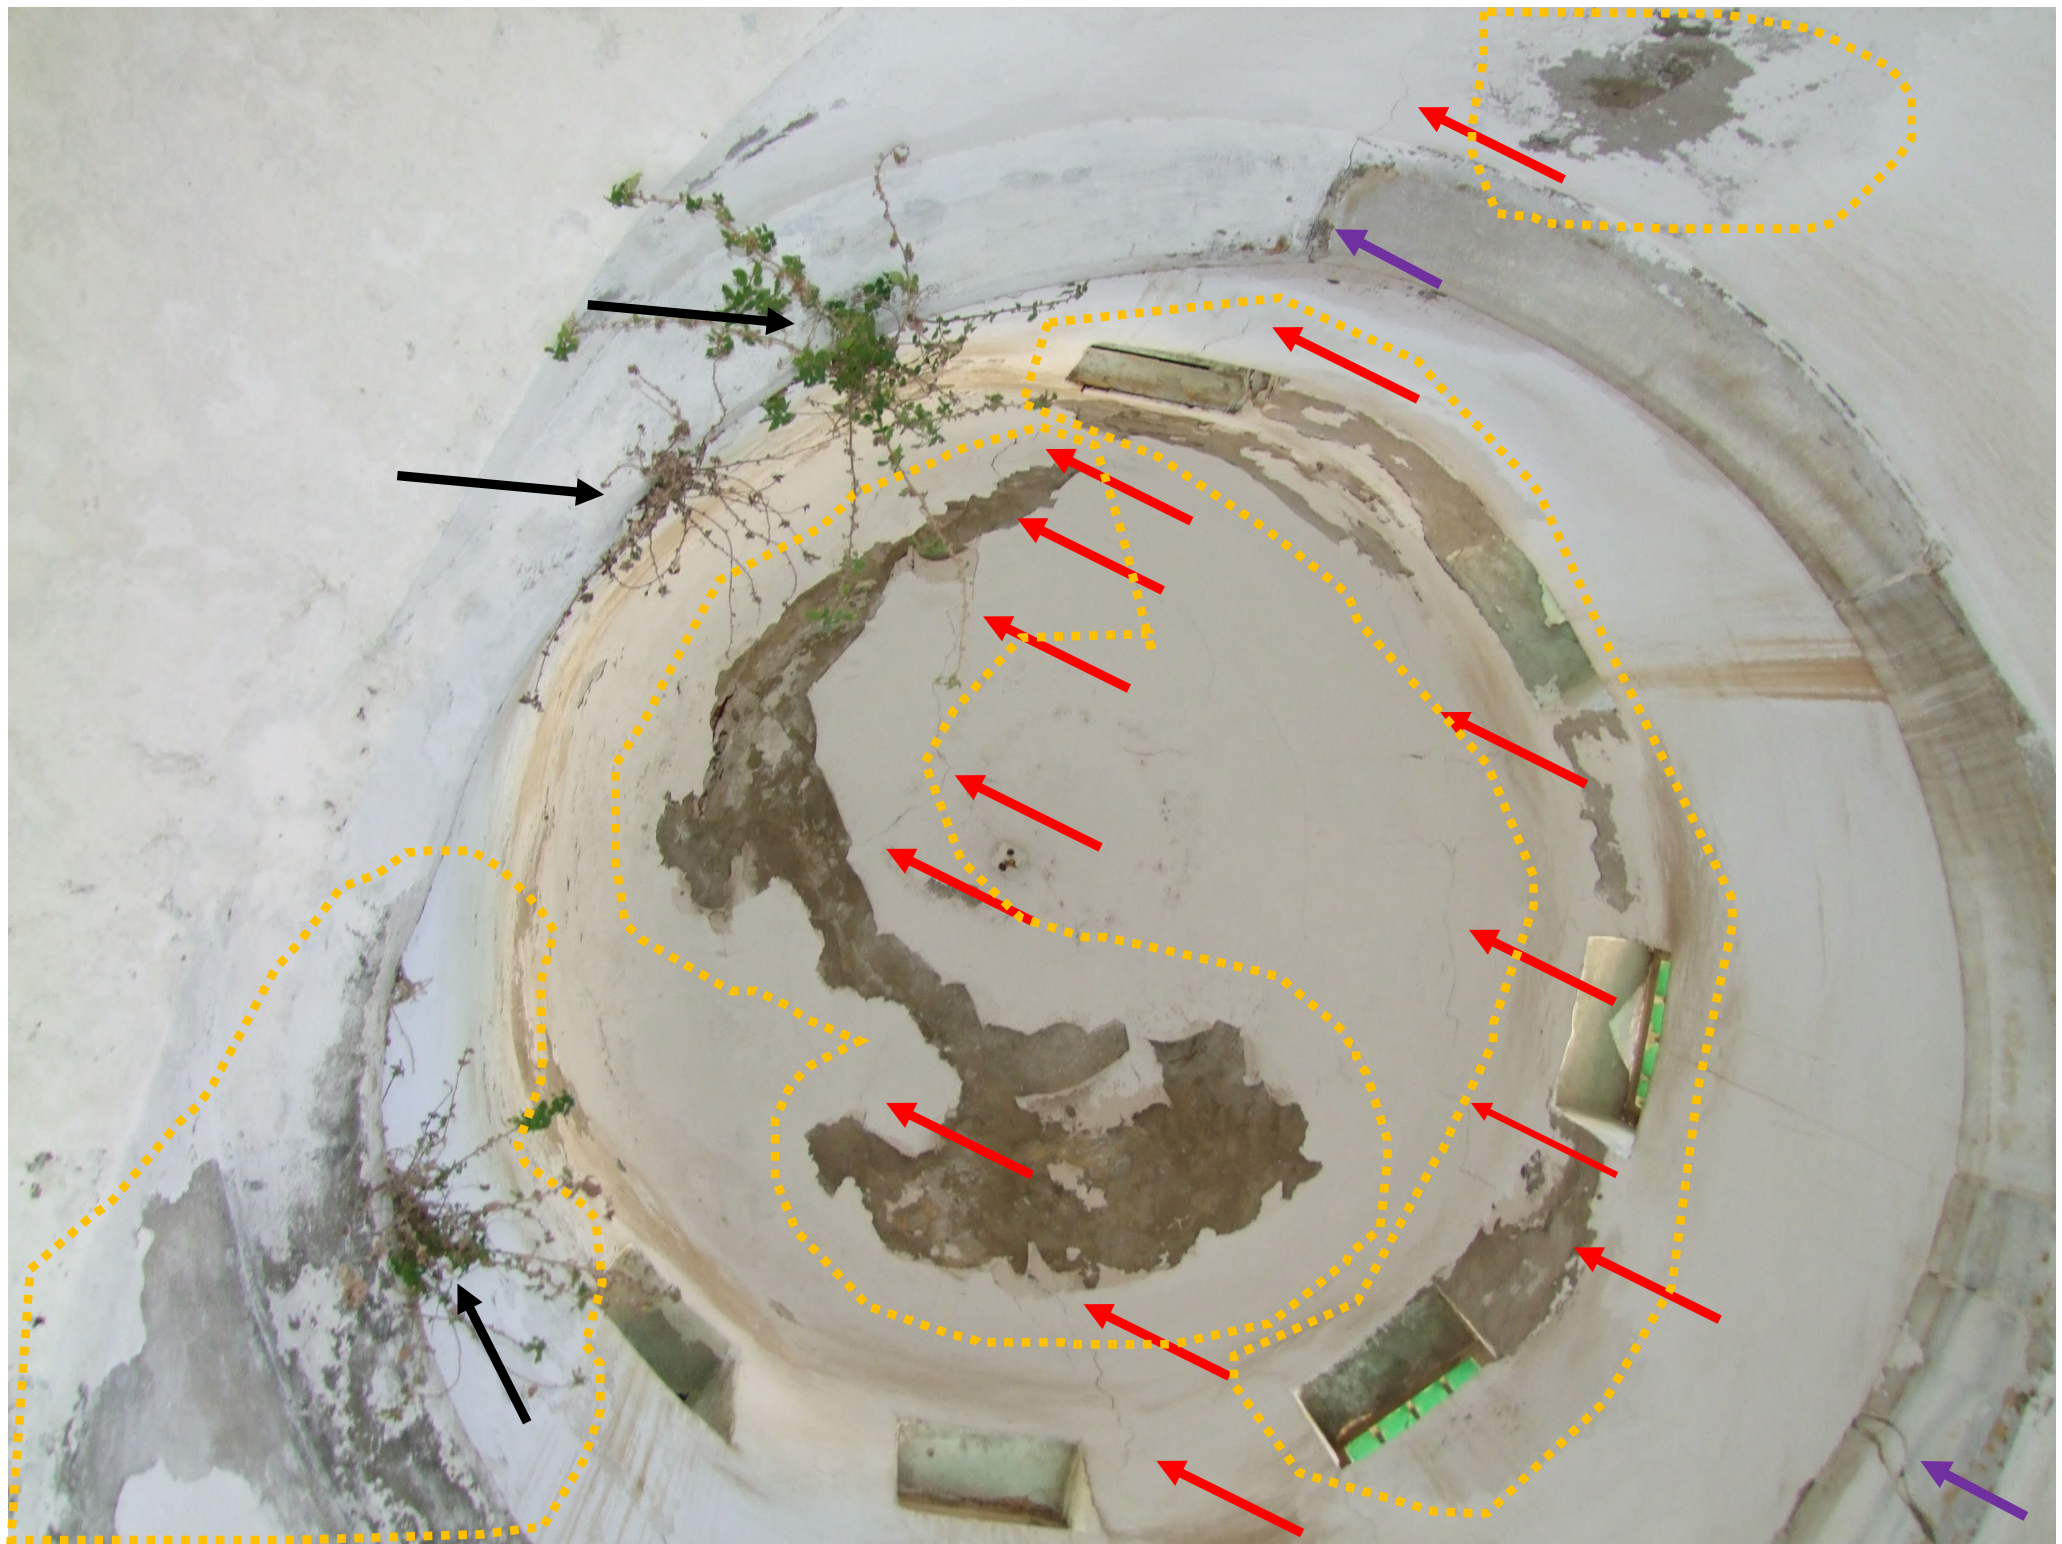
Damage to the interior of the dome

Encrustation

Dampness - plaster exfoliation

Fractures - marble

Cracks

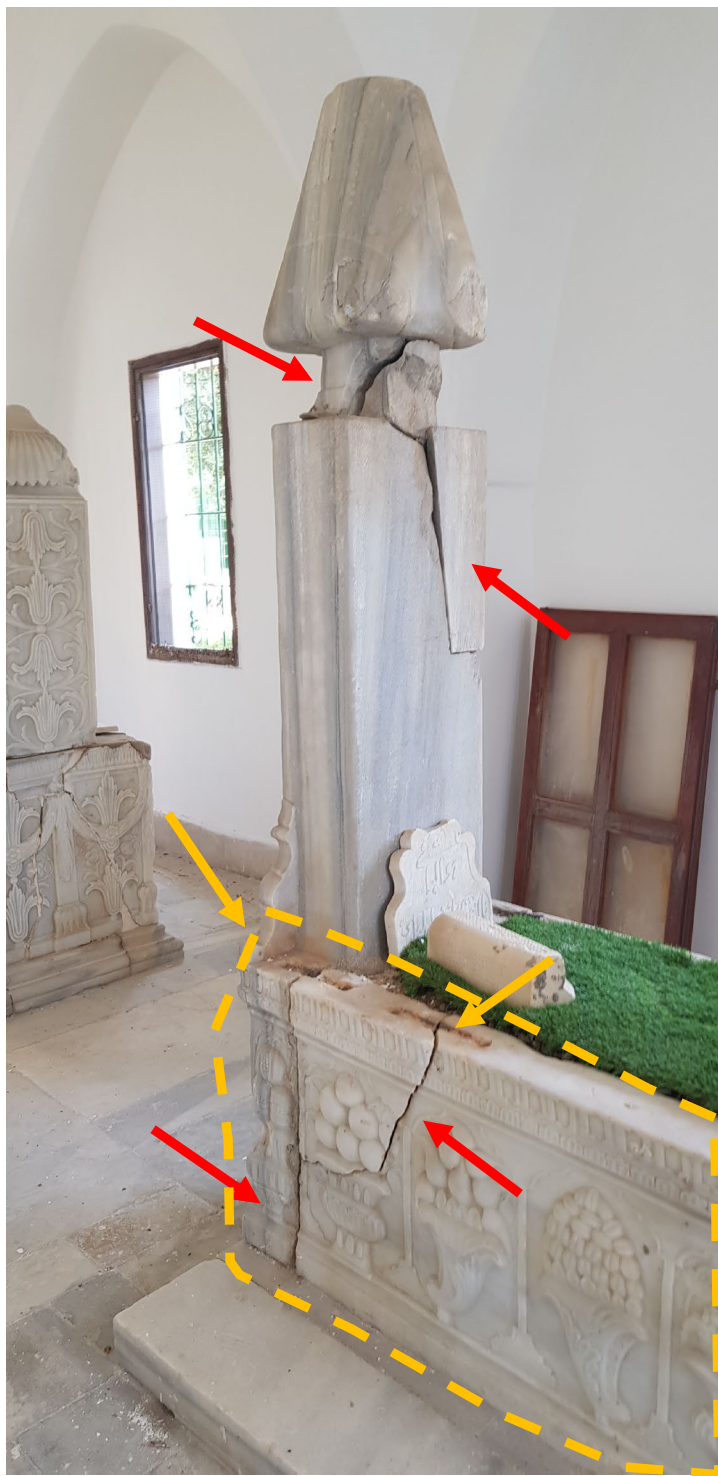
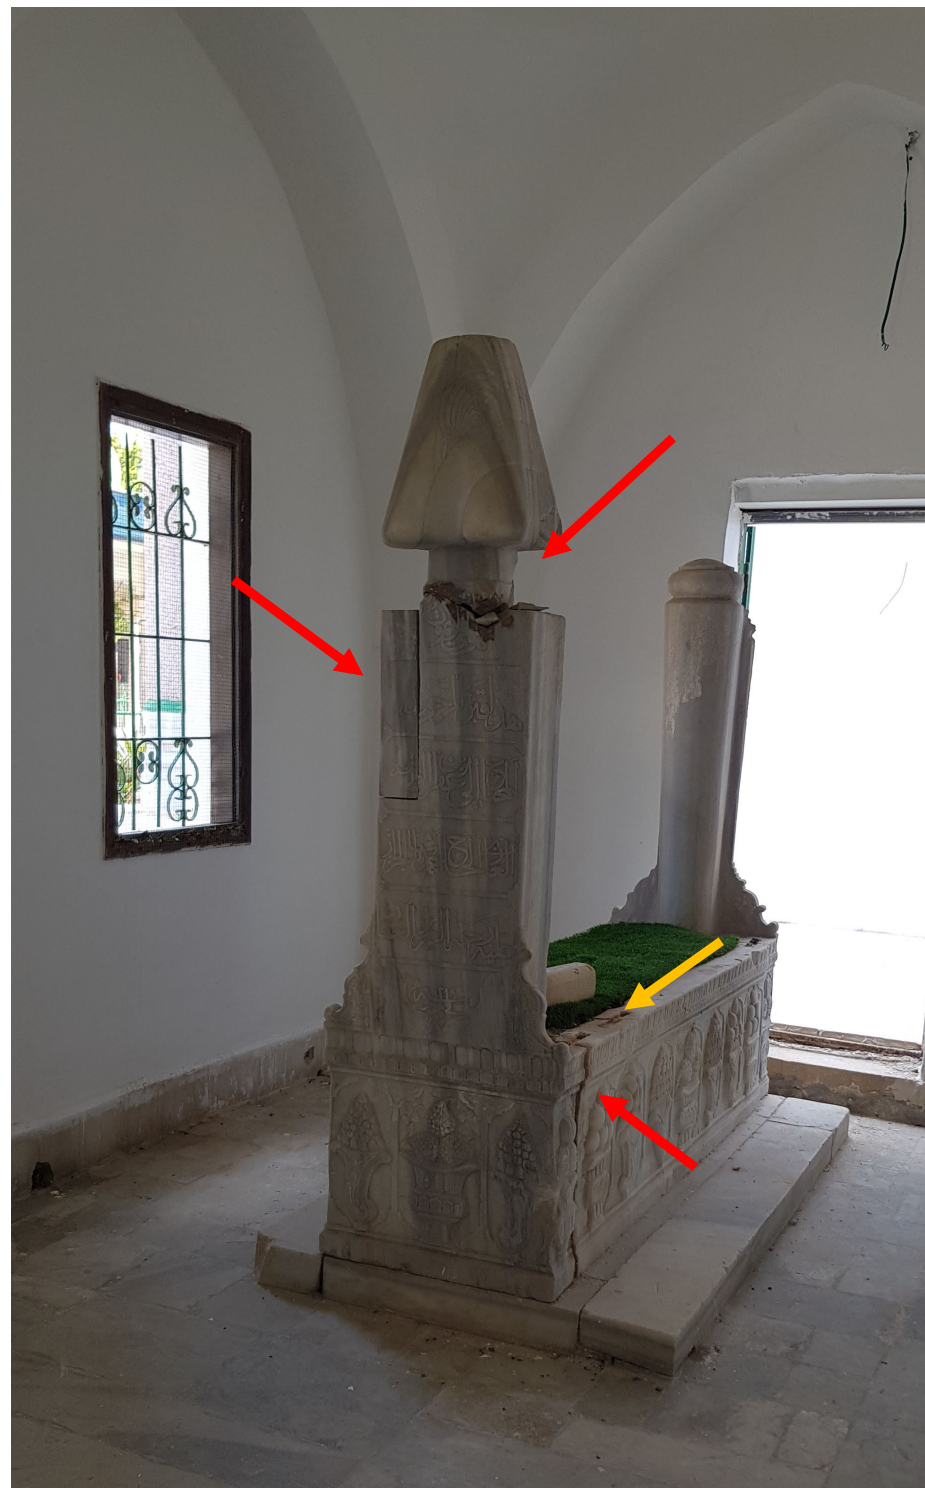
Damage to El-Jazzar Pasha's grave

Rust

Patina - surface deposits

Cracks/Fractures
---	------	---	---------------------------	---	------------------
