Preservation Survey and Situation Assessment

> Acre's El-Jazzar Mosque

Commissioned by: El-Jazzar Islamic Waqf Board of Trustees

Dr. Abdel Razeq Matani Expert on Islamic Archeology and Architecture

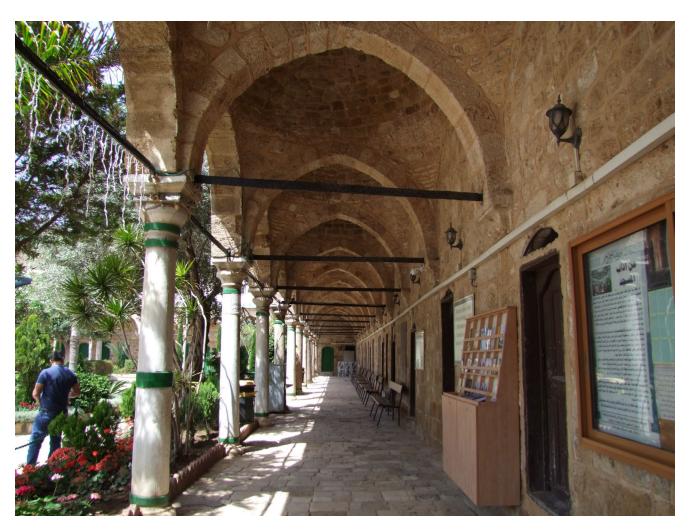
Figure 10: The facade of the western arcade Architectural Documentation and 3D laser scanner survey of el-Jazzar mosque in Acre

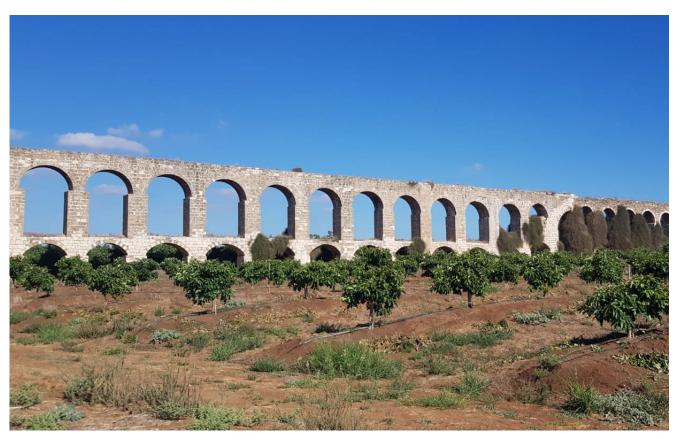
Figure 11 (from below): A 1880 drawing of Acre, (Wilson, 1880).

The siphon towers that were connected to the ceramic pipes that led the water from the aquaduct to the city of Acre, which were used to increase the water flow, can be seen in this drawing.

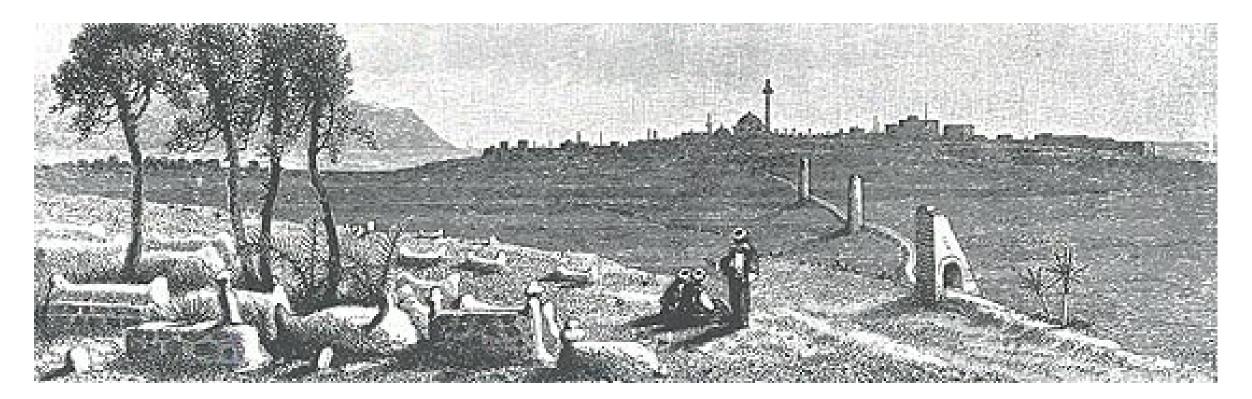
A section of the aquaduct

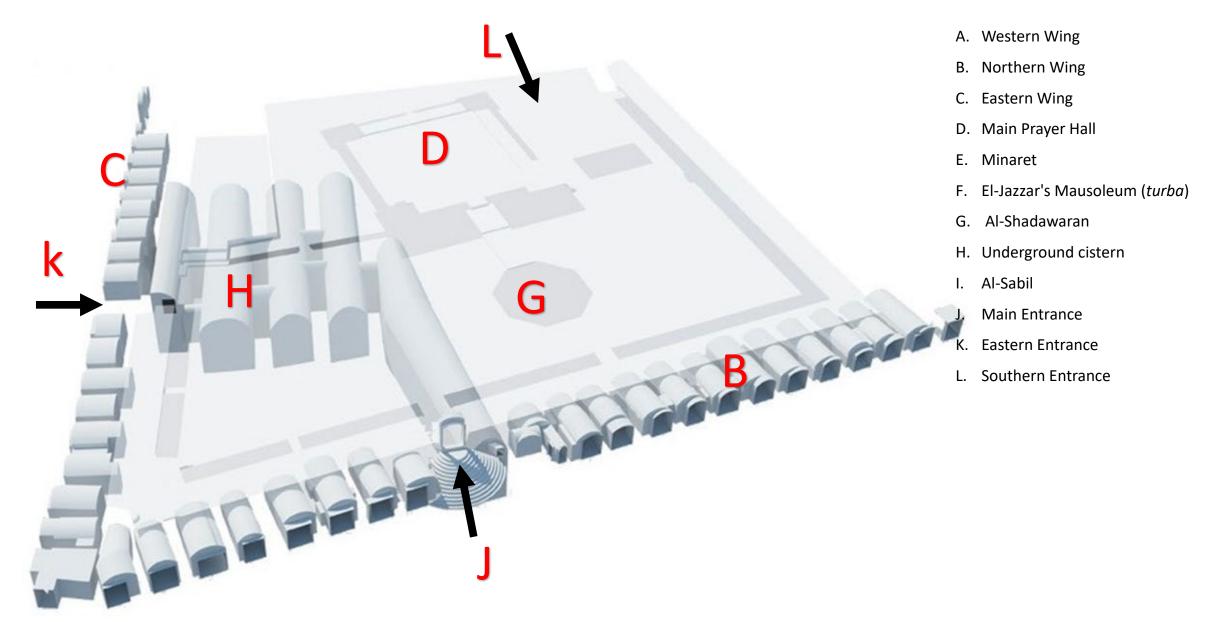
Figure 12: A model of the lower level of El-Jazzar Mosque.

As commonly done in mosques built in the classic Ottoman style, El-Jazzar Mosque is built atop elevated foundations, resulting in an enormous ramp, which contains the shops under the mosque and the immense underground cistern.

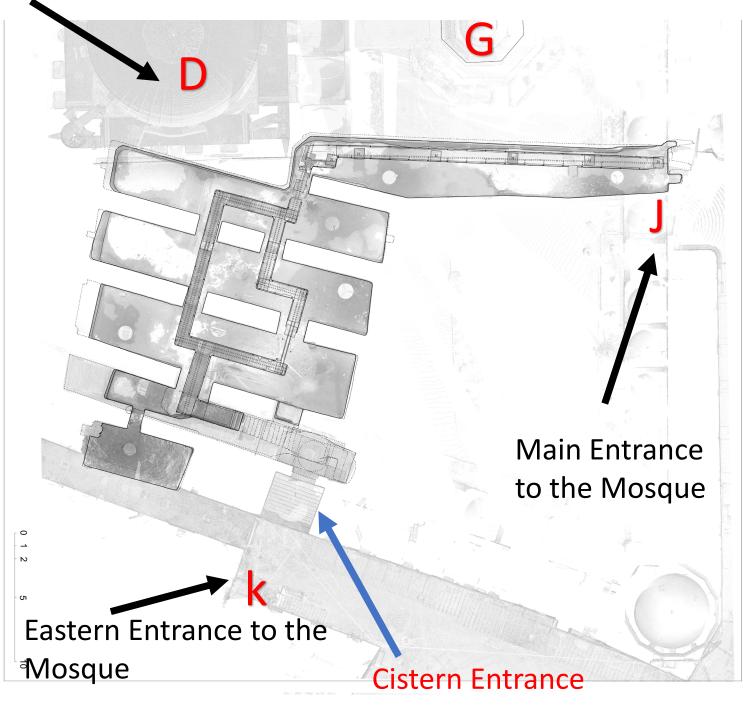
Figure 13: A schematic of the cistern.

In the past, the cistern was a tourist site. It is currently closed because of the restoration work that needs to be done there. Main Prayer Hall

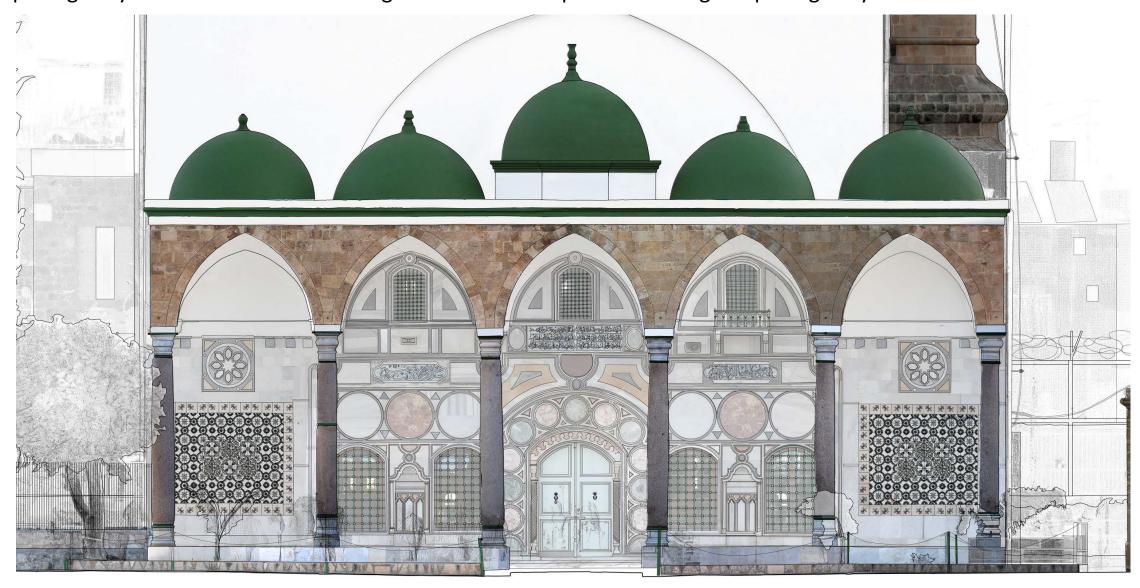
Figure 16: The acsadra at the front of the prayer hall. Courtesy of:

Three decorative windows are embedded into the arches in the upper part of the acsadra's facade wall. The floor of the acsadra is comprised of two levels: The lower level is a passageway through which the entrance to the prayer hall can be accessed (elevated another 0.10 meters). It is located in the center, and creates two raised surfaces on either side of the passageway. The raised surfaces emerge from a wide step located along the passageway.

Severe cracks in the bases of the massive columns at the front of the prayer hall (the acsadra) and in the platform upon which the bases rest have been documented. These cracks endanger the stability of the massive marble columns at the entrance, and may cause the columns and the entire acsadra to collapse. They may also cause additional damage to the structure, due to the size and nature of the columns.

Risk level: A very high level, putting the prayer hall at risk. The damage may affect other elements of the mosque.

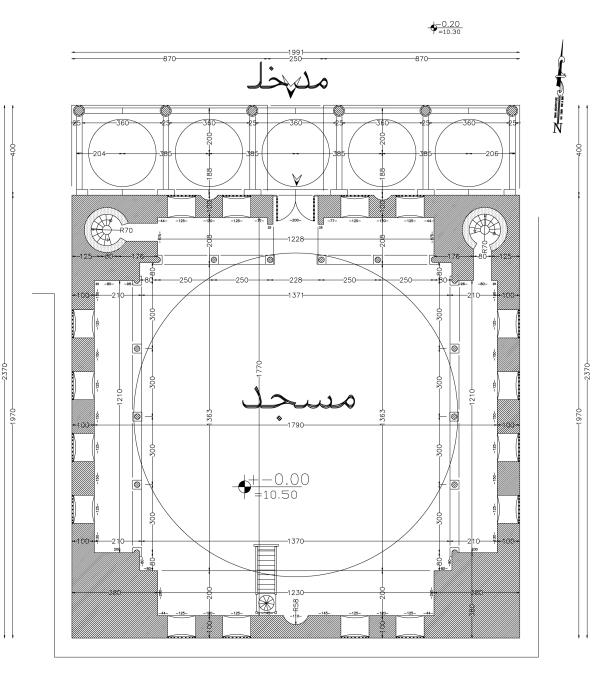
Figure 17: The Floor Plan of the Prayer Hall.

The prayer hall has a square structure, and is capped with one large dome, which covers the entire area of the square. The dome is supported by bulky imposts resting on four elephant leg pillars in the corners of the square (approximately 3X3 m). The intersection between the two arches produces pendentives. The dome is buttressed, on the exterior, by small support arches on its sides. This roof construction method allowed for building a large internal space in the prayer hall, and also made it possible to build a tall and wide dome, ensuring that the mosque would dominate the skyline. The internal prayer area is surrounded by three internal arcades (to the north, east and west). The roof of the arcades was used as a balcony and as an additional prayer area. There are seven windows in the eastern and western walls: four are in the bottom part of the war (raised 0.45 meters off of the floor), and three are in the upper part of the wall, above the balconies.

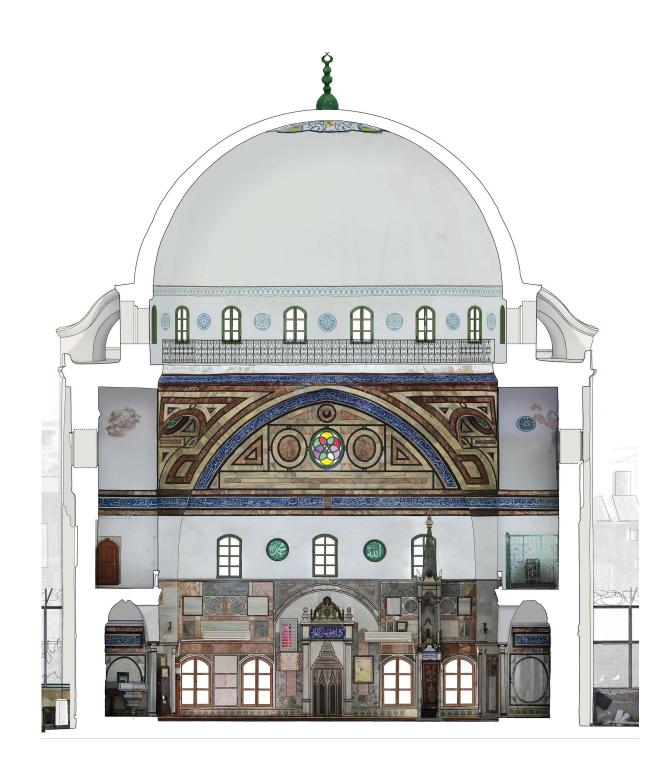
The *Qiblah* wall is adorned with colorful granite slabs interspersed with blue tiles (*qashan*). The *mihrab*, opposite the main entrance to the prayer hall, is at the center of the wall. The *minbar* is to the west of the *mihrab*. There are two windows on either side of the *mihrab* – a total of four windows. The windows are rectangular (length: 2 meters, width: 1.3 meters, depth: 1.15 meters) and are raised above the floor (by 0.45 meters). The window sills are tiled with granite, and capped with a Segmental arch.

Figure 18: The Qiblah wall.

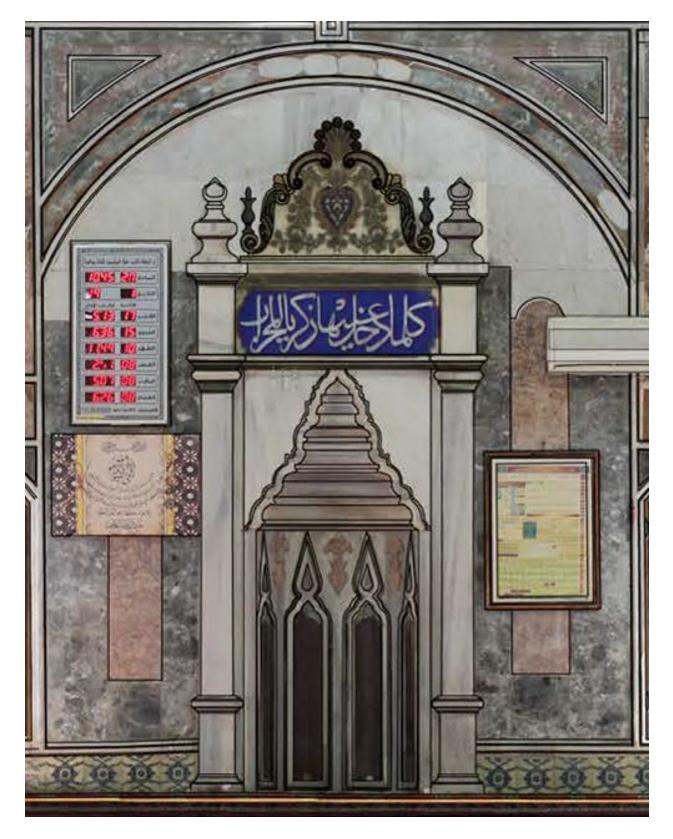
The literal meaning of the word *mihrab* is "the highest and central point of the house." This name is given to the prayer niche, where the imam (الإمام) stands and leads the services. The *mihrab* is at the center of the mosque, within the *giblah* (usually at the center of the wall). The *mihrab* (height: 2.8 meters, width: 1.10 meters, depth: 0.63 meters) is raised 0.10 meters above the prayer hall, and is immaculately decorated and designed with granite panels are varying colors and sizes. The *mihrab* can be divided into two sections: the frame of the *mihrab*, which is comprised of two square pillars (the height of the pillars is 2.30 meters, the height of the base of the pillars is 0.72 meters, and the height of the capital is 0.30 meters), resting on large bases, and they have rectangular capitals. The pillars frame the *mihrab* on both sides. Above the capitals of the pillars is a decorative blue rectangular frieze (1.4 X 0.4), which is also framed by two small pillars. The following Quranic verse is engraved into the frieze: كلما دخل عليها زكريا المحراب. The niche of the *mihrab* is comprised of a semicircular lower section (height: 1.70 meters, depth: 0.63 meters), and a decorative, conch-shaped upper section that tapers toward the top (the width of the upper edge is 0.10).

Figure 19: The *Mihrab*, from the records from the 2017 survey. Architectural Documentation and 3D laser scanner survey of el-Jazzar mosque in Acre

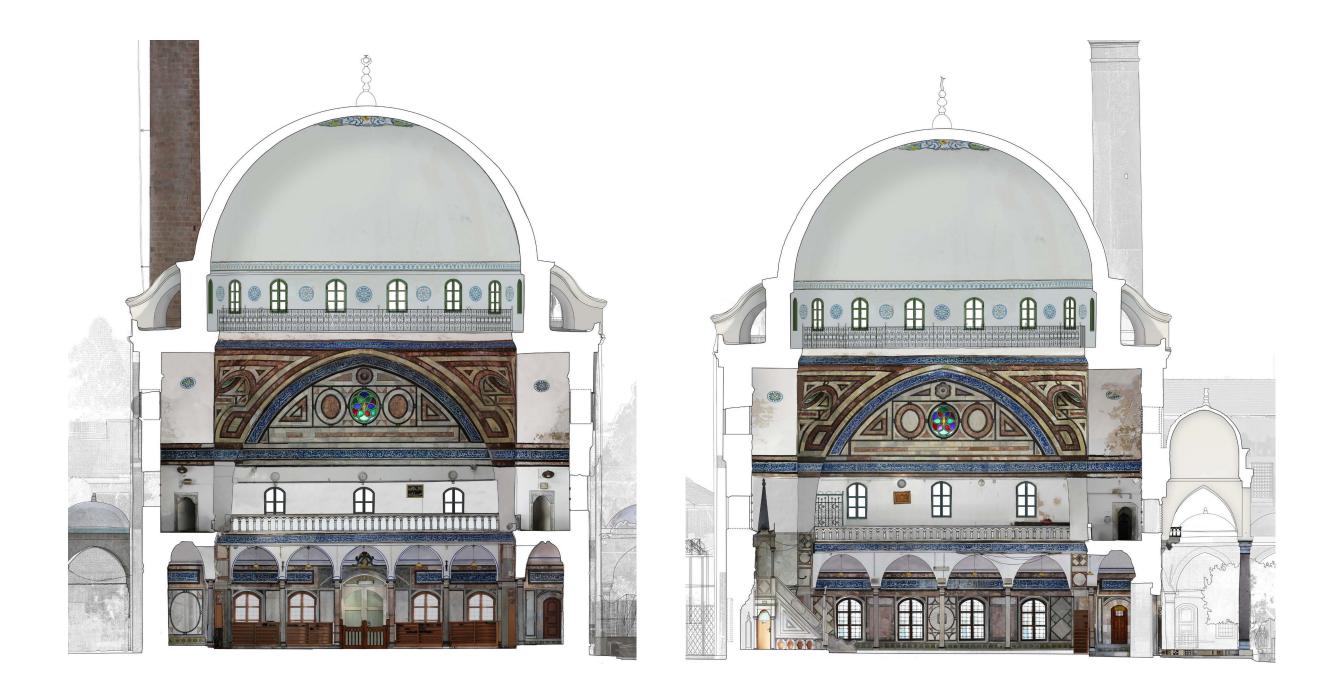
Figure 20: The western wall (to the right) and the northern wall (to the left) of the prayer hall

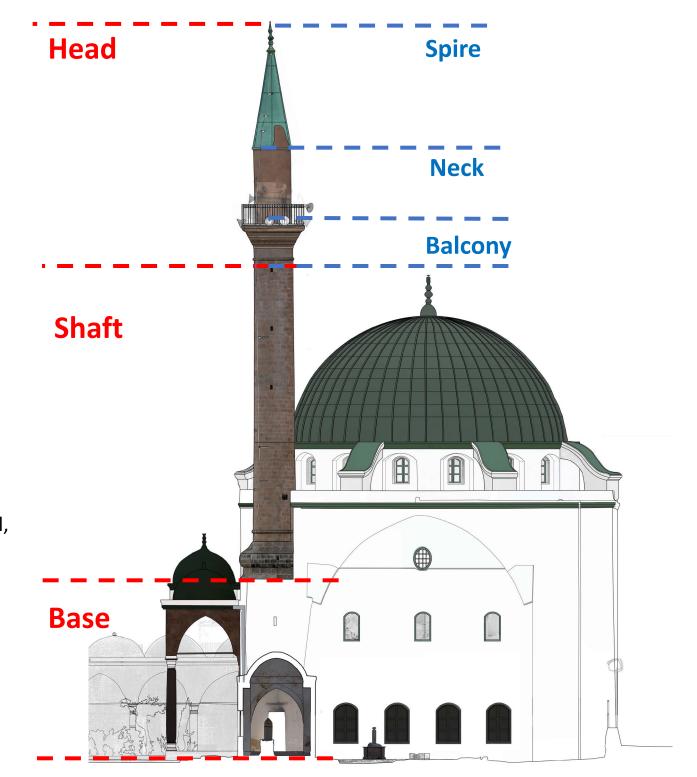
Figure 21: The minaret, viewed from the east Architectural Documentation & 3D laser scanner survey of el-Jazzar mosque in Acre

The mosque has a minaret (Al-Madhana), located in the northwestern corner of the prayer hall. The minaret is reached via a staircase that emerges from the prayer hall. The minaret reaches a height of 23 meters above the prayer hall, and is topped with a 1-meter high metal crescent. The minaret was apparently damaged several times. In 1812, the main minaret was damaged and developed cracks after being hit by a bolt of lightning. The minaret was rebuilt in 1816, and when it was restored, the minaret's original shape was preserved.

The parts of the minaret: The base of the minaret is attached to the elephant leg pillar in the corner of the prayer hall, a barrelshaped element (diameter: 2 meters, height: 14 meters) with a rounded, recessed base attached to the corner of the prayer hall, within which is a spiral staircase. The parapet is comprised of a cylindrical *jawsak*, or neck (height: 4 meters) resembling the shaft of the minaret, rising over a small elliptical balcony (diameter: 3 meters, height: 1 meter) with a balustrade (the height of the balustrade is 1 meter). Above the *jawsak* is a conical canopy (*el-Burnus,* Height: 3 meters), capped with a crescent.

During the survey, vertical cracks in the minaret's segmented central column were documented, including cracks in the segments at the base of the minaret, which is part of the structure of the central prayer hall (the northwestern corner of the structure). Moreover, a number of the stones in the stairs are crumbling, particularly on the top surface of the stones, and there are vertical cracks in the shaft of the minaret itself.

Risk level: The minaret is at a very high risk of collapse, necessitating serious, immediate and controlled intervention to prevent the minaret from collapsing and to prevent any further collateral damage to the prayer hall itself.

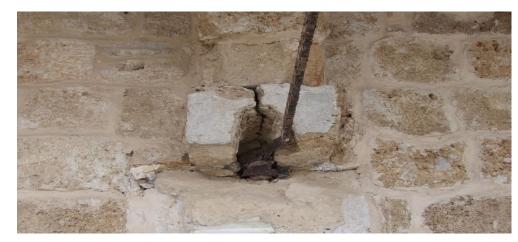
Cracks in one of the capitals that supports a dome in the arcade, and rust in the girder

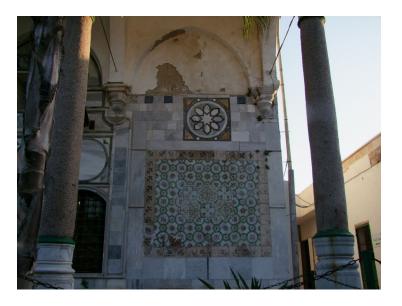
The weathering in the marble and *qashan* inlay, in the western corner, along the facade of the prayer hall (the arcade)

The intervention must be prudent, and it must be carried out by experts and professionals trained in this type of work, so that the artistic values of these elements can be preserved, and so that they can be given the proper treatment.
