Preservation Survey and Situation Assessment

Acre's El-Jazzar Mosque

Engineering-Construction failures and risks in The Minaret (Al-Madhana) (summary)

February 2023

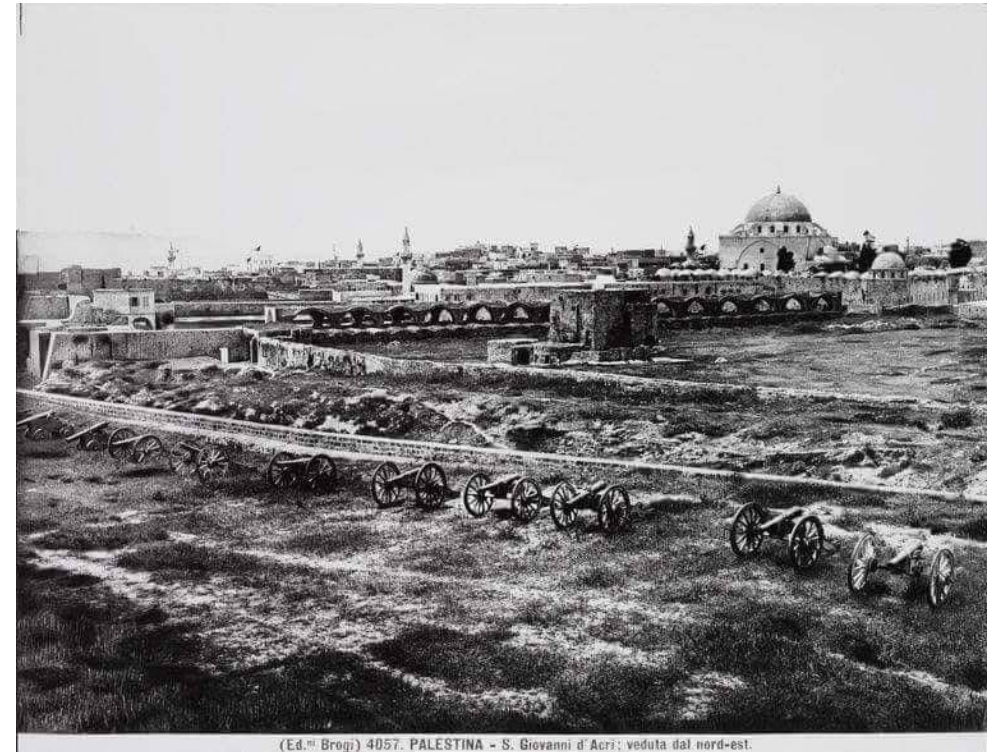
The El-Jazaar Mosque, 1870

This photograph, taken in 1870, shows that the mosque did not have a minaret at the time. The minaret had probably fallen off earlier. As of yet, no information on this incident has been obtained, and the exact time it occurred is unknown.

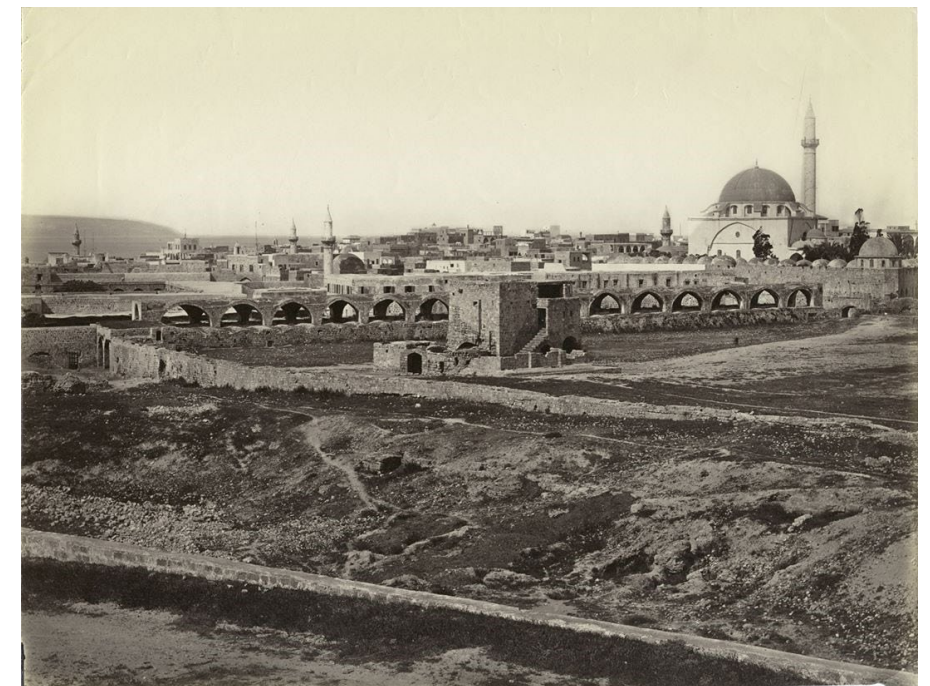
The El-Jazaar Mosque, 1880

- A photograph from 1880, showing that a minaret had been built for the mosque. The new minaret was probably built between 1870 and 1880.

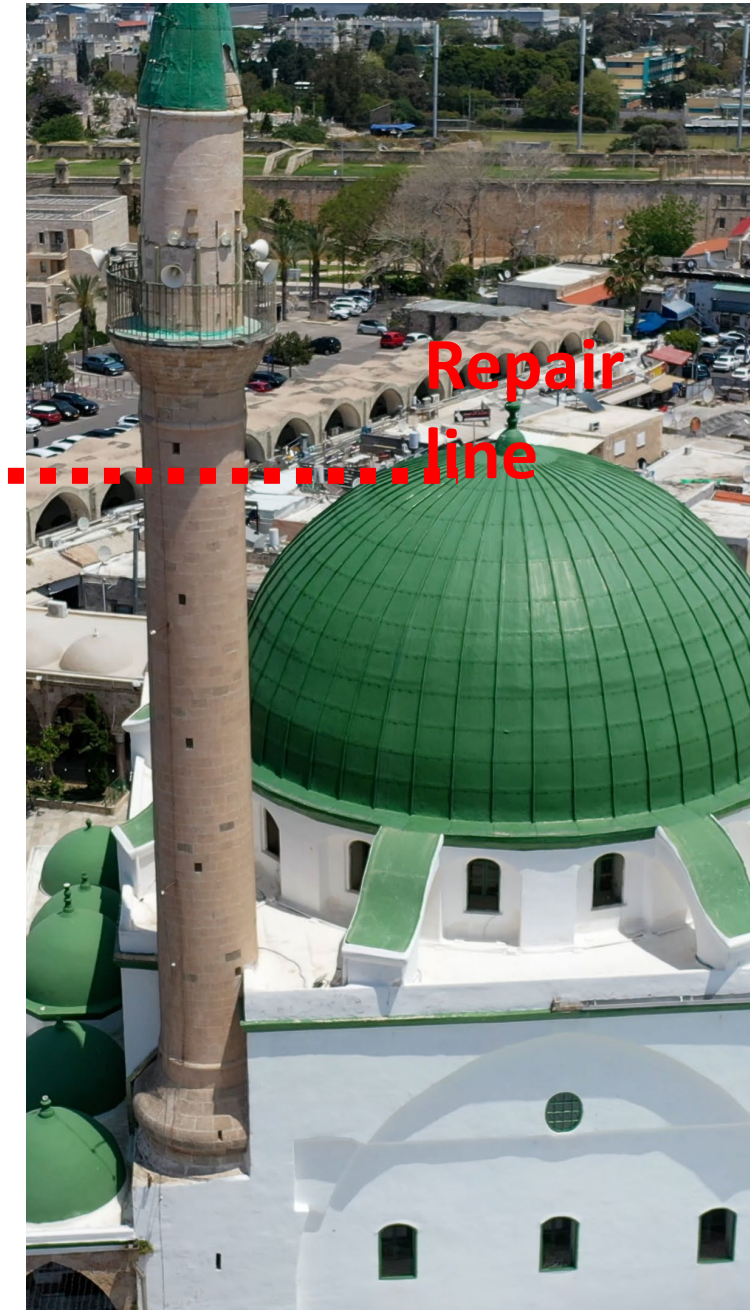
The foundations of the minaret

The base of the minaret is extremely delapidated. Cracks in the minaret's central column and in the wall stones were documented. Some of these damages were probably due to dampness that seeped into the shaft of the minaret, making the metallic nails that attached the stones to each other rust and expand.

Many years ago, a fire had broken out at the base area. This fire and the heat it produced caused damage to the stones and cracking.
