Preservation Survey and Situation Assessment

Acre's El-Jazzar Mosque (Various examples)

Dr. Abdel Razeq Matani

February 2023

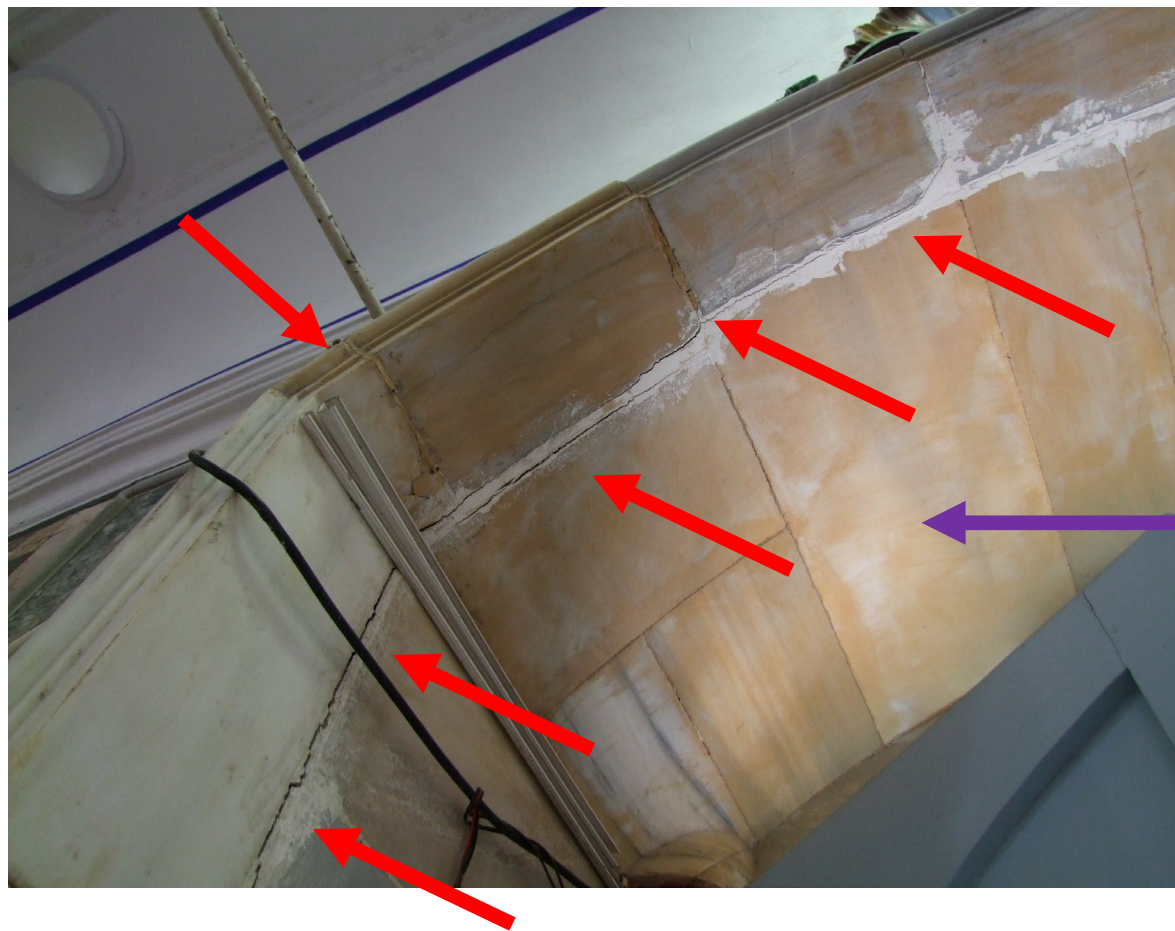
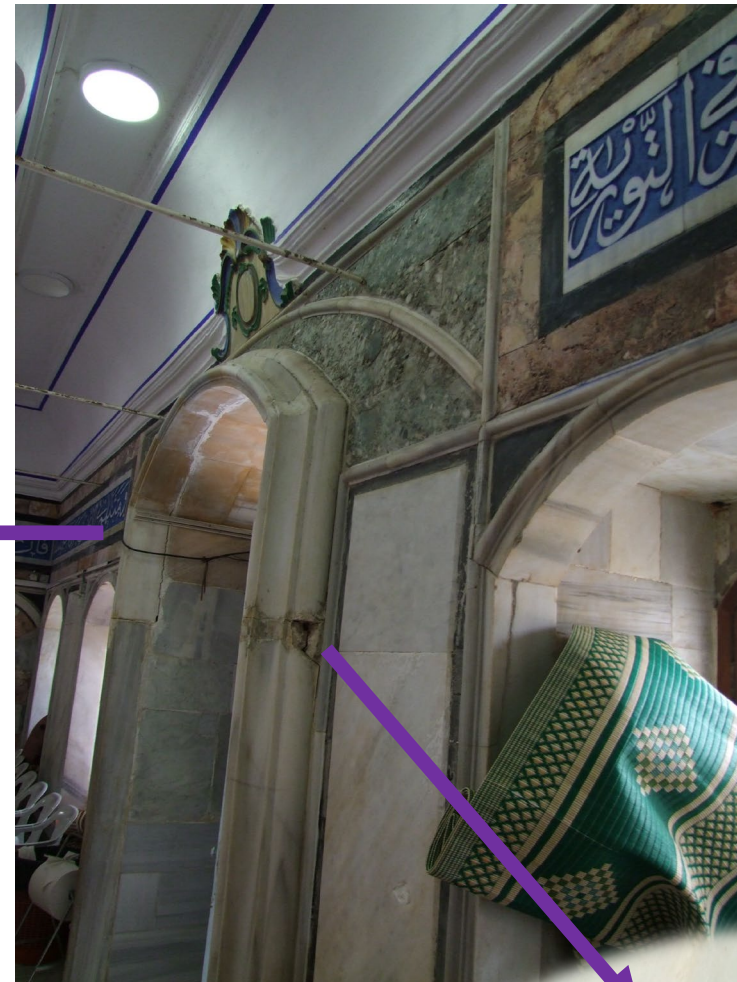
**Damage to the
lintel
Above the entranceway**

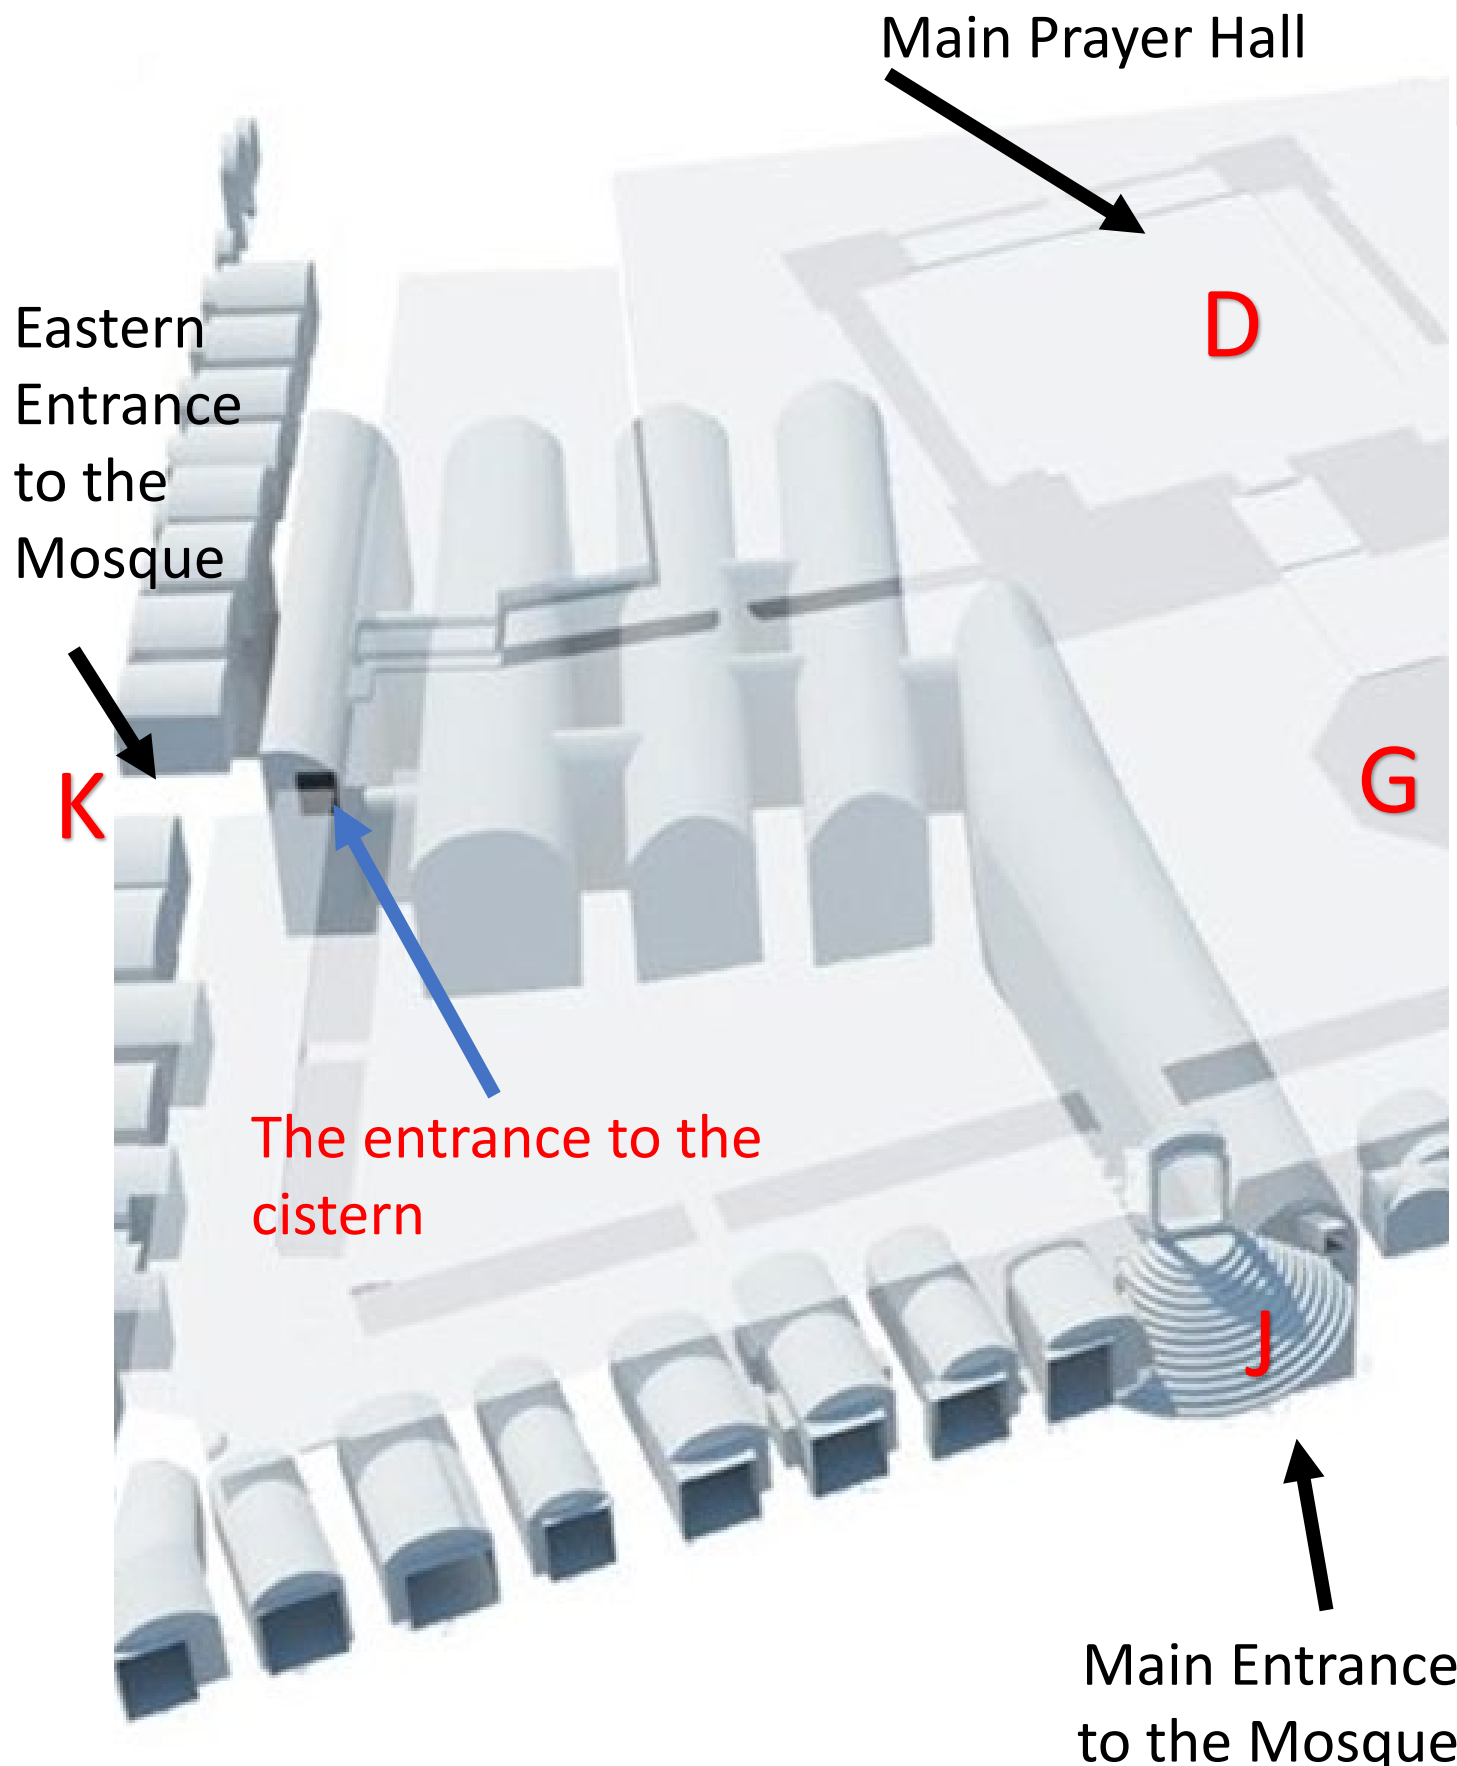
The underground cistern (H)

An underground cistern in the northeastern part of the courtyard of the mosque. The water was channeled into the cistern through an aquaduct that supplied water from the el-Kabri area, supplementing the rainwater that had drained into the cistern from the openings in the courtyard of the complex. The water was used for drinking and for ritual ablution. They were channeled to the *mutawadda* at the heart of the compound, and to the *sabil*, adjacent to the complex's main entrance. The entrance to the cistern is close to the compound's eastern entrance. The cistern is reached through a small door. After entering, a stairwell leads down to the base of the cistern. The cistern is comprised of four central pointed barrel-vaults, in addition to the vault at the entrance, and a small vault that drained the water entering the cistern.

In the past, the cistern was a tourist site. Metal and wooden paths were installed, but today, it is closed to the public because of the restoration work that needs to be done there.

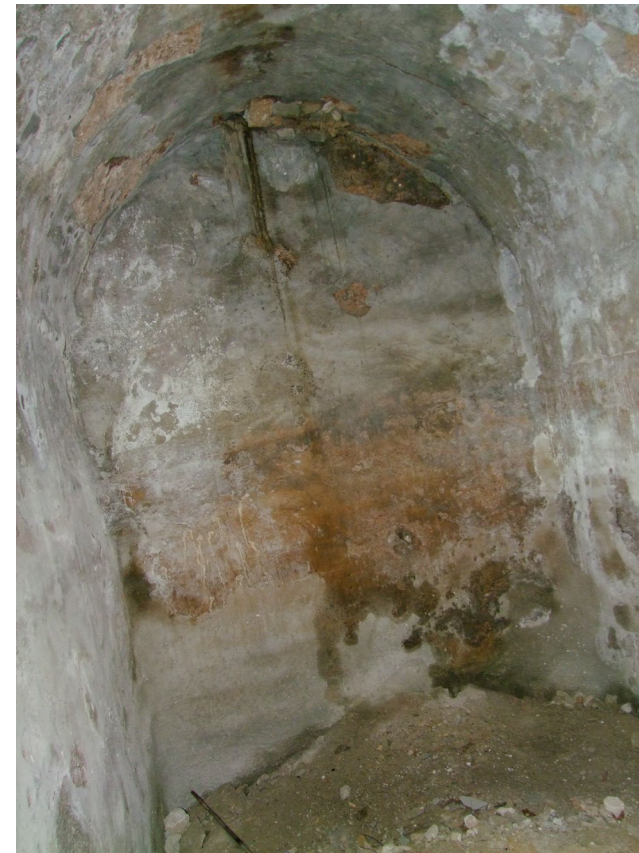
- Piles of trash and filler material in the reservoir
- The opening of the upper pit is boarded off with wooden and metal boards, covered in a layer of cement.
- Severe weathering of the stones in the ceiling and above the opening of the upper pit, in the walls of the reservoir, and in the wall separating Reservoir 1 from Reservoir 2
- Damage and detachment of the original layer of plaster from the walls
- Severe dampness in the ceiling and walls

Right: General view of the reservoir

Above: The ceiling of the reservoir and the upper pit

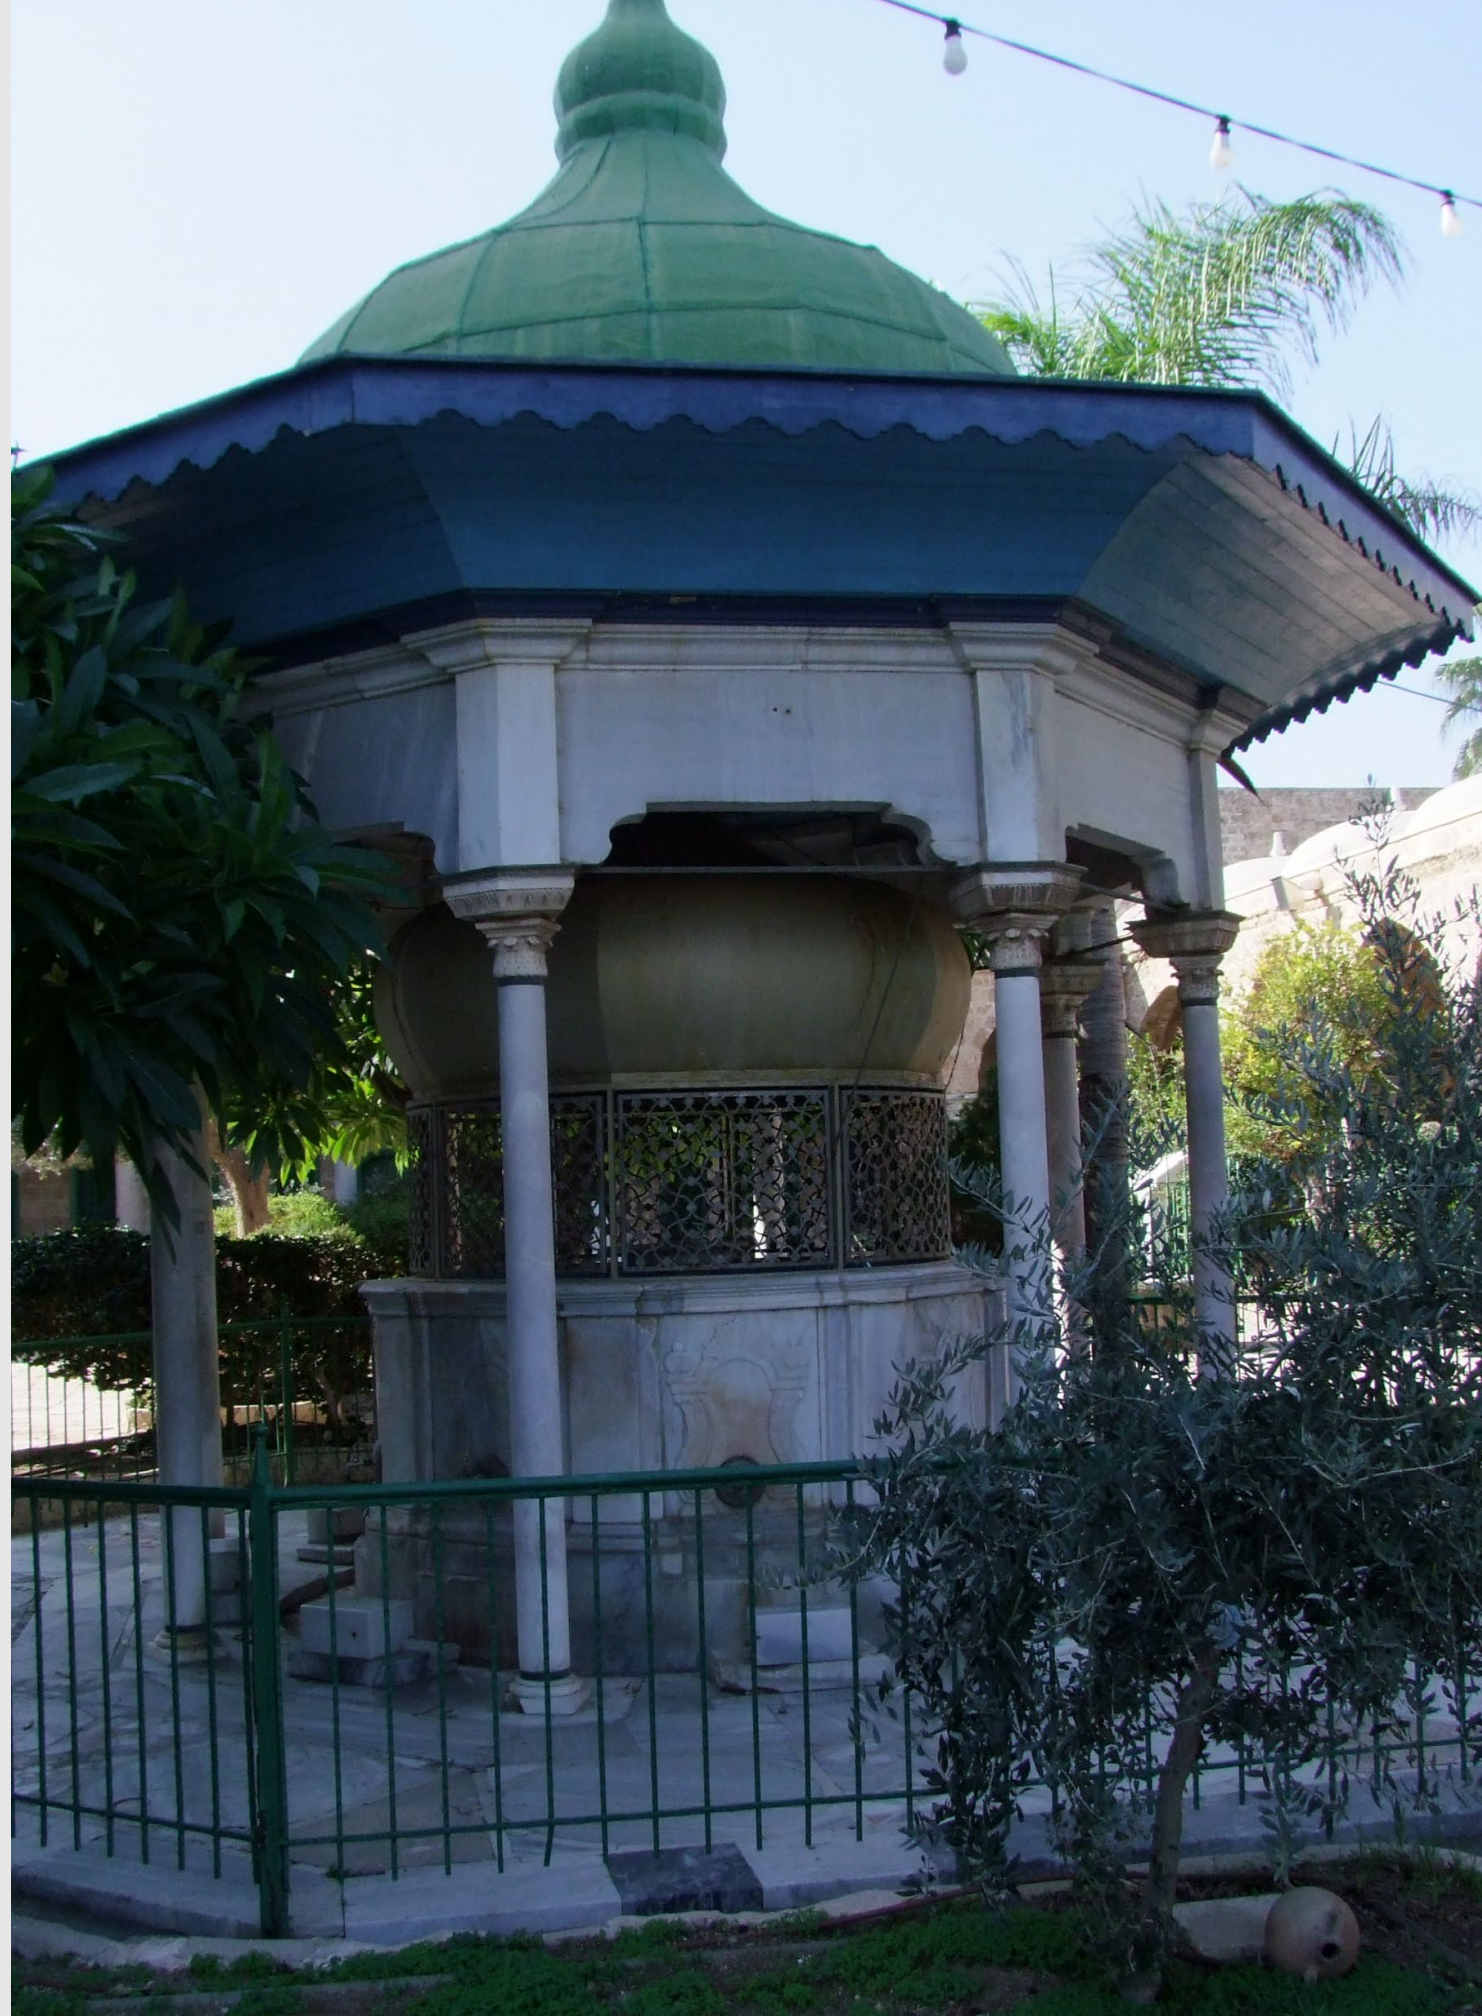
Column 2

- Light pulverization and erosion in the shaft
- Severe erosion and cracks in the pillar's capital
- Cracks in the base of the pillar, fractures and missing pieces in the base of the pillar
- Rust in the metal rings attaching the pillar
- Surface deposits and patina in the marble slabs above the pillar
